EA05-005
STEPTOE & JOHNSON
FOR TEXAS INSTRUMENTS
2/23/2006
ATTACHMENT PART 3 OF 3

Determine cause of high resistance at terminals

The defect is due to the formation of a thick layer of a corrosion product containing copper, zinc, carbon, and oxygen. This layer is always thickest at the outside tip and it diminishes greatly as one approaches the plastic base. We don't see any evidence of it inside the electronics cavity.

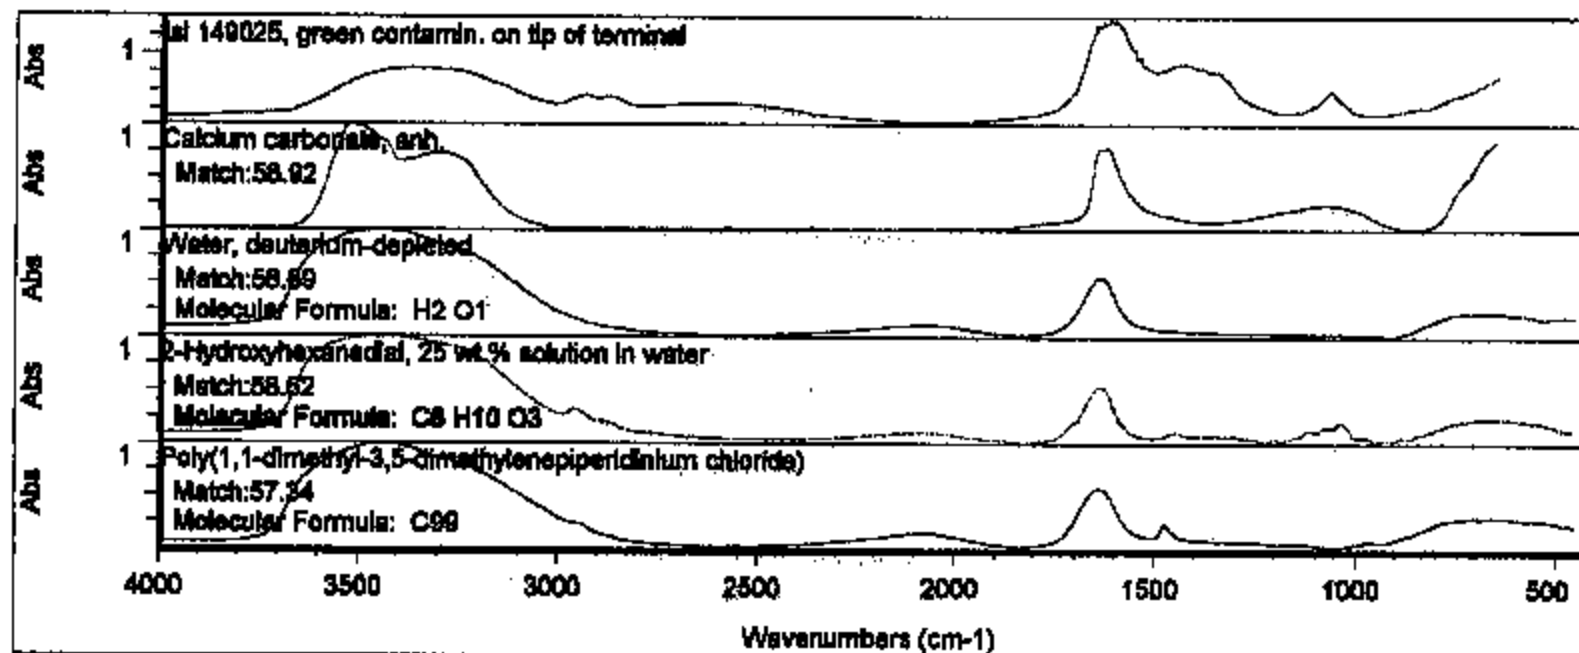
Spectrum: ts1 149025, green contamin. on tip of terminal

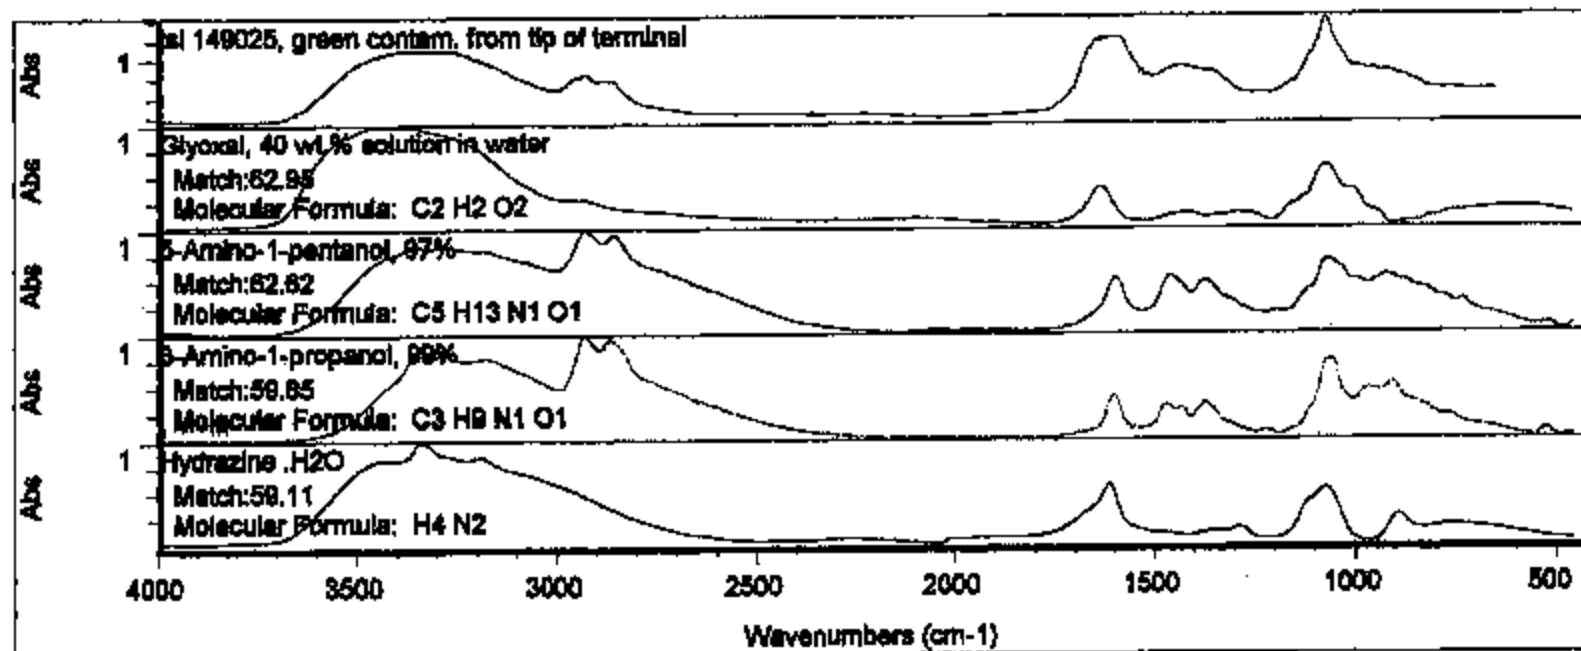
Spectrum: tsl 149025, green contam. from tip of terminal

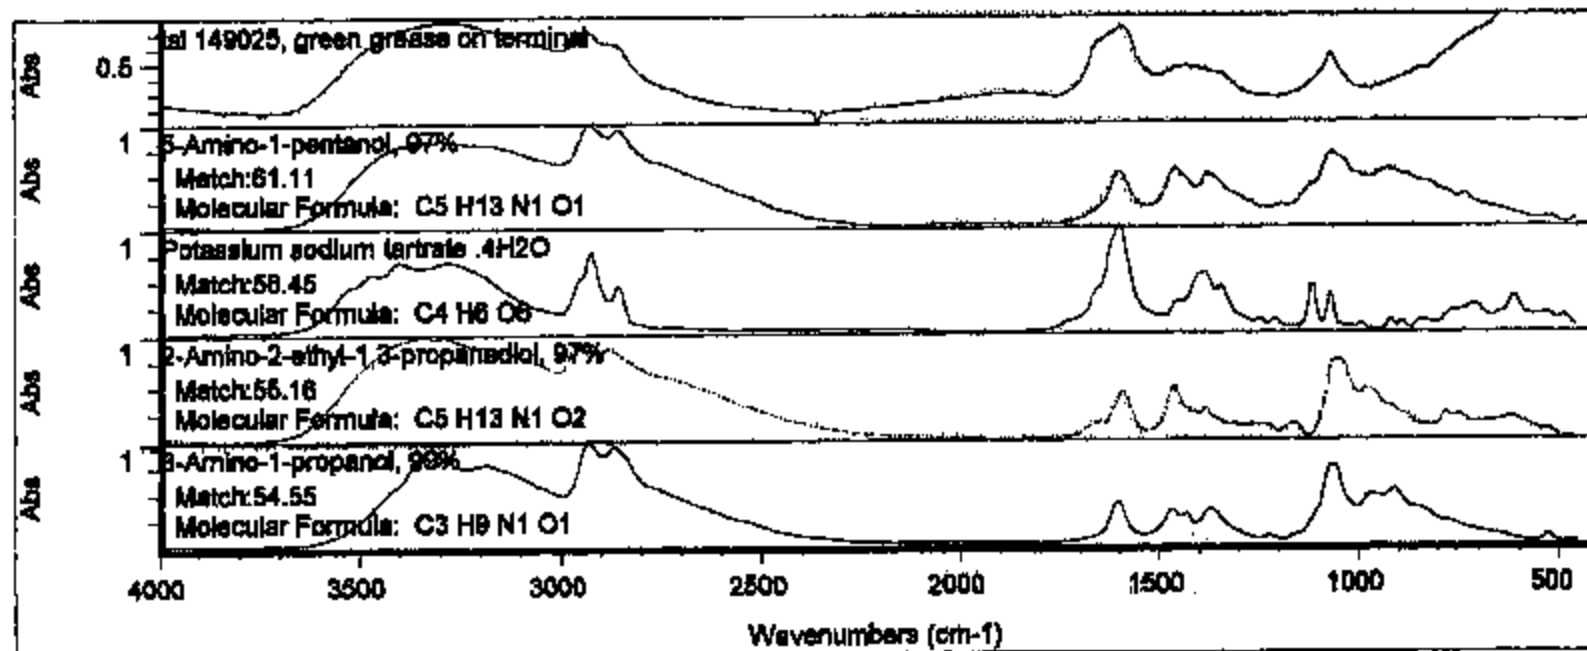
Spectrum: tal 149025, green grease on terminal

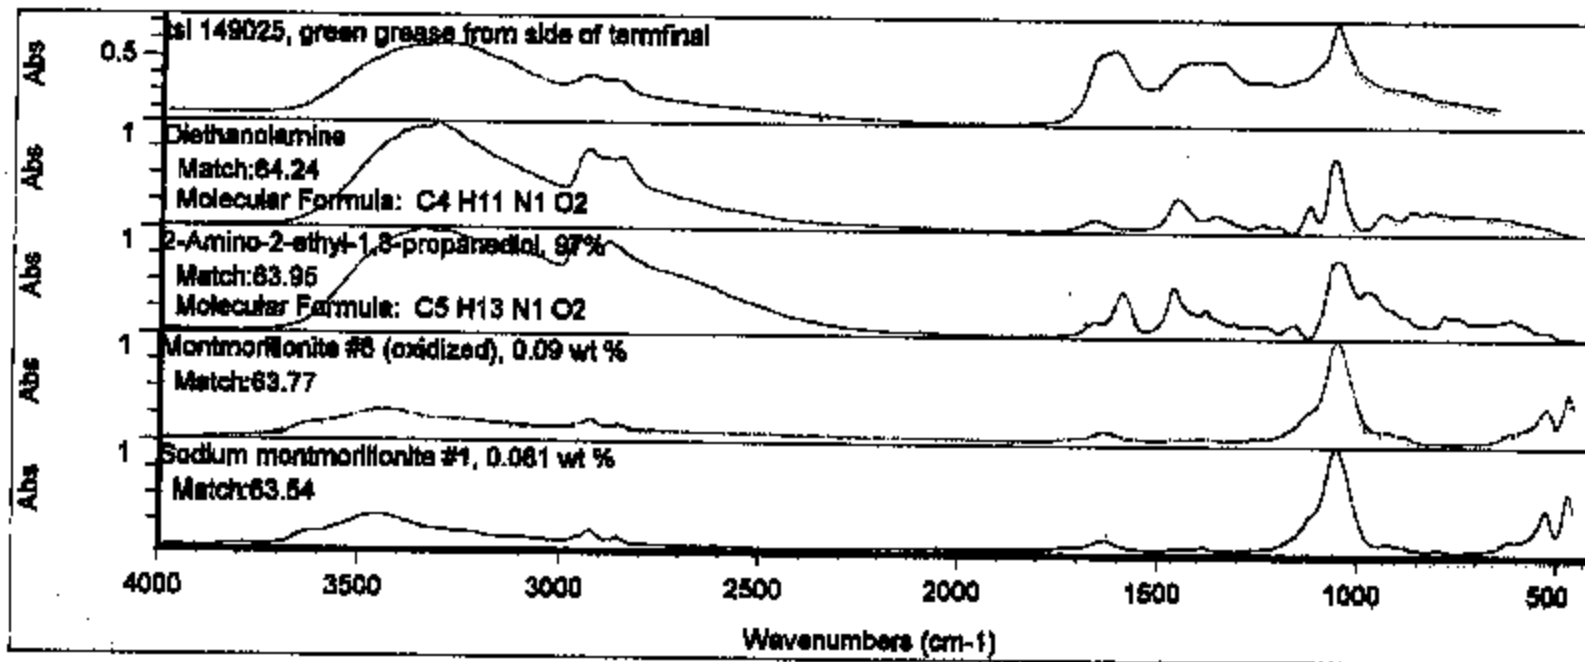
Spectrum: tal 149025, green grease from side of terminal
 Wed Jun 24 16:01:13 1998
 Region: 3995.85 649.98
 Search type: Correlation
 Comment:

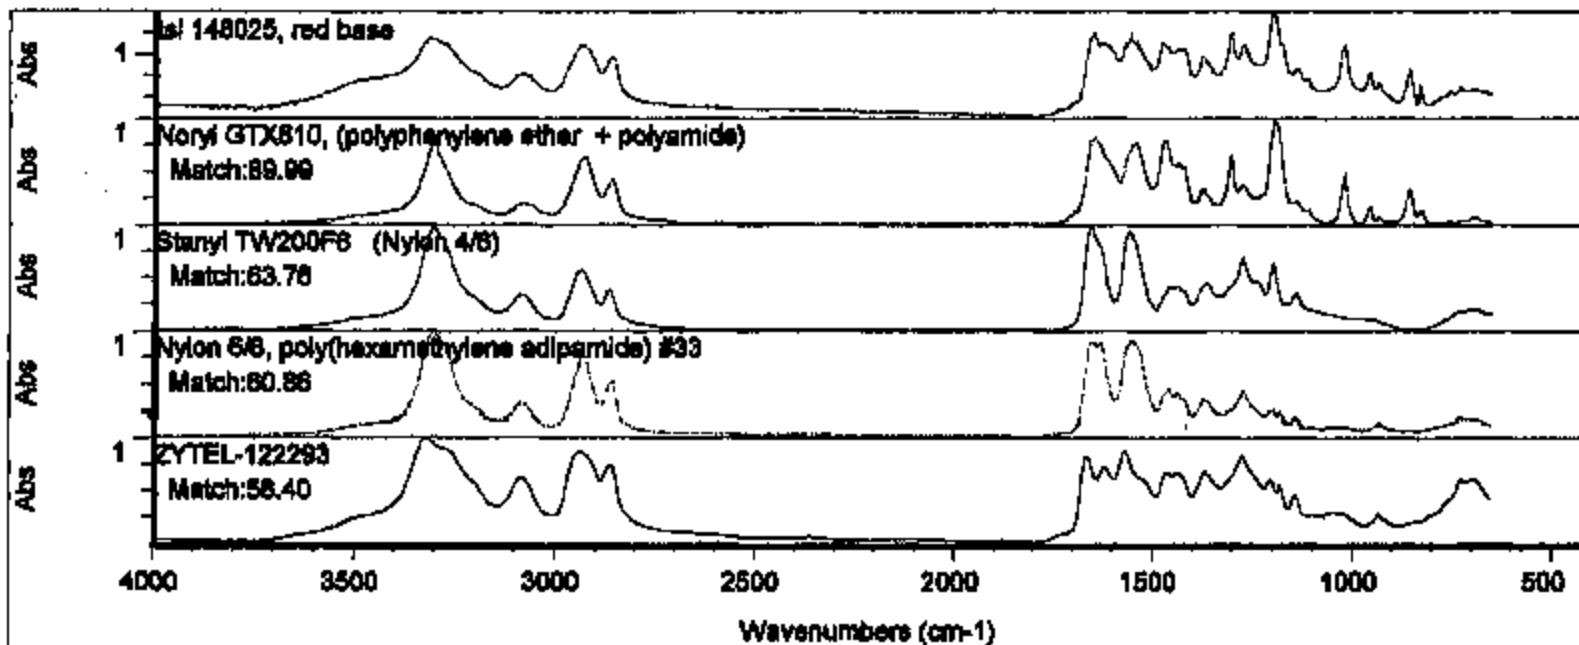
Spectrum: tsl 148025, red base

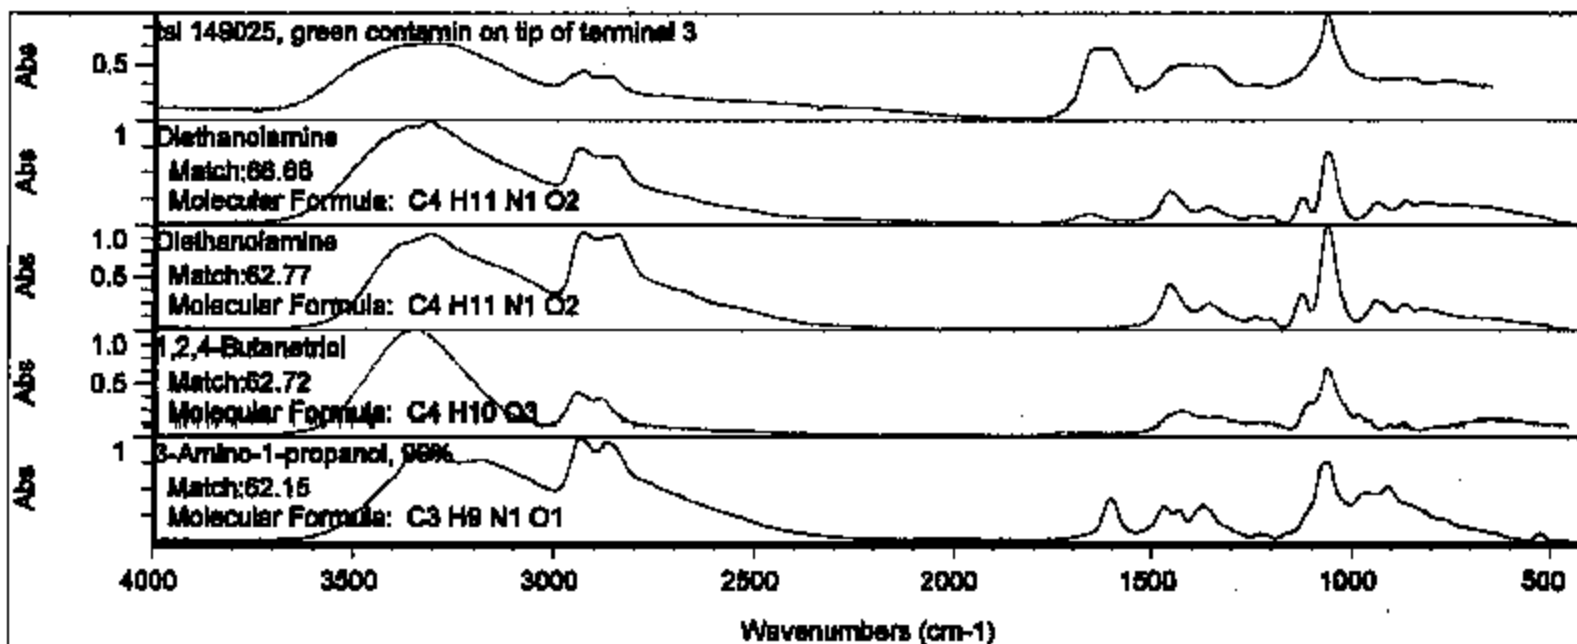
Spectrum: ts1 149025, green contamin on tip of terminal 3
