MITSUBISHI
4/6/2005
LETTER TO ODI
ATTACHMENT
DOCUMENT NO. 1 - 12
PART 2 OF 4

< Meeting Minutes regarding MMNA ST Headlamp Connector Melting Damage >

<MMNA Production Vehicle Headlamp Connector>

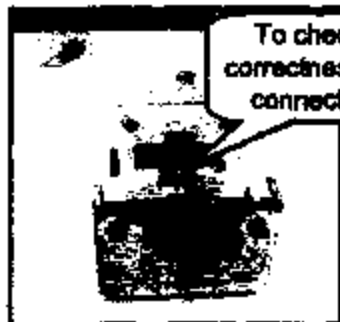
*Trial #2:
Simulate wrong insertion
of connector to checker
fixture*

*Terminal is still good.
(Not loose)*
