MITSUBISHI
4/6/2005
LETTER TO ODI
ATTACHMENT
DOCUMENT NO. 13 - 25
PART 3 OF 4

Meeting Minutes : Document Number J801-B091

<MMNA Headlamp Connector Melting Damage Meeting 01.5.31 >

Company	Mitsubishi Motors Corporation																
Subject: MMNA Headlamp Connector Melting Damage Report (Harness supplier terminal clamping control investigation) Date of Issue: May 31, 2001 Report No.: J801-B901 Author: YAZAKI Date of Test: Unknown (close to May 31, 2001) Test Place: YAZAKI																	
Test Vehicle and Sample Sample: Harness terminal Plant: YAZAKI Nimi plant, Daitoh plant, EMI, YTMI																	
Scope(s) Investigate control of terminal clamping activities at wiring harness supplier																	
Summary of Test Conditions and Test Results -Conclusion: (1)Contact force control, Wire tension (Fixing force) control 1)Contact force control : Not controlling. 2)Wire tension (Terminal Fixing force) : controlling (2)Applicator variation, clamping shape and press machine control																	
<table border="1"> <thead> <tr> <th>Machine</th> <th>Type</th> <th>Items Checked</th> <th>Checking Frequency</th> </tr> </thead> <tbody> <tr> <td>Applicator</td> <td>87</td> <td>from

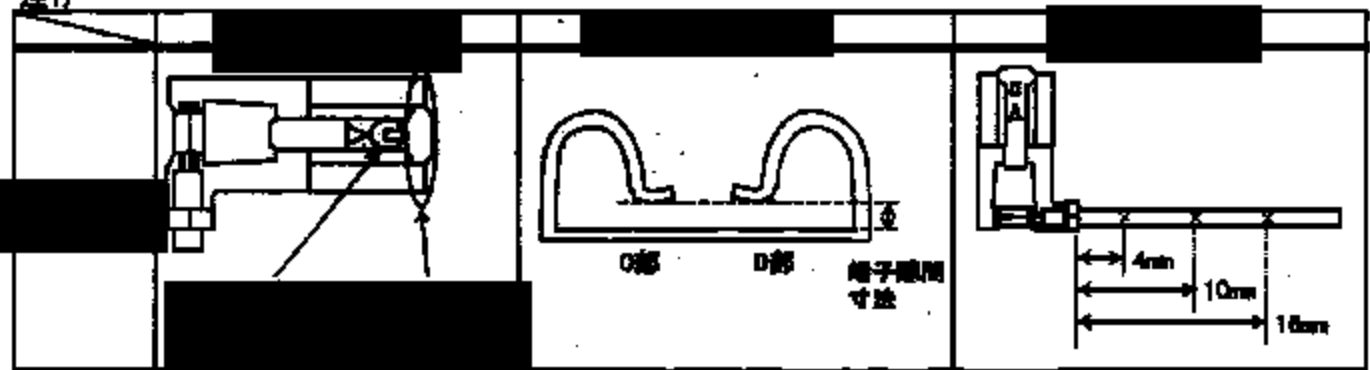
(所見)

Company	Mitsubishi Motors Corporation
Subject: Investigation of parts recovered from market (Investigation of parts recovered from market) Date of Issue: unknown Report No.: N/A Author: N/A (Yazaki) Date of Test: unknown Test Place: unknown (maybe YAZAKI in Washizu City)	
Test Vehicle and Sample Vehicle: Model(s): ST24S Sample1: Recovered parts 256713 (April 12, 2001) Sample2: Recovered parts 256491 (April 11, 2001)	
Scope(s) Investigate parts recovered from the market and contribute to analysis of root cause	
Summary of Test Conditions and Test Results -Conclusion: (1) Visual inspection No marks at mating side of terminals corrosion present on terminal surface (2) Electrical resistance values Resistance at the clamp is relatively low, however the terminal contact resistance is significantly high. (3) Impurities specifying investigation After bench test, significant amount of chlorine (Cl) detected from the sample. However, little Cl detected from the recovered samples. (4) Terminal gap investigation Com terminal gap wider than male terminal width (0.75mm), thus no contact The deeper the terminal is from entrance of male connector, the wider the Com terminal gap becomes. (5) Wiring hardness investigation The exothermic source could not be identified as either the terminal contact or clamp.

物7A(D)		
COM		測定不可 (0.48)	測定不可 (1.17)	—
Lo		4.28 (1.27)	148.6 (1.07)	—
Hi		9.80 (0.71)	208.8 (0.78)	—
Lo	A部	多量 Cu, Sn, I 少量 O, S, Cl, K	多量 Cu, Sn 少量 O, Na, S, Cl, Ca	多量 Cl, Fe, Cu, Zn, Sn 少量 O
	B部	多量 Cu, Sn 少量 O, Cl, Zn	多量 — 少量 —	多量 Cl, Cu, Sn 少量 O, Cr, Fe, Zn, Te
Hi	A部	多量 Ca, Cu, Sn 少量 C, O, Mg, S, Cl, K, Zn	多量 Sn 少量 O, Na, S, Cl, Cu	—
	B部	多量 Cu, Sn 少量 C, O, Mg, Cl	多量 — 少量 —	—
COM	G部	1.40(入口), 1.08(奥)	1.94(入口), 1.27(奥)	—
	D部	0.85	0.87	—
Lo	G部	0.88	0.88	—
	D部	0.88	0.88	—
Hi	G部	0.85	0.78	—
	D部	0.83	0.70	—
4mm		—	138	—
10mm		—	138	—
18mm		—	182	—

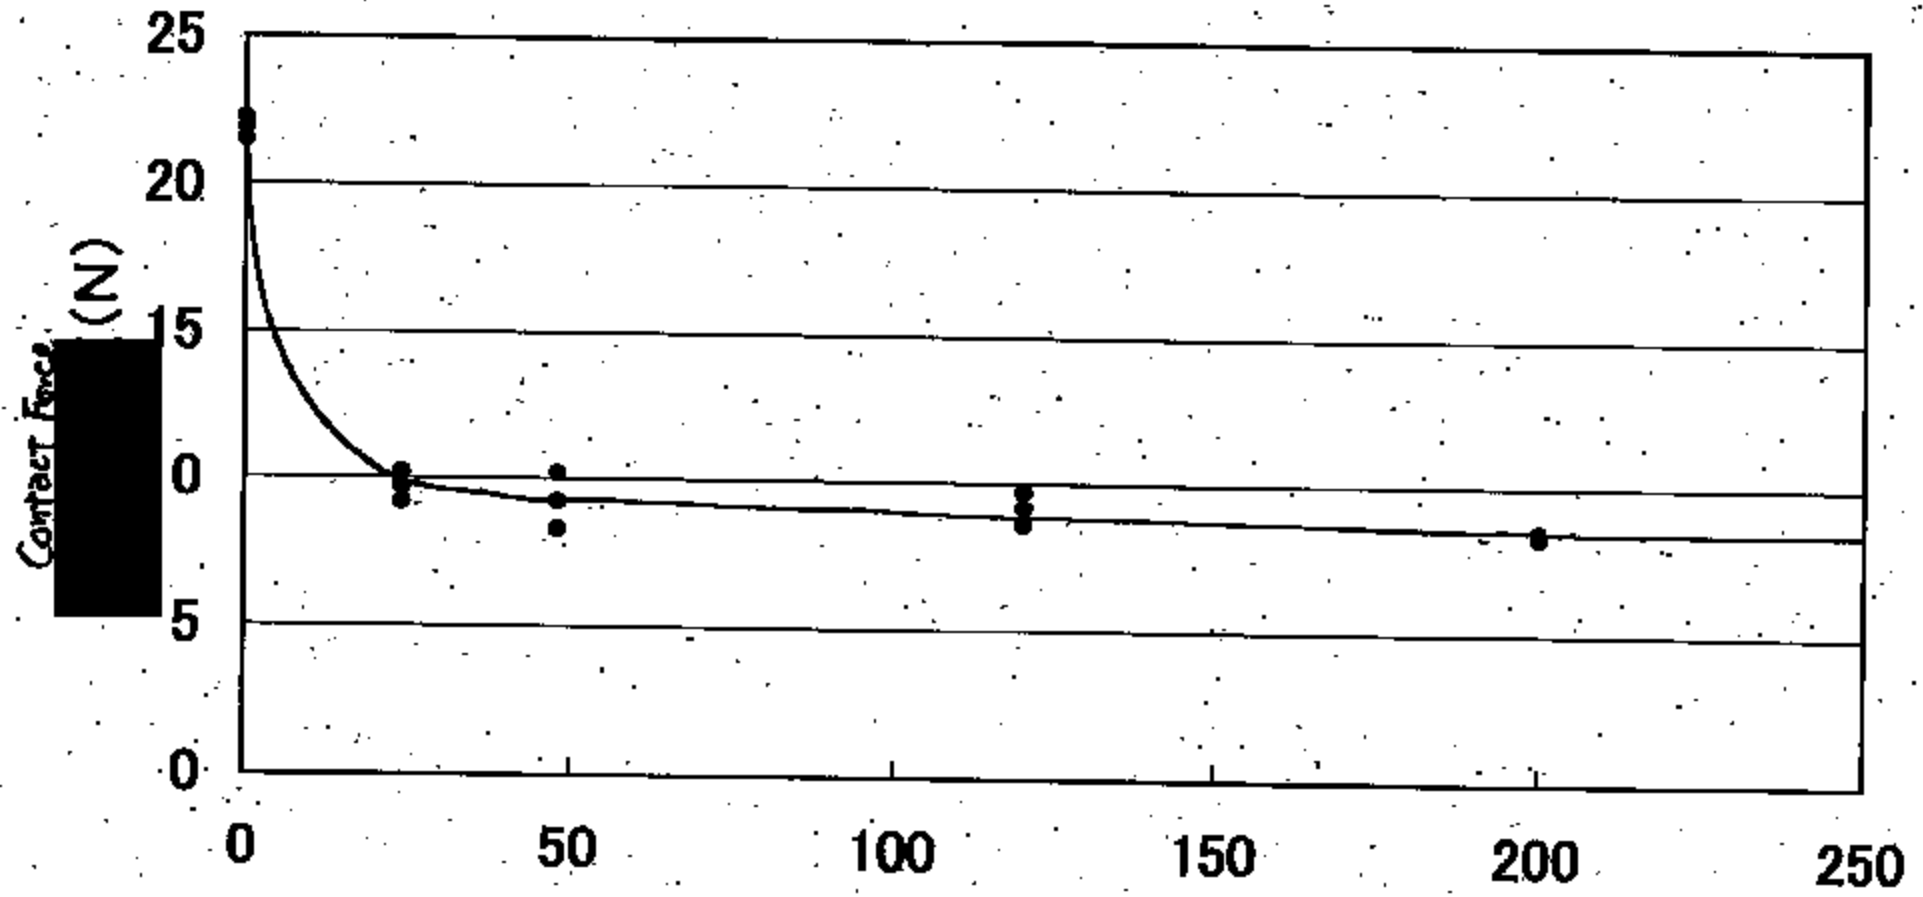
◀ Q Terminal STRESS relaxation by samples at 100°C ▶
[Redacted]
100°C
(JK)

(1) thermal stress relaxation characteristics of 312 terminal (AMP name: Q terminal)

- Figure at right shows current status
- Plan to conduct up to 500 hours. Report for 300 hour point. (Yazaki Corp. ⇒ MMC)

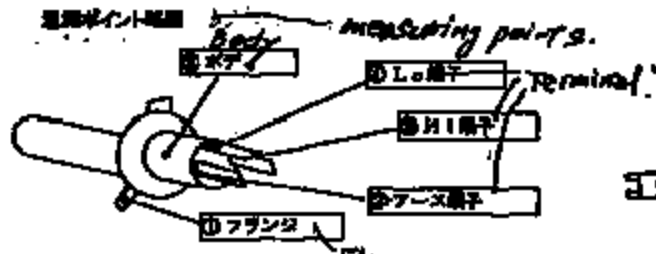
Stanley measured Data (3)

CONCLUSION:
ランプ本体での温度を比較し、上記図面参照より、バルブメーカーの違い及び灯体差による大きな温度差は認められませんでした。

There is no significant difference among the bulb supplier & lamp bodies, from Lamp Unit independent temperature measure ment. test result.

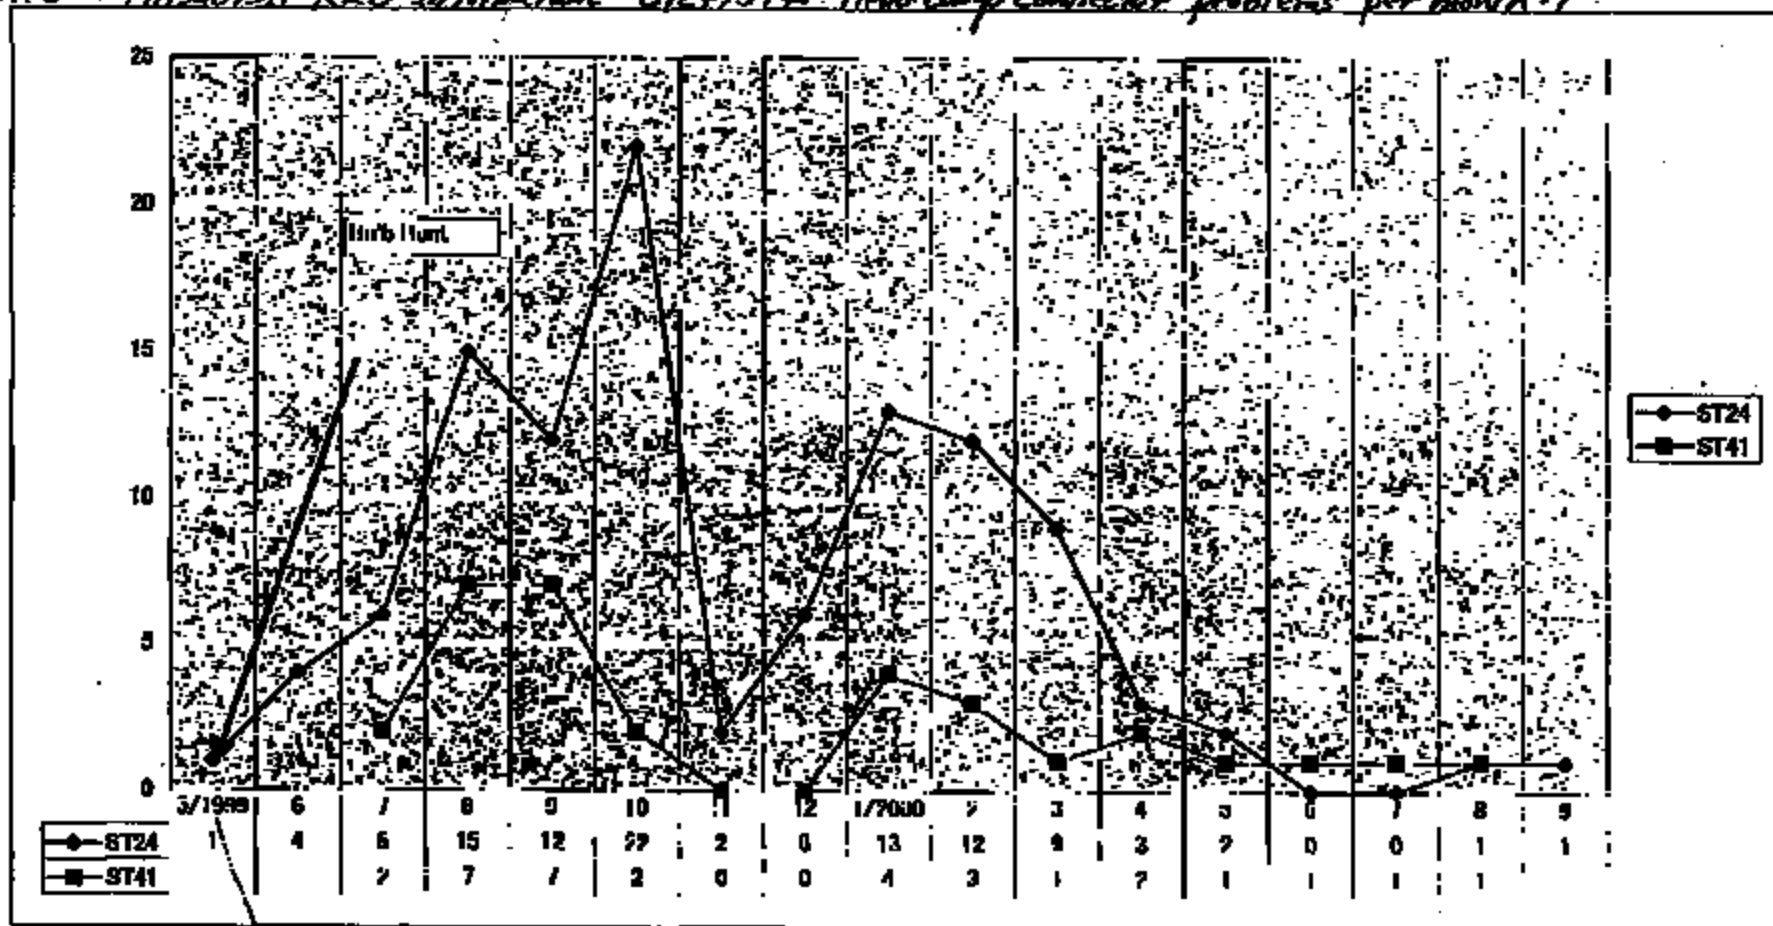
《Title : Mitsubishi R&D Information ST24/ST41 Head Lamp Connector problems per month》

Bulb male terminal bend control modifications since 99.5.11. Melting damage continued to occur even after that time and thus not major cause.

5/1 (ANN) 5/1 (in) A A/ (4) 20
 Bulb bent modification done from 5/1 delivered lot.
