MITSUBISHI
4/6/2005
LETTER TO ODI
ATTACHMENT
DOCUMENT NO. 26 - 34
PART 4 OF 4

MMMA ST24/28/41 Melt Headlamp Connector

ST24S Headlamp connector failure mode confirmation

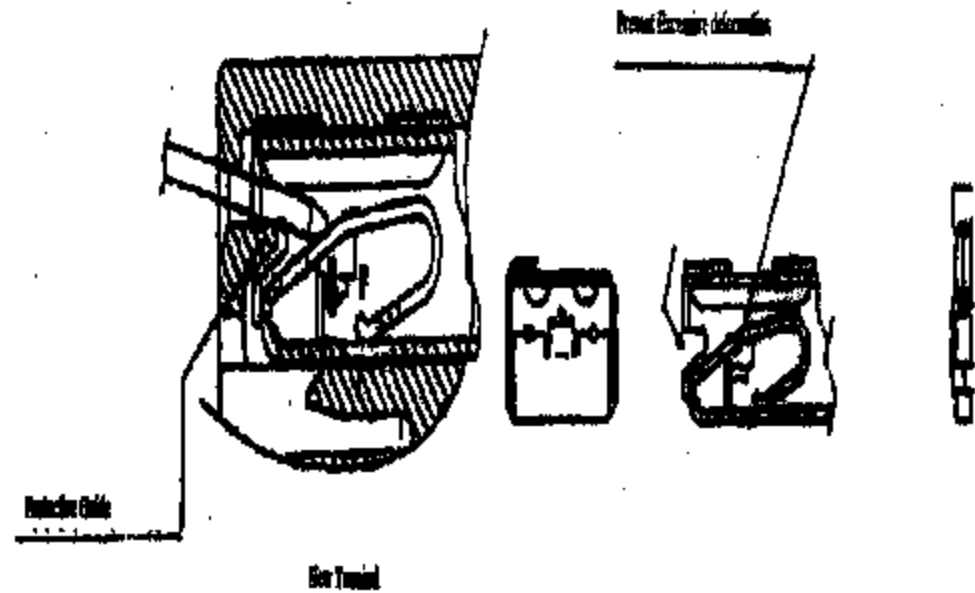
are required when replacing a defective light bulb.
res high force, wiggling) following can occur:
terminal -> Terminal Deformation -> Low Contacts Pressure ->
contacts -> Rising of Contacts Temperature -> Melt Connector
terminal -> Terminal Deformation -> Low Contacts Pressure -> Loose
ion -> Sparking/Discharging -> Increase of Resistance at Contacts ->
ature -> Melt Connector

7.1 The wire harness design will be changed in Aug. 01 (running change)!

- * Adoption of Anti-wiggling terminal:
- * Built-in protective guide at every cavity
- * Spring type contact for prevention of terminal deformation
- * Terminal Material Change: From Brass (threshold: 120 D.C.) to a

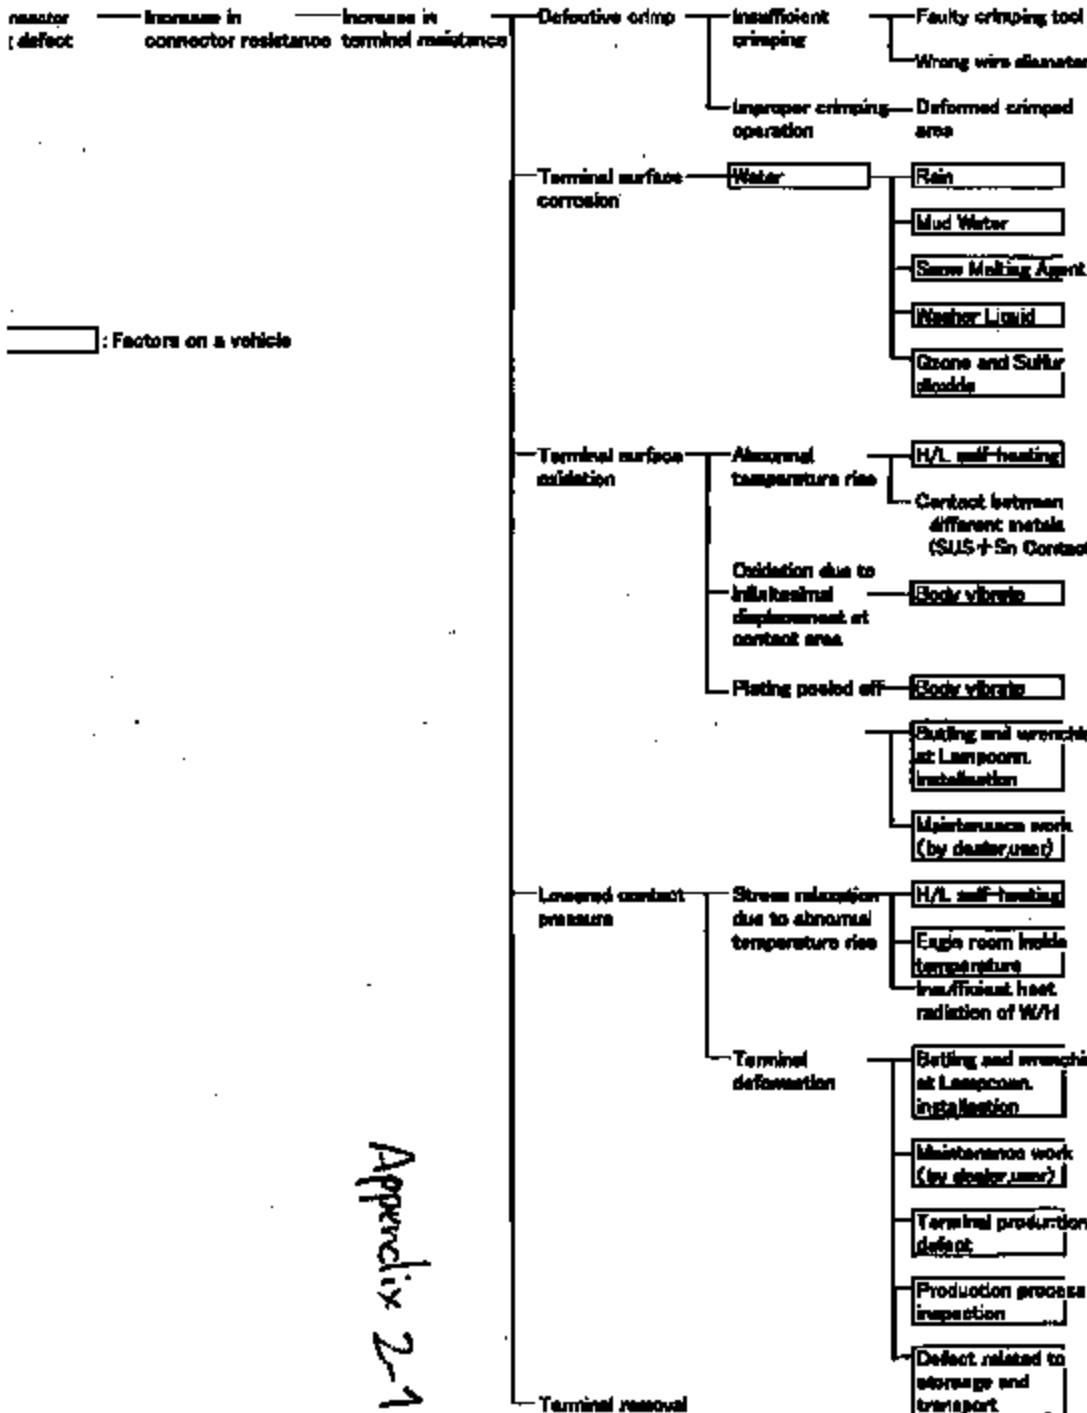
- Contact resistance of the terminals melted are very high although press contact resistance are low.
- Gaps of the terminal melted are wider than the other terminals and the gaps are the same as male terminal thickness or wider than male terminal.
- Appearances of arc marks on the terminal contact surface are similar with the arc mark caused on simulation test.
- From qualitative analysis, Cl which is found on the both of terminal corroded and discolored thinning portions caused by melted wire cover.

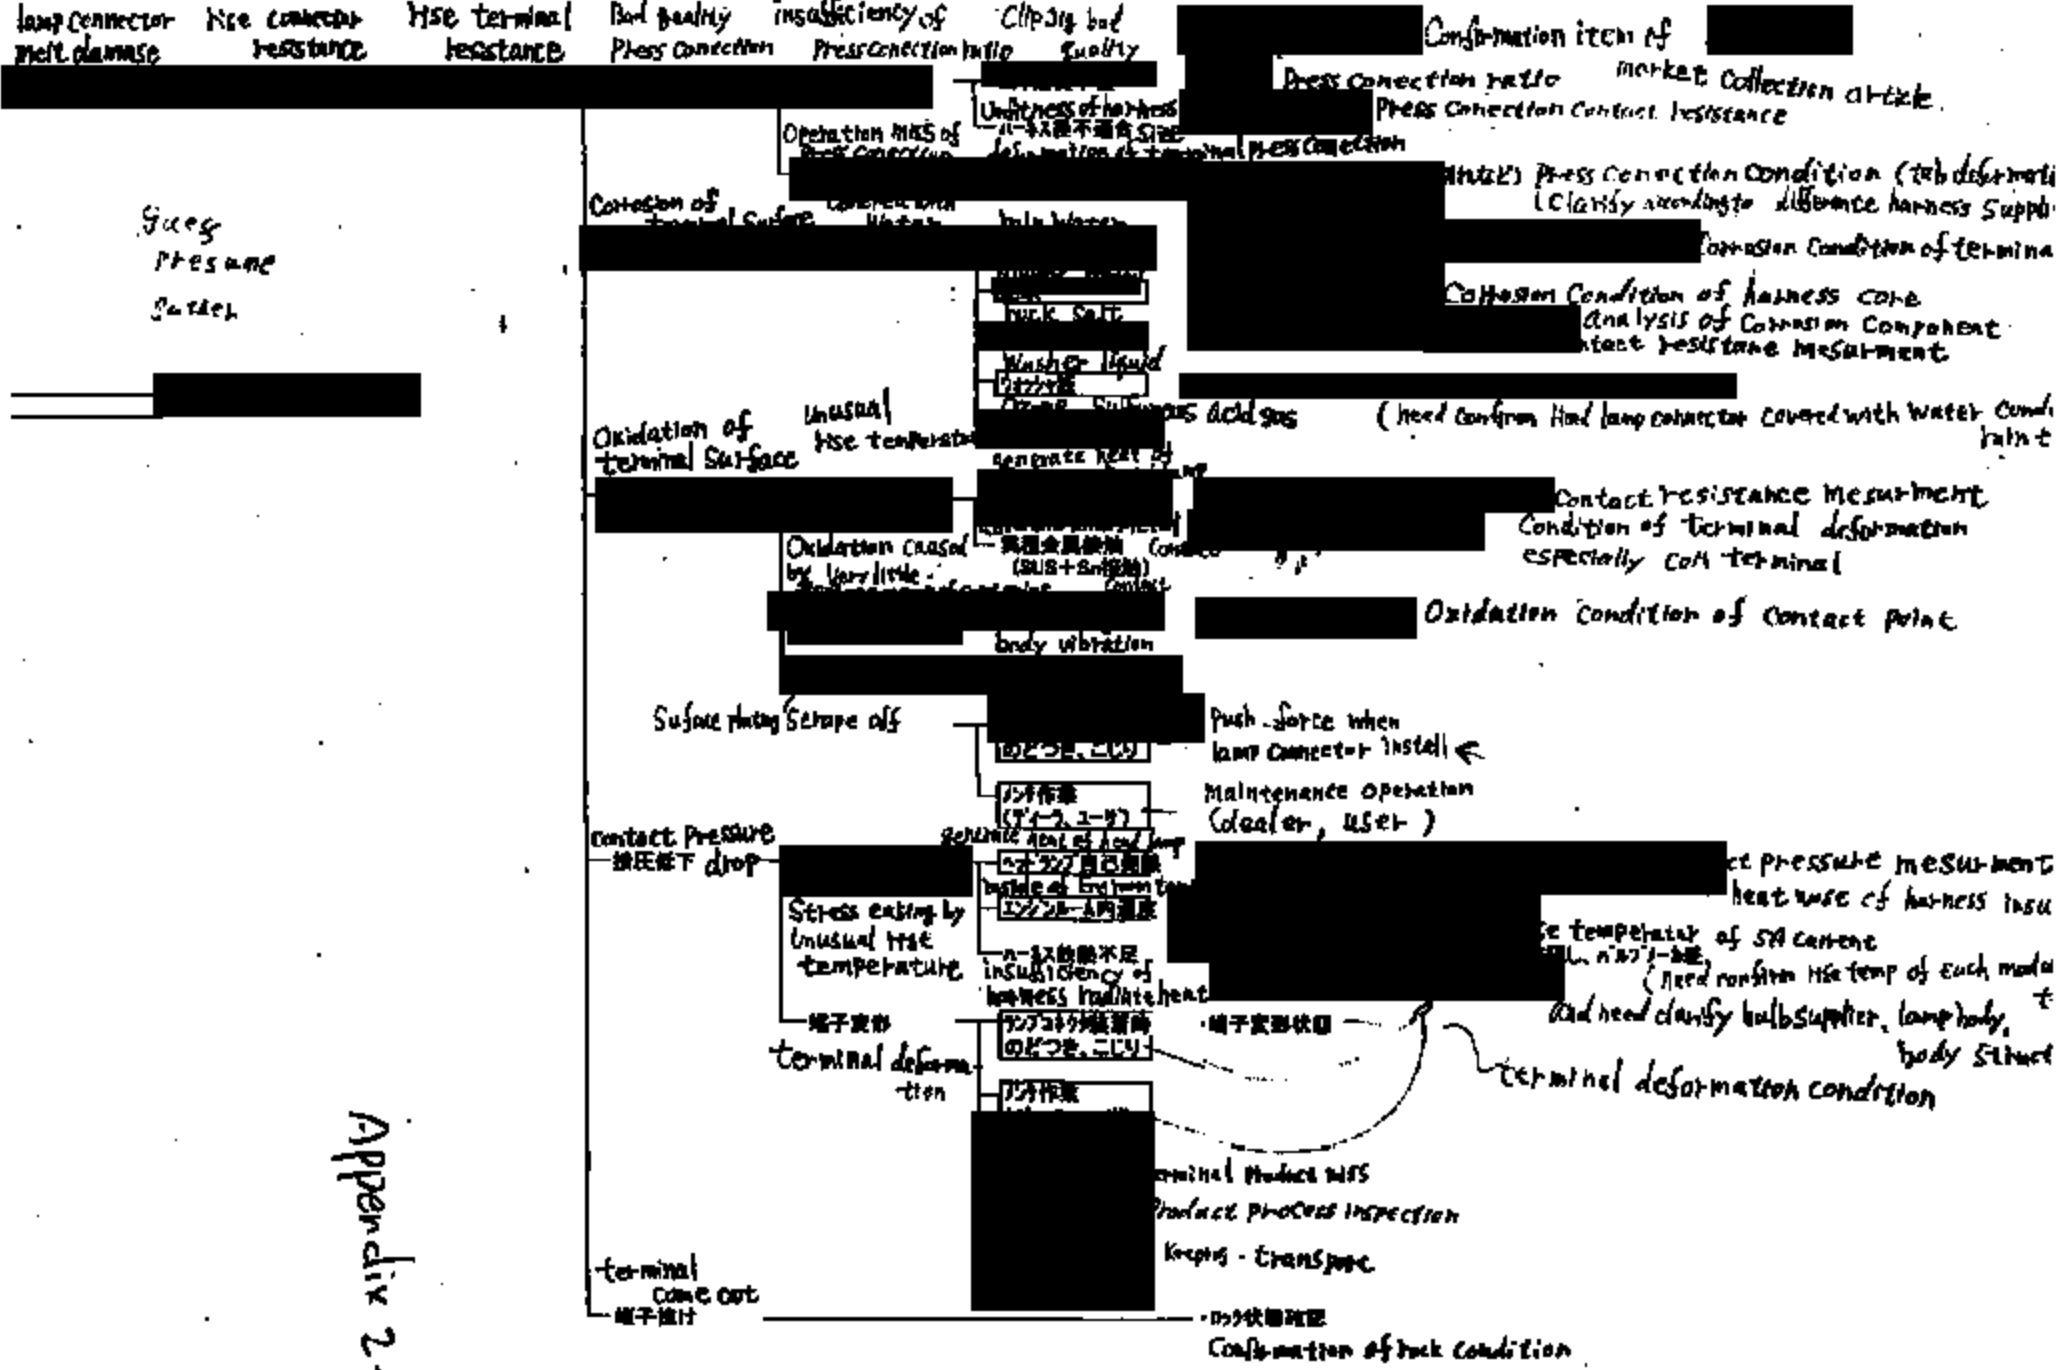
MMA STヘッドランプコネクタ溶損原因のFTA解析結果(MMC実施結果)

- (1) Wiggling of connector/terminal → Terminal Deformation → Low Contacts Pressure → Increase of Resistance at Contacts → Rising of Contacts Temperature → Melt Connector
- (2) Wiggling of connector/terminal → Terminal Deformation → Low Contacts Pressure → Loose Contacts Caused by Vibration → Sparking/Discharging → Increase of Resistance at Contacts → Rising of Contacts Temperature → Melt Connector

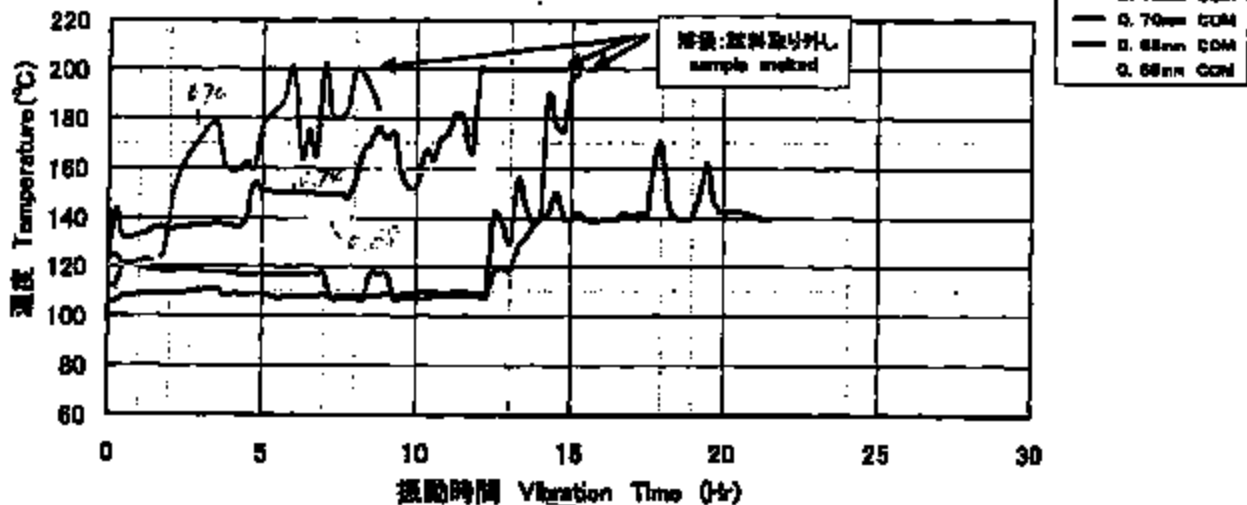
端子温度 Terminal Temperature (Room Temperature 70°C)

Terminal with more than 0.70mm contact gap had melted. Terminal with 0.68mm gap is still on going. Same test with NQ terminal will start.

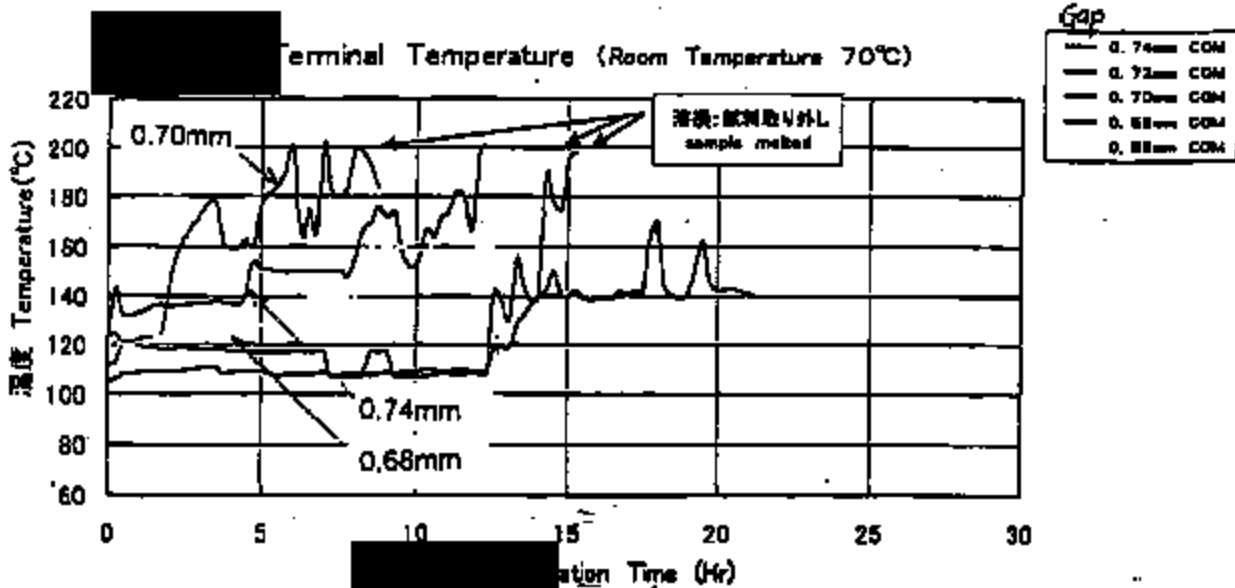
Terminal with more than 0.70mm contact gap had melted. Terminal with 0.68mm gap is still on going. Same test with NQ terminal will start.
