PE05-035
HYUNDAI
8/26/2005
REQUEST NO. 4
PART 3 OF 6

Consumer Assistance Center Case Report

CAUSE & ORIGIN REPORT

REQUEST: The investigation was authorized on October 22, 2004, by Mr. Rick Baisch, a claims representative with State Farm Insurance Company. The purpose of this investigation was to determine the cause and origin of a fire that occurred on September 30, 2004 in a 2003 Kia Sedona.

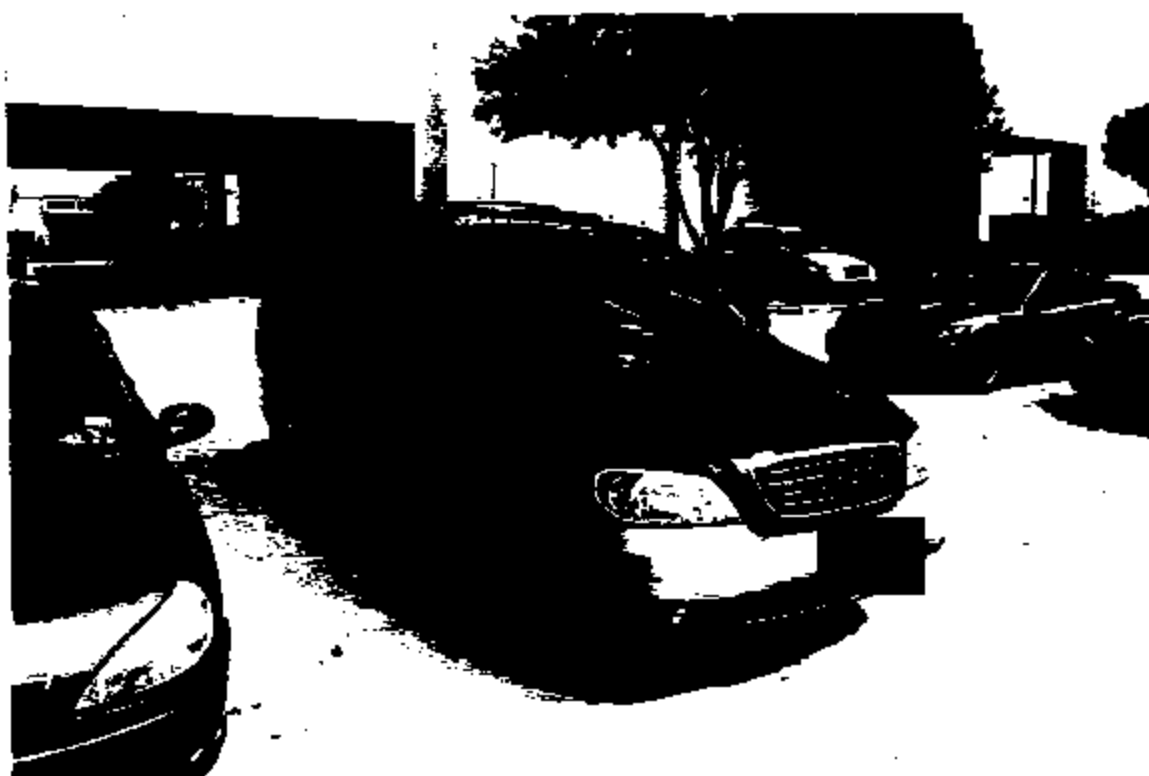
#5

PHOTO #5: Shows a view of the right front portion of the vehicle.

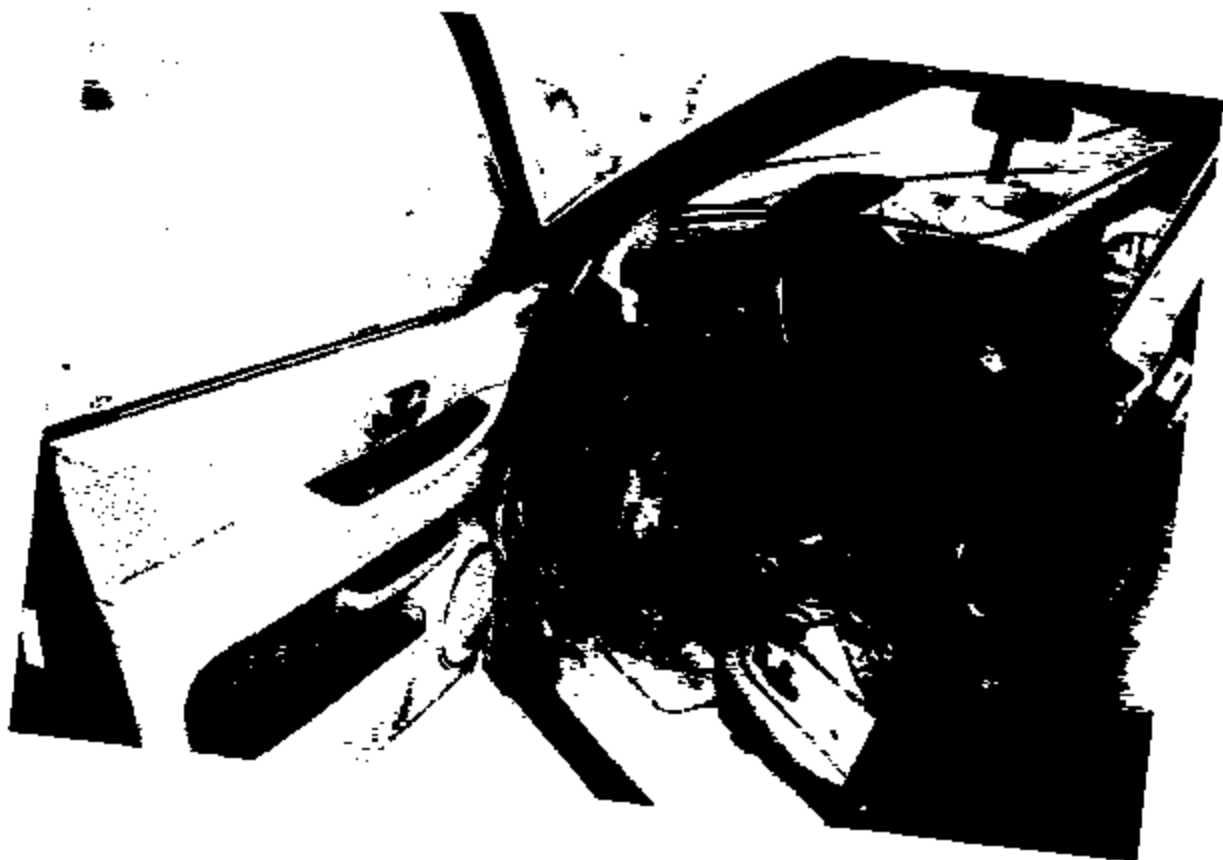
#13

PHOTO #13: Shows an overall view of the left front passenger compartment. Note this is area of most fire damage.

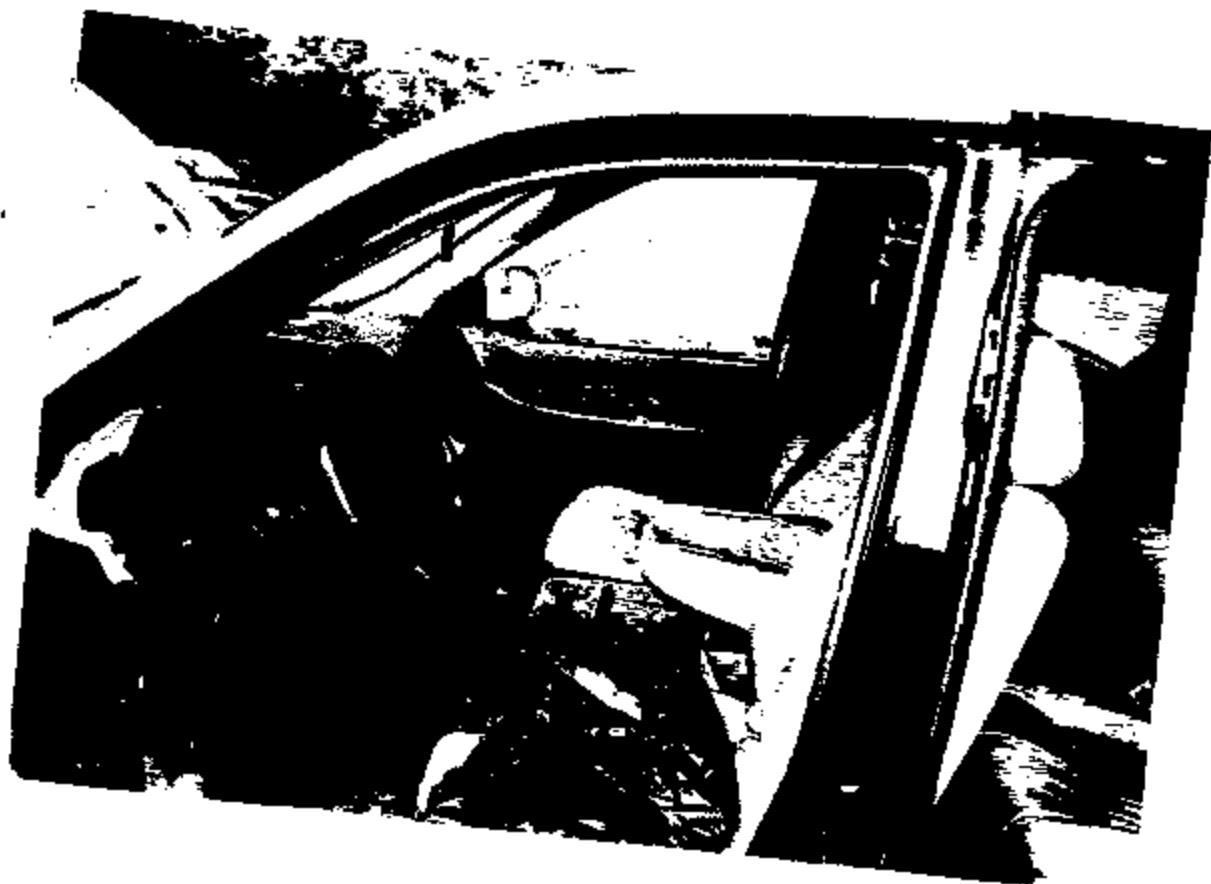
#14

PHOTO #14: Shows a view of the front seating area which shows some soot accumulations but no severe fire damage.

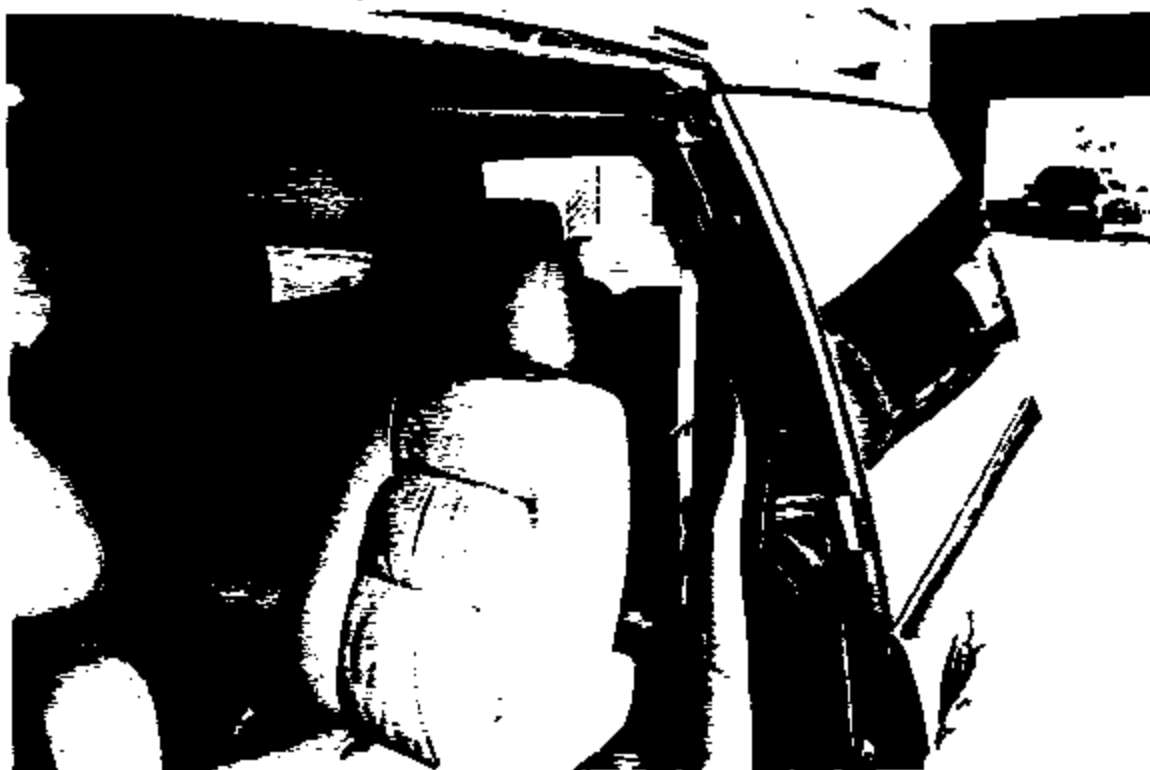
#15

PHOTO #15: Shows a view of the rear passenger compartment. Note the upholstery is sooted but no significant fire damage was noted.

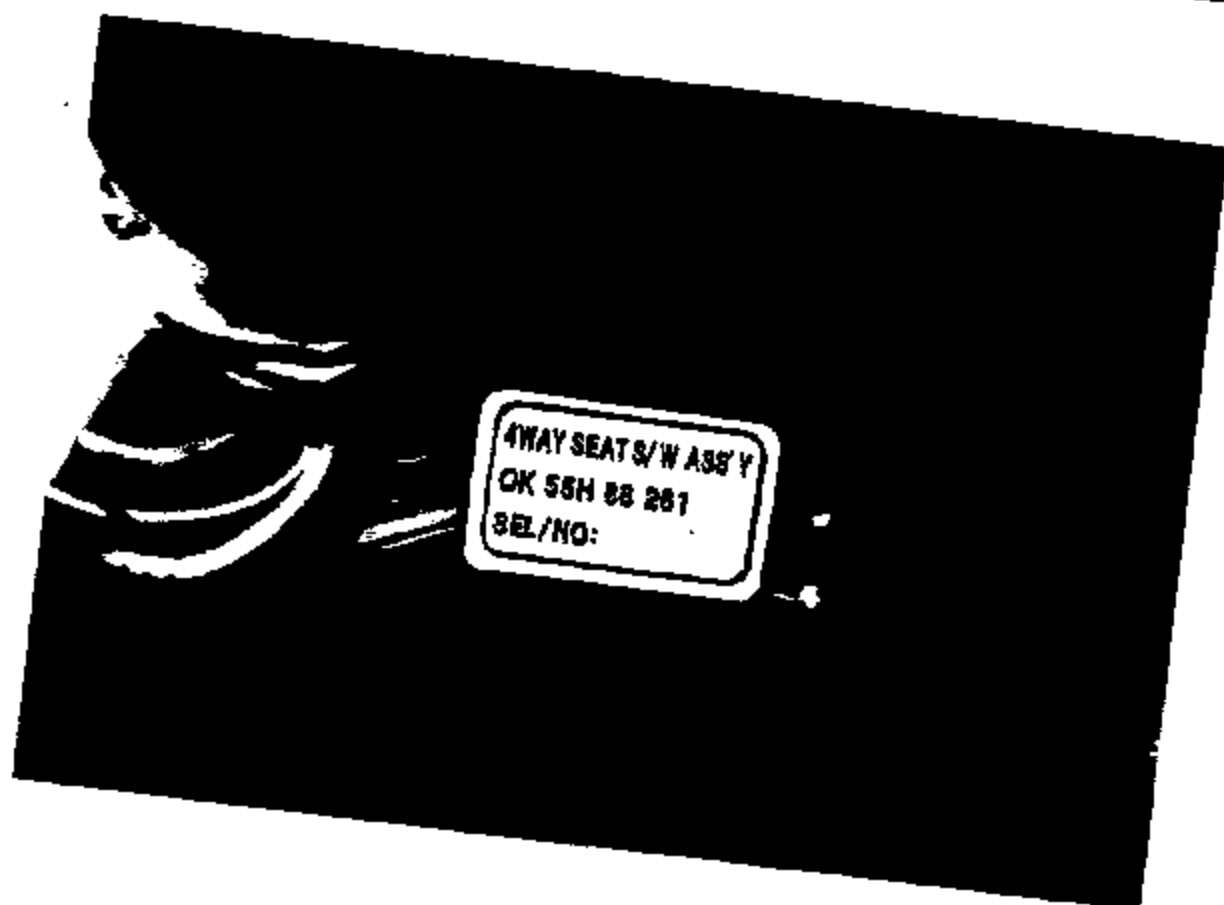
#34

PHOTO #34: Shows a closeup view of the four-way seat switch assembly. Note it did not appear that there was any internal damage with the switch but it was not opened.
