**PE05-067**  
**HEIL TRAILER**  
**12/19/2005**  
**EXHIBIT 7, 8, & 9**  
**PART 3 OF 3**

## FAILURE ANALYSIS OF TANK TRAILER FRAME COMPONENTS

ATS JOB #D 75275

Failure Analysis of Tank Trailer Frame Components

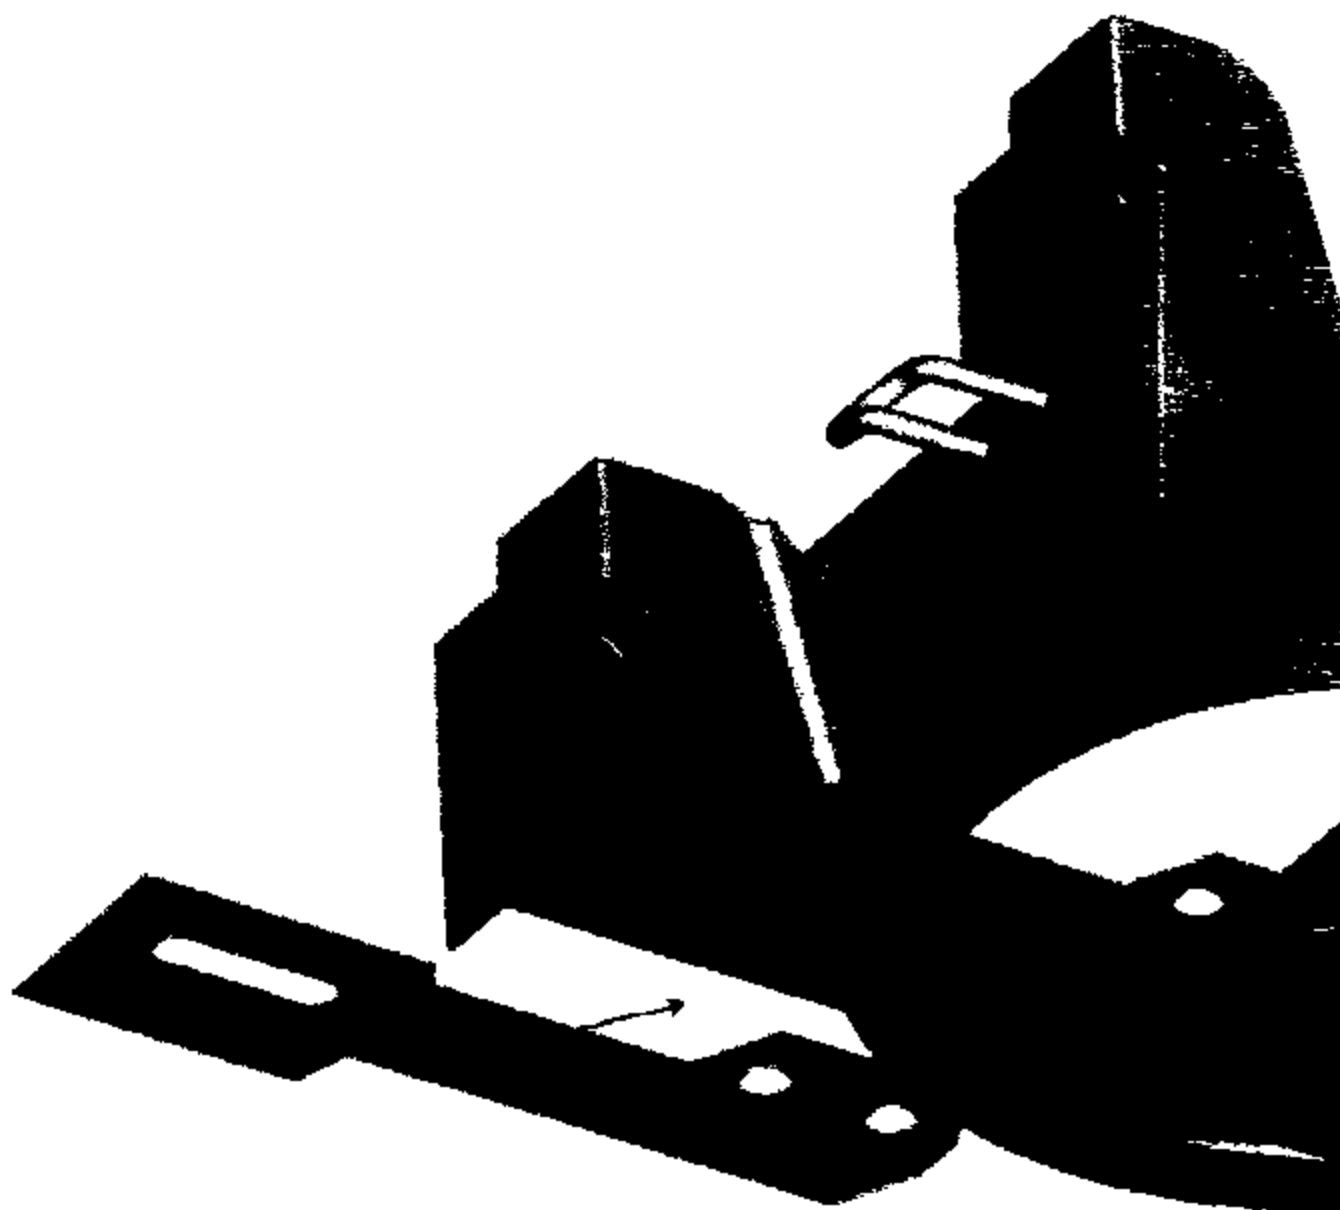
Did you have any thoughts/concerns on using a one piece tower/air bag plate? Please see the attached image.

I like the concept; I think I would extend it past the end of the frame tube so there couldn't be a weld across the bottom of the tube to the rear of the bag plate.
