DAIMLERCHRYSLER

February 20, 2006

Reference: NVS-213cla; EA05-018

This document contains DaimlerChrysler Corporation's ("DCC") response to the referenced inquiry regarding the 2004 through 2005 Dodge Durango sport utility vehicles and Ram pickup trucks equipped with 5.7L V8 engines that have been manufactured for sale or lease in the United States. By providing the information contained herein, DCC is not waiving its claim to attorney work product and attorney-client privileged communications.

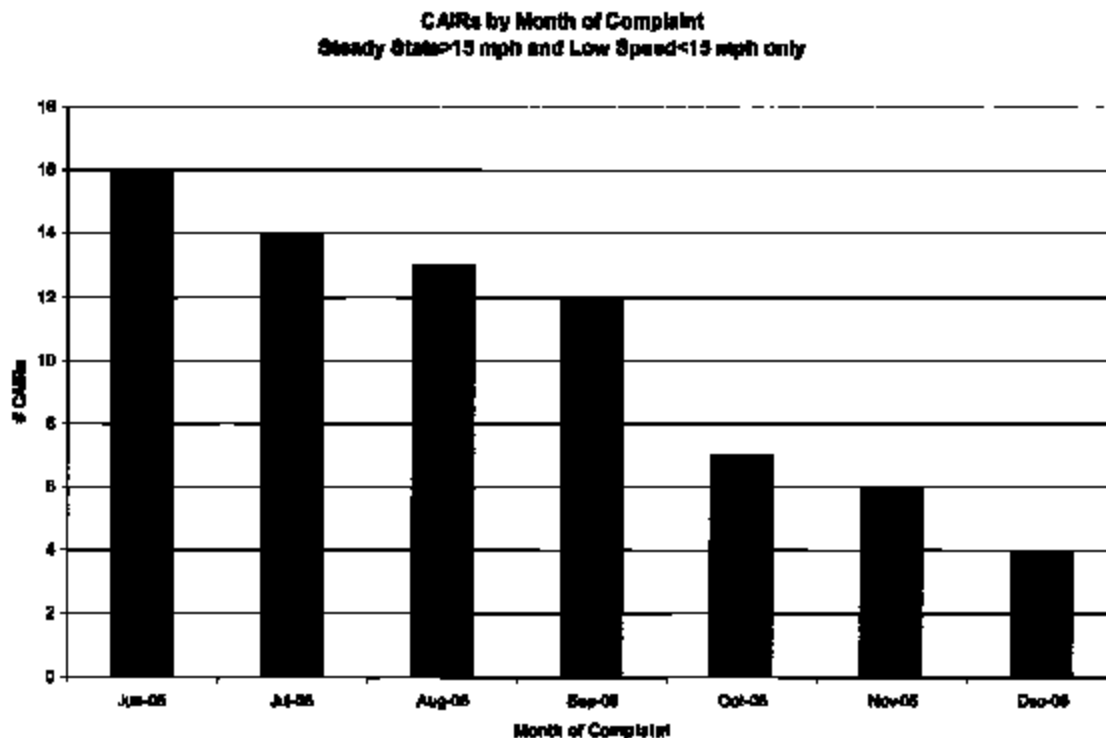
The chart below reflects CAIR input for steady state and low speed stall allegations received between June 1 and December 28, 2005. This data shows an overall complaint rate that is low and clearly decreasing.

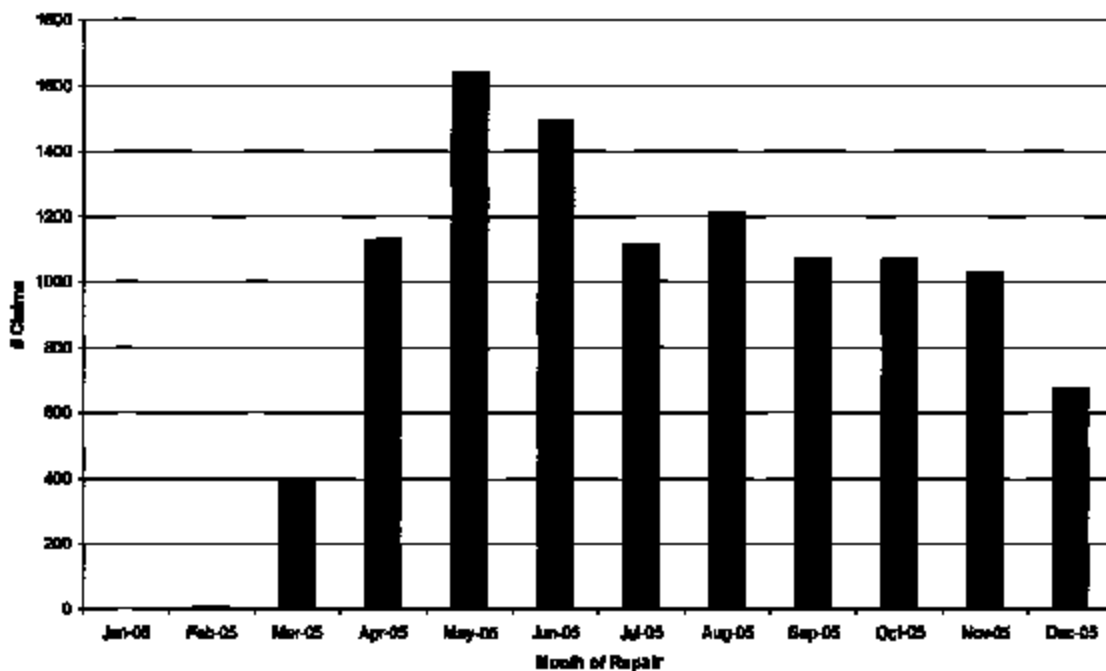
**LOP 08194391 Claims by Month of Repair
TSB 18-013-05 Rev. A**

**** Note:** LOP 08194391 is the LOP solely associated with TSB 18-013-05 Rev.A. This TSB was issued to address Idle fluctuations, rough Idle and MIL illumination, but may have been applied by service personnel to vehicles to address, among other things, reports of stalling while driving. It is impossible to determine which claims, if any, may be related to the alleged condition.

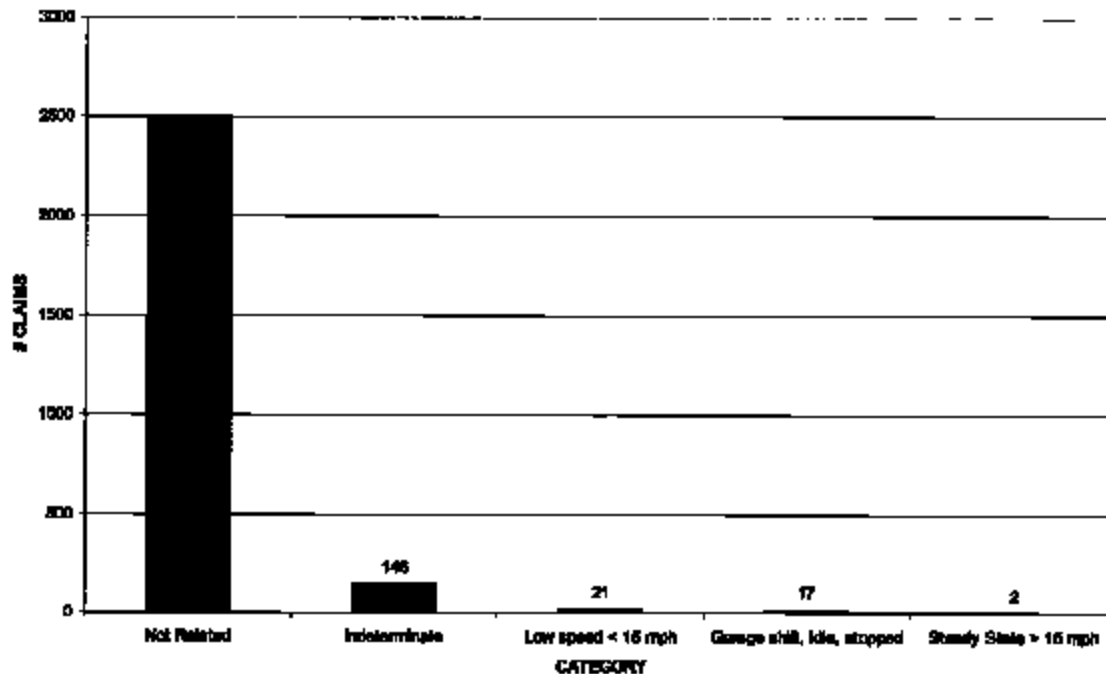
WARRANTY NARRATIVES BY CATEGORY

Most warranty claims do not have associated narrative data. A number of the warranty claims included with the EA response did have narrative data available. An analysis of those narratives showed that the vast majority or 93% were clearly not related to the alleged condition. Based on the available narrative data, only a small number were found that may relate to the alleged condition, and are shown on the chart below.

Note: There were over 2600 warranty narratives. DCC used a word search to filter out narratives that were not related to the alleged condition. In an attempt to catch all narratives that may be related, several variations of words were used. The word search criteria used is as follows:
