DaimlerChrysler Corporation

This document provides an update as requested per EA05-018 Q11, regarding alleged 5.7L V8 engine stalling while driving on 2004-2005 model year Dodge Durango sport utility vehicles and Dodge Ram pickup trucks. This update provides warranty claims that may be related to the alleged defect that were received by DaimlerChrysler Corporation ("DCC") between December 29, 2005 and February 28, 2006. December 28, 2005 was the cut off date for data provided in the response to EA05-018 on February 20, 2006. DCC has conducted a reasonable and diligent search of records kept in the ordinary course of business for such information. By providing the information contained herein, DCC is not waiving its claim to attorney work product and attorney-client privileged communications.

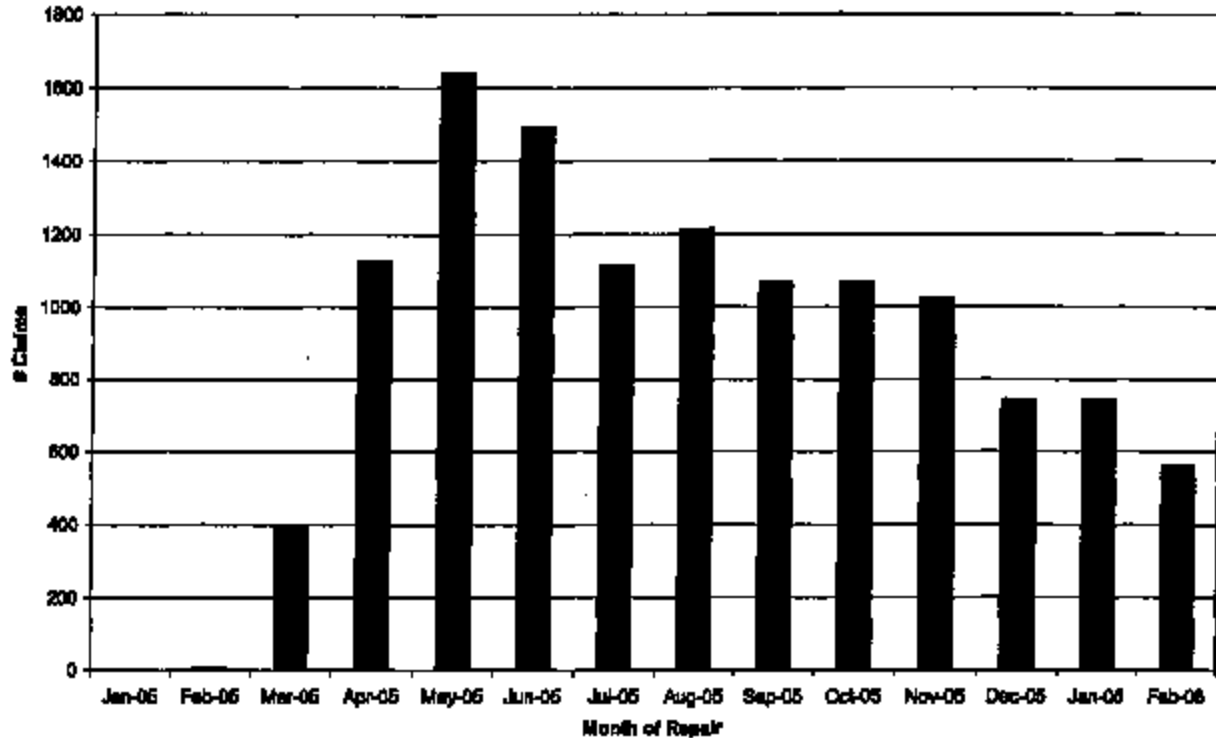
LOP 85194391 Claims by Month of Repair
T8B 18-013-05 Rev. A

LOP 08194391 is the LOP solely associated with TSB 18-013-05 Rev. A. This TSB was issued to address idle fluctuations, rough idle and malfunction indicator lamp ("MIL") illumination, but may have been applied by service personnel to vehicles to address, among other things, reports of stalling while driving. It is impossible to determine which claims, if any, may be related to the alleged condition.
