DAIMLERCHRYSLER

DaimlerChrysler Corporation
Stephan J. Speth
Director
Vehicle Compliance & Safety Affairs

This document provides an update as requested per EA05-018 Q11, regarding alleged 5.7L V8 engine stalling while driving on 2004-2005 model year Dodge Durango sport utility vehicles and Dodge Ram pickup trucks. This update provides warranty claims that may be related to the alleged defect that were received by DaimlerChrysler Corporation ("DCC") between March 1, 2006 and March 31, 2006. DCC has conducted a reasonable and diligent search of records kept in the ordinary course of business for such information. By providing the information contained herein, DCC is not waiving its claim to attorney work product and attorney-client privileged communications.

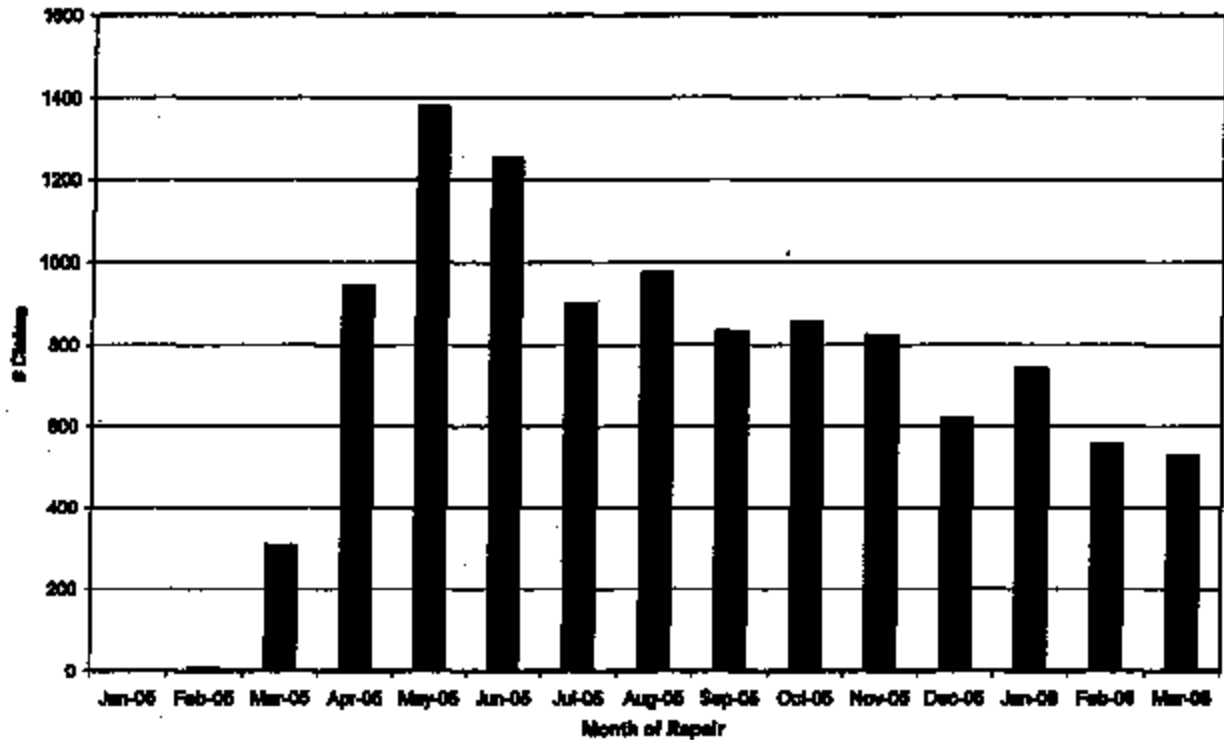
**LOP 06194381 Claims by Month of Repair
TSB 18-013-06 Rev. A**

LOP 08194391 is the LOP solely associated with TSB 18-013-05 Rev. A. This TSB was issued to address idle fluctuations, rough idle and malfunction indicator lamp ("MIL") illumination, but may have been applied by service personnel to vehicles to address, among other things, reports of stalling while driving. It is impossible to determine which claims, if any, may be related to the alleged condition.

Often times when a vehicle is brought into a dealership for service, technicians will search for any TSBs that are applicable to the vehicle and apply them, even though the complaint may not be related to the issue that a given TSB would address.
