# DAIMLERCHRYSLER

This document provides an update as requested per EA05-018 Q11, regarding alleged 5.7L V8 engine stalling while driving on 2004-2005 model year Dodge Durango sport utility vehicles and Dodge Ram pickup trucks. This update provides warranty claims that may be related to the alleged defect that were received by DaimlerChrysler Corporation ("DCC") between April 1, 2006 and April 30, 2006. DCC has conducted a reasonable and diligent search of records kept in the ordinary course of business for such information. By providing the information contained herein, DCC is not waiving its claim to attorney work product and attorney-client privileged communications.

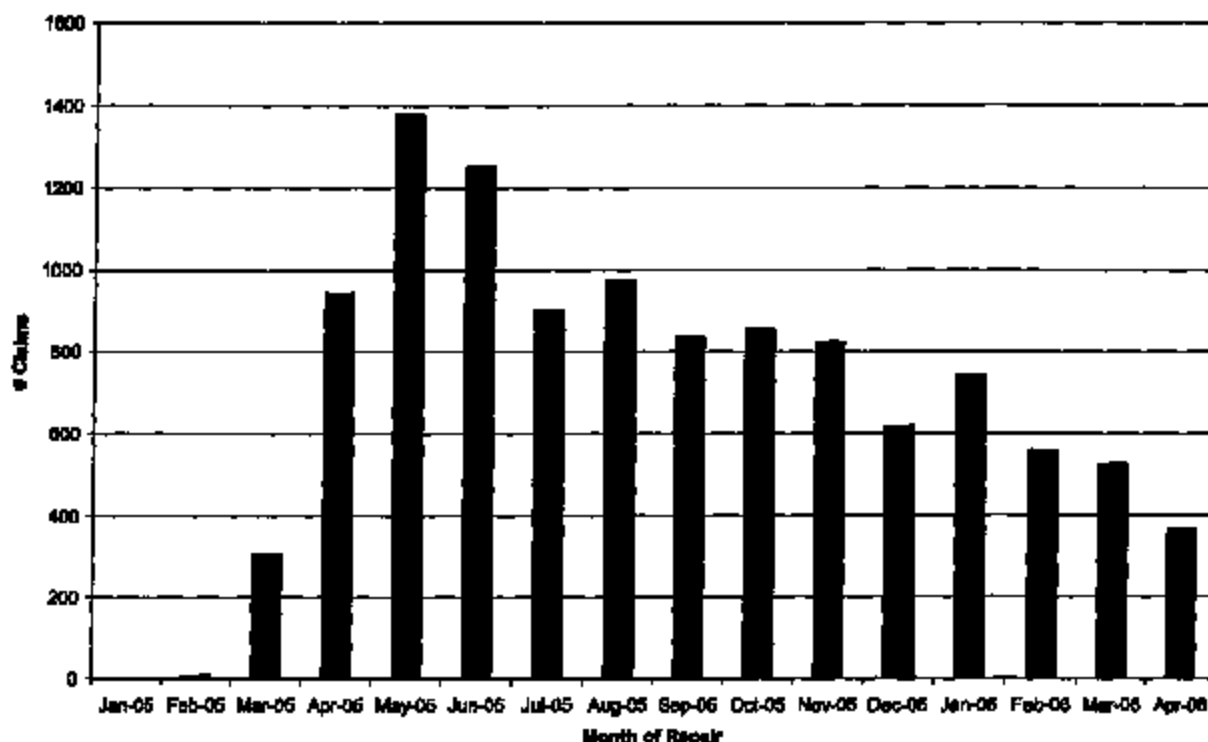
**LOP 08194391 Claims by Month of Repair**  
**TSB 18-013-05 Rev. A**

LOP 08194391 is the LOP solely associated with TSB 18-013-05 Rev. A. This TSB was issued to address idle fluctuations, rough idle and malfunction indicator lamp ("MIL") illumination, but may have been applied by service personnel to vehicles to address, among other things, reports of stalling while driving. It is impossible to determine which claims, if any, may be related to the alleged condition.
