DaimlerChrysler Corporation

This document provides an update as requested per EA05-018 Q11, regarding alleged 5.7L V8 engine stalling while driving on 2004-2005 model year Dodge Durango sport utility vehicles and Dodge Ram pickup trucks. This update provides warranty claims that may be related to the alleged defect that were received by DaimlerChrysler Corporation ("DCC") between June 1, 2006 and June 30, 2006. DCC has conducted a reasonable and diligent search of records kept in the ordinary course of business for such information. By providing the information contained herein, DCC is not waiving its claim to attorney work product and attorney-client privileged communications.

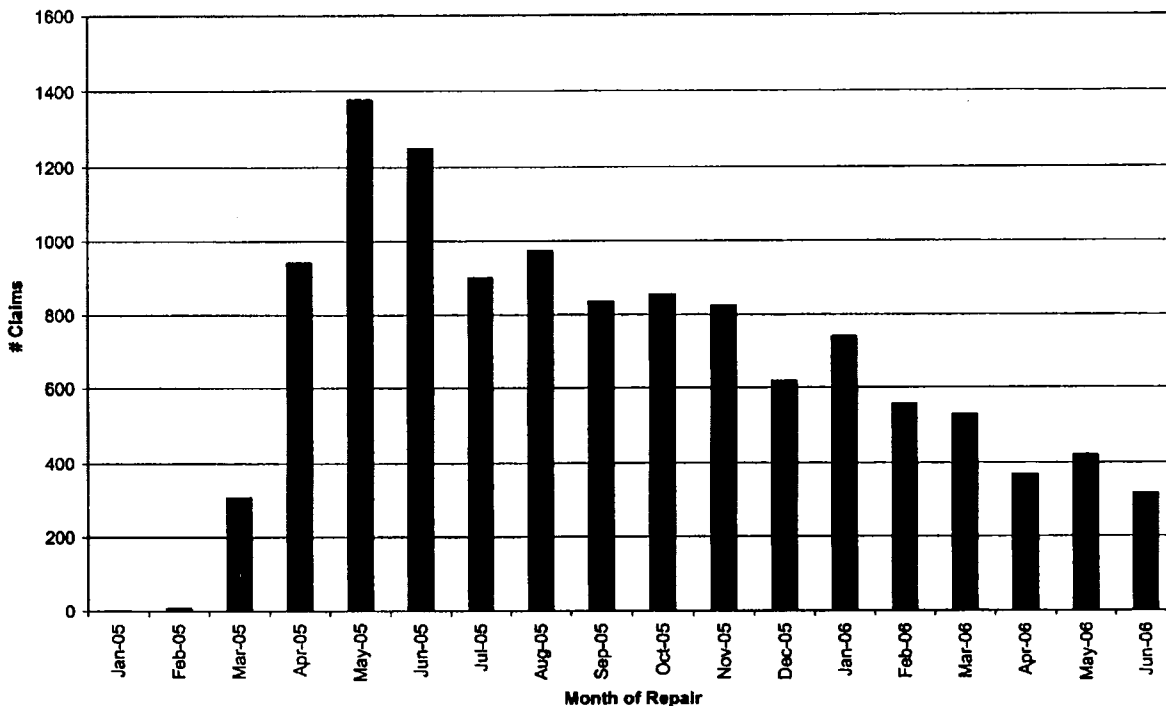
LOP 08194391 Claims by Month of Repair
TSB 18-013-05 Rev. A

LOP 08194391 is the LOP solely associated with TSB 18-013-05 Rev. A. This TSB was issued to address idle fluctuations, rough idle and malfunction indicator lamp ("MIL") illumination, but may have been applied by service personnel to vehicles to address, among other things, reports of stalling while driving. It is impossible to determine which claims, if any, may be related to the alleged condition.
