DaimlerChrysler Corporation

This document provides an update as requested per EA05-018 Q11, regarding alleged 5.7L V8 engine stalling while driving on 2004-2005 model year Dodge Durango sport utility vehicles and Dodge Ram pickup trucks. This update provides warranty claims that may be related to the alleged defect that were received by DaimlerChrysler Corporation ("DCC") between July 1, 2006 and July 31, 2006. DCC has conducted a reasonable and diligent search of records kept in the ordinary course of business for such information. By providing the information contained herein, DCC is not waiving its claim to attorney work product and attorney-client privileged communications.

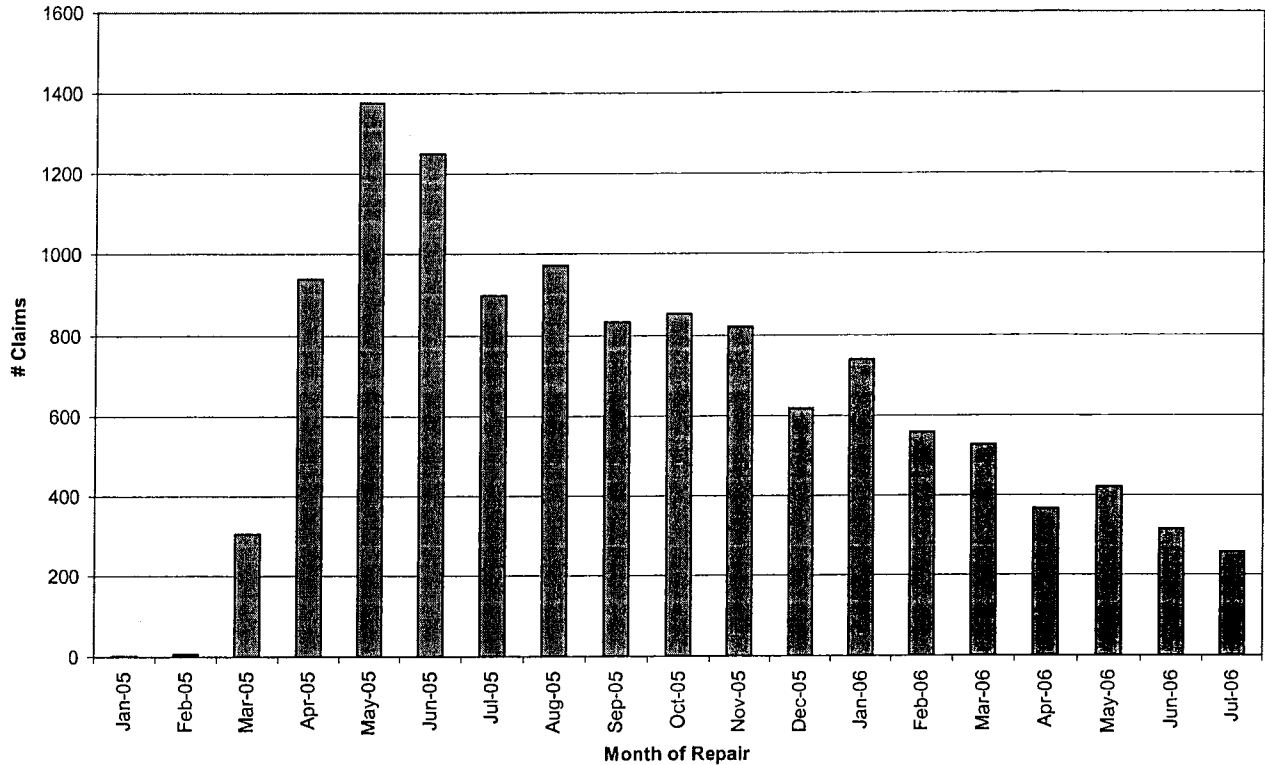
LOP 08194391 Claims by Month of Repair
TSB 18-013-05 Rev. A

LOP 08194391 is the LOP solely associated with TSB 18-013-05 Rev. A. This TSB was issued to address idle fluctuations, rough idle and malfunction indicator lamp ("MIL") illumination, but may have been applied by service personnel to vehicles to address, among other things, reports of stalling while driving. It is impossible to determine which claims, if any, may be related to the alleged condition.
