DaimlerChrysler Corporation

This document provides an update as requested per EA05-018 Q11, regarding alleged 5.7L V8 engine stalling while driving on 2004-2005 model year Dodge Durango sport utility vehicles and Dodge Ram pickup trucks. This update provides warranty claims that may be related to the alleged defect that were received by DaimlerChrysler Corporation ("DCC") between September 1, 2006 and September 30, 2006. DCC has conducted a reasonable and diligent search of records kept in the ordinary course of business for such information. By providing the information contained herein, DCC is not waiving its claim to attorney work product and attorney-client privileged communications.

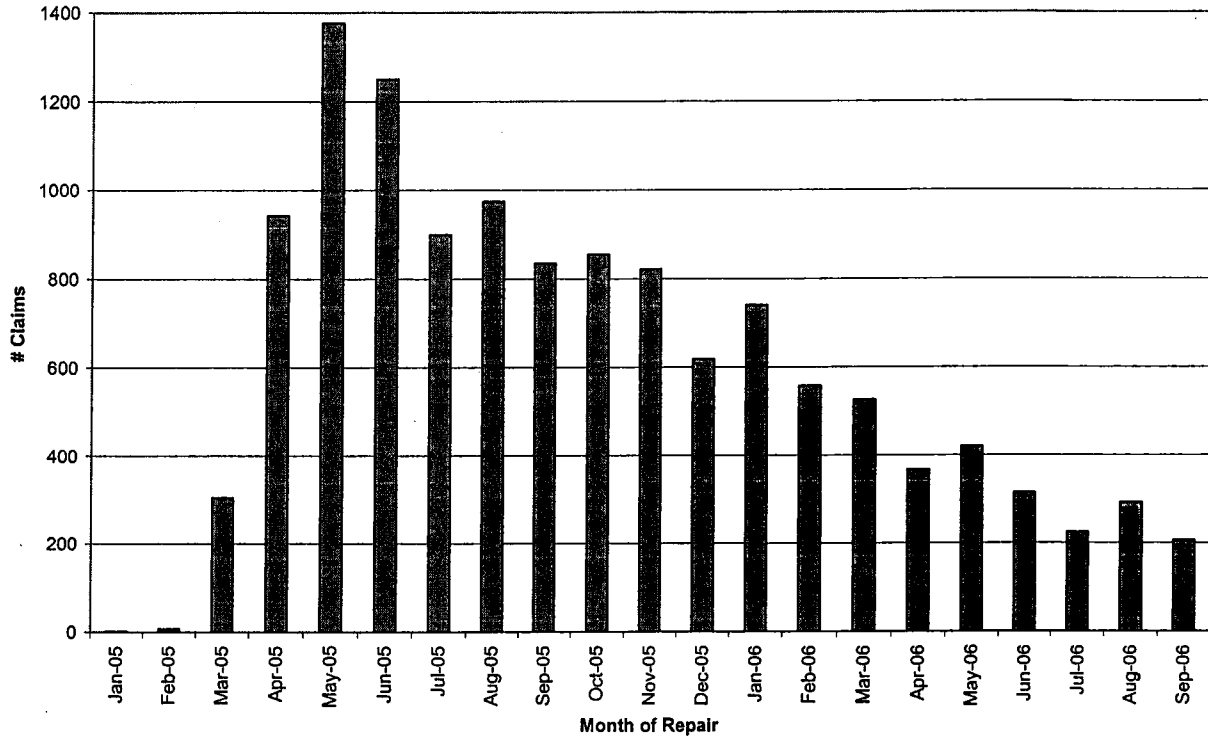
LOP 08194391 Claims by Month of Repair
TSB 18-013-05 Rev. A

LOP 08194391 is the LOP solely associated with TSB 18-013-05 Rev. A. This TSB was issued to address idle fluctuations, rough idle and malfunction indicator lamp ("MIL") illumination, but may have been applied by service personnel to vehicles to address, among other things, reports of stalling while driving. It is impossible to determine which claims, if any, may be related to the alleged condition.
