# DAIMLERCHRYSLER

October 2, 2006

This document provides an update as requested per EA05-018 Q11, regarding alleged 5.7L V8 engine stalling while driving on 2004-2005 model year Dodge Durango sport utility vehicles and Dodge Ram pickup trucks. This update provides warranty claims that may be related to the alleged defect that were received by DaimlerChrysler Corporation ("DCC") between August 1, 2006 and August 31, 2006. DCC has conducted a reasonable and diligent search of records kept in the ordinary course of business for such information. By providing the information contained herein, DCC is not waiving its claim to attorney work product and attorney-client privileged communications.

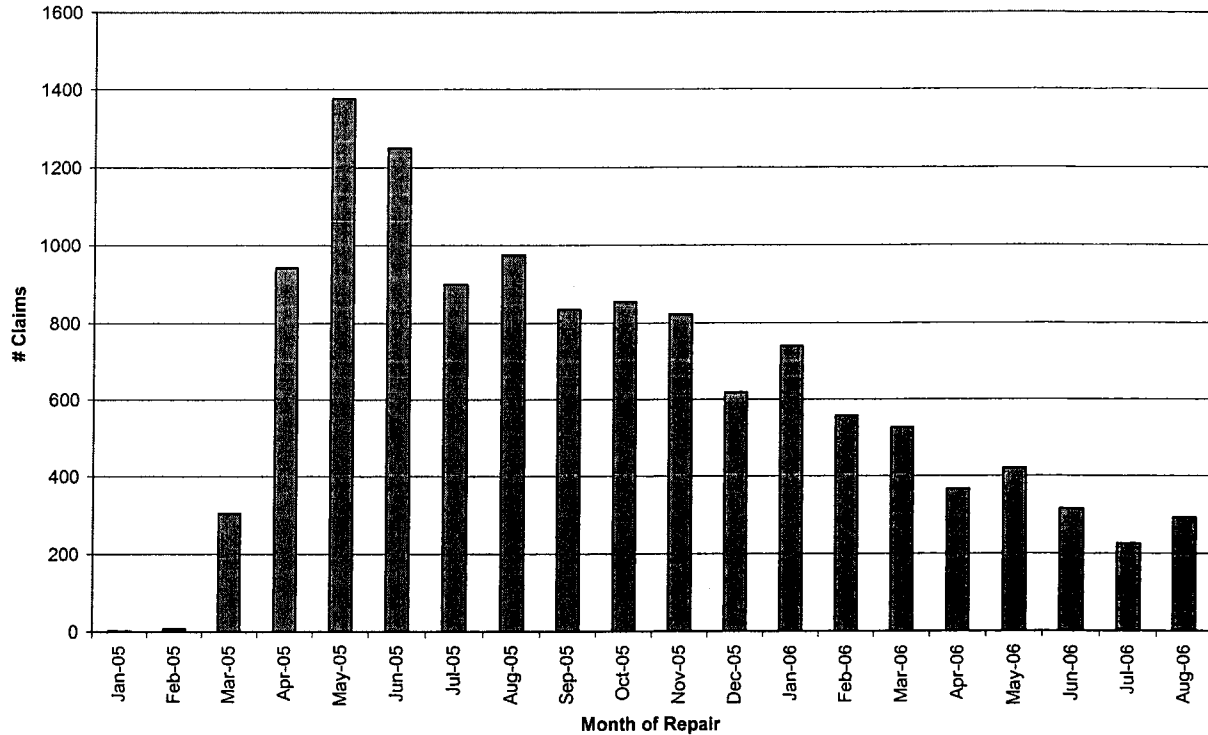
**LOP 08194391 Claims by Month of Repair**  
**TSB 18-013-05 Rev. A**

LOP 08194391 is the LOP solely associated with TSB 18-013-05 Rev. A. This TSB was issued to address idle fluctuations, rough idle and malfunction indicator lamp ("MIL") illumination, but may have been applied by service personnel to vehicles to address, among other things, reports of stalling while driving. It is impossible to determine which claims, if any, may be related to the alleged condition.
