October 7, 2005

Subject: PE05-042 NVS-212mbs; Exterior Door Handle

Attached is our response to your letter dated August 19, 2005 requesting information concerning alleged exterior door handles sticking open on certain 2004-2005 Volkswagen Touareg vehicles.

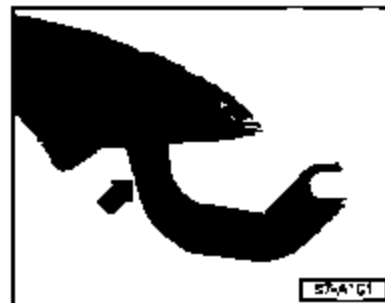
When opened from the outside, some actuated door handles can stick and remain in the extended position because internal friction is higher than the spring forces that return the handle to its rest position. This is due to a potential for increased friction between the door handle and the lock cylinder housing (see illustration 57-A099) because some guide nubs that were molded into the plastic door handle (see arrow in illustrations 57-A101) were slightly higher than specified. These guide nubs were originally intended to minimize handle "wobble" during the opening process.

When the outside door handle is pulled, it moves slightly in a horizontal direction towards the rear of the vehicle. During this movement, parts of the handle slide by the stationary lock cylinder housing, that provide support while these parts slides outwards past two ribs (see illustrations 57-A099 and 57-A100).

When pulled out to open the door, the outside door handle can intermittently stick in the area of the guide nubs (see illustration 57-A101) as described above because these nubs exceeded specifications. Additionally, the friction between the door handle and the lock cylinder housing keeps the door handle in the extended position because the sticking condition in the area of the nubs prevents the exterior door handle from returning (including slightly in a horizontal direction) into its rest position.

The guide nubs are subject to wear during normal vehicle use. Volkswagen believes the prevailing tolerances within the door handle assembly, combined with normal opening and closing cycles, cause the nubs to wear down thereby reducing internal friction within the door handle assembly.

Furthermore the implementation of measures in production (lubrication, deletion of the guide nubs, introduction of a low friction guide surface on the lock cylinder housing) for Touareg vehicles subsequently produced has caused the sticking phenomenon to cease completely inasmuch as no reports relating to these vehicles have been received.

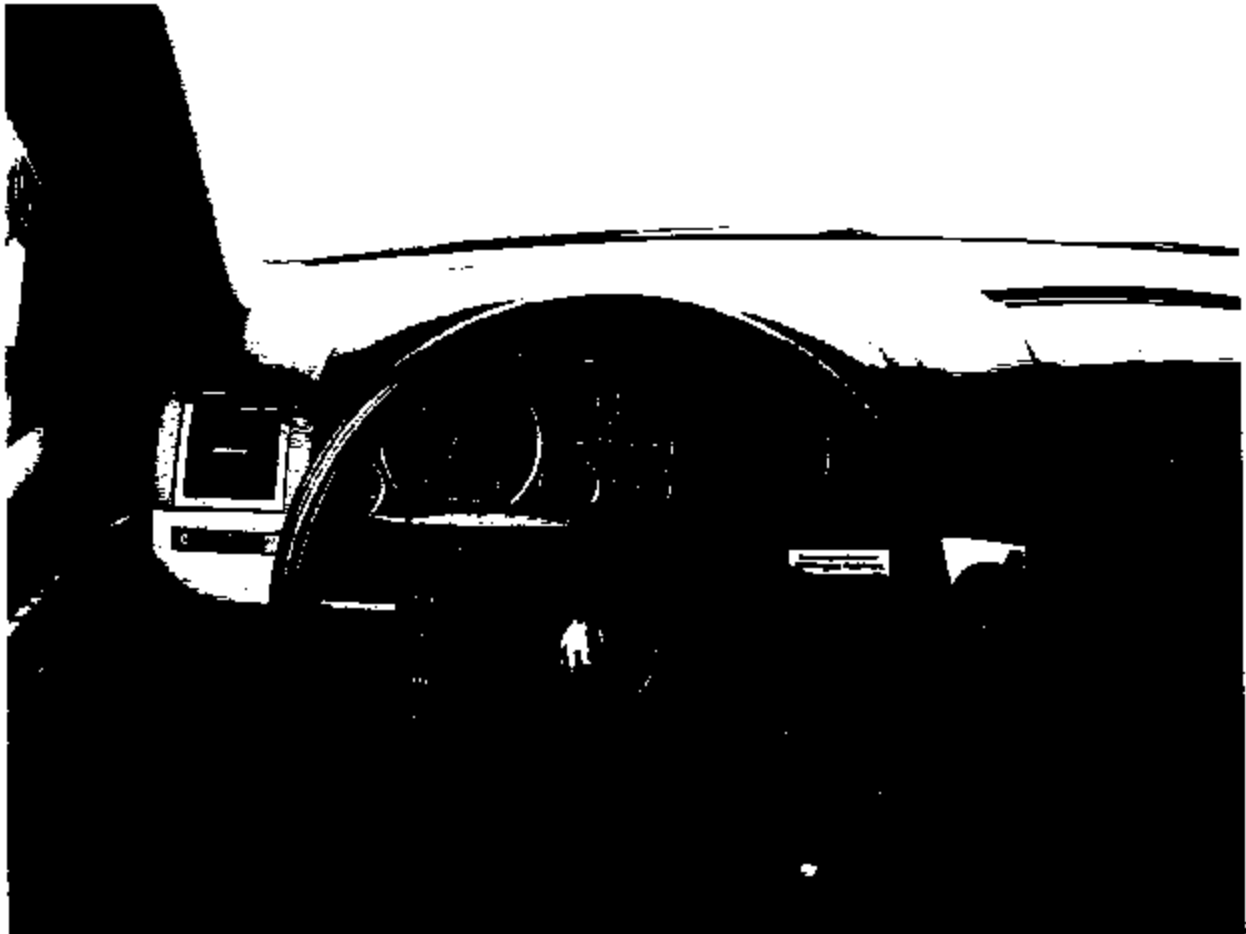
View of the Touareg Cockpit (with activated warning for the right rear passenger door)

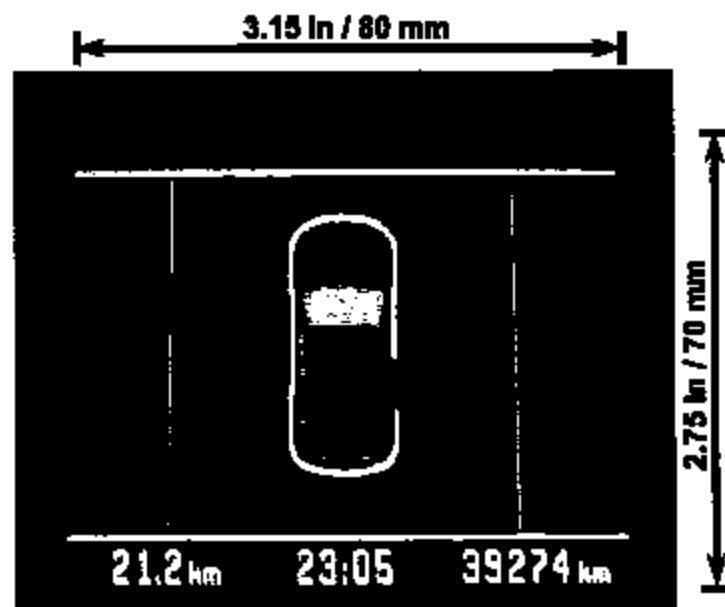
Full-scale photograph of the visual warning (rear passenger door)
