VOLVO

February 13, 2006

NVS-213dlr
PE05-057

This letter and its enclosures comprise the response of Volvo Cars of North America, LLC (VCNA) to your request for information relating to Preliminary Evaluation PE05-057 received on December 1, 2005. VCNA was granted a request to answer PE05-057 by February 15, 2006.

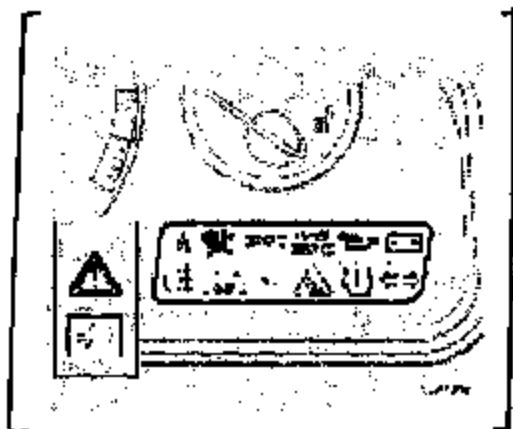
The B+ cable joint at the starter motor may be relaxed or may not have been properly torqued at the factory. The joint is not correctly tightened at the starter motor. The starter motor may not crank and the battery may have low charging status. If this condition were to occur while driving, the driver will get very clear warnings, primarily in the DIM (Driver Information Module) but later also shown as reduction of engine torque, enabling the driver to handle the vehicle to a safe stop. Refer to the picture below for the warning that will be seen in the DIM:

- *There have been no reported fires.*
- *If this condition were to occur while driving, the driver will get very clear warnings, primarily in the DIM (as shown above) but later also shown as a reduction of engine torque, enabling the driver to handle the vehicle to a safe stop*

Volvo has decided to have a customer satisfaction campaign (Service Campaign 152) for this condition for the following reasons:
