- TIRE FORENSICS REPORT -

PN 67722
Purchase Order DTNH22-06-P-08366

SUBJECT: Forensic Evaluation on 9 Toyo Tires.

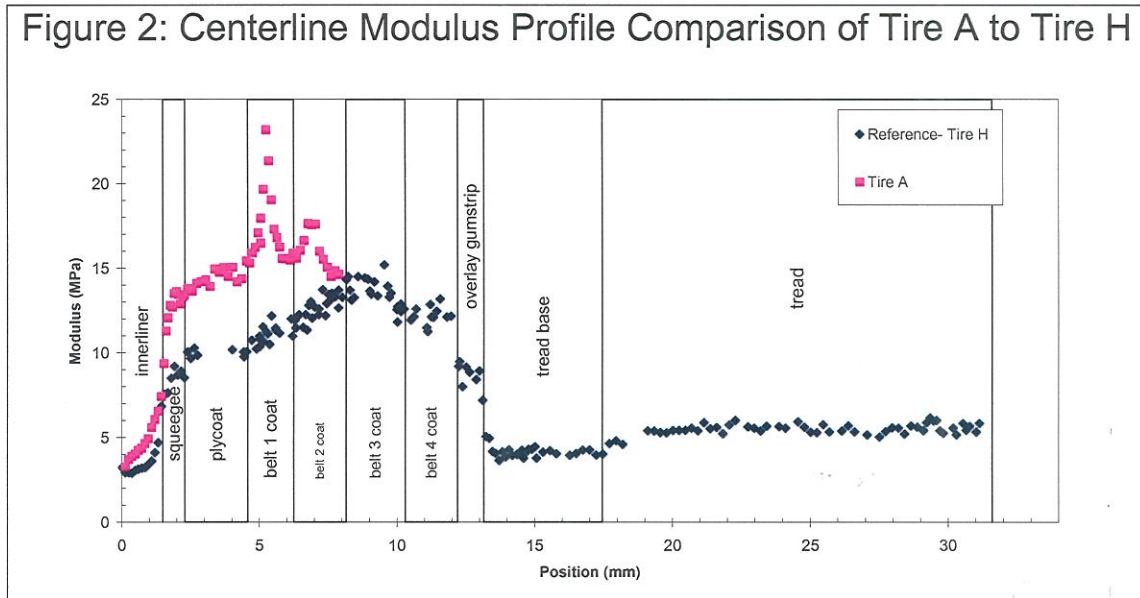
Figure 2: Centerline Modulus Profile Comparison of Tire A to Tire H

In comparison, the centerline region of tire A was much higher modulus (Figure 2). The overlay plot shows that there was very high modulus increase in the squeegee, plycoat, belt 1 coat, and belt 2 coat. The modulus increase is a result of oxidation. This could be called unusually high level of property deterioration.

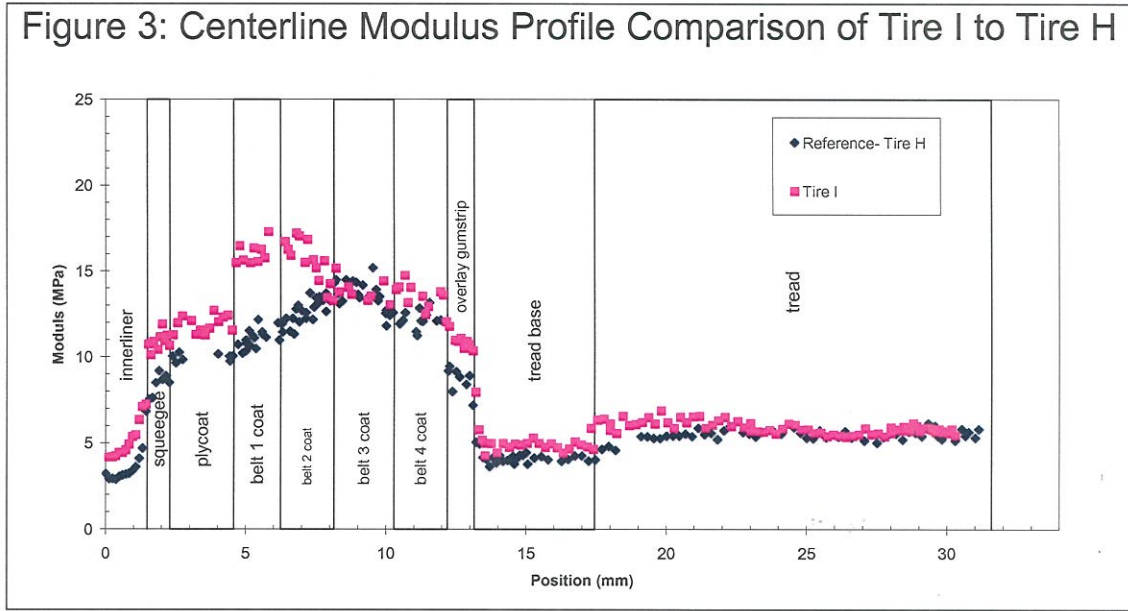
The centerline modulus profile of tire I is shown in Figure 3. The results point to major oxidation in the belt-1-coat and belt-2-coat compounds. This may be associated with high heat and strains in this region of the tire or oxygen somehow reaching this compound (i.e., cord wicking).

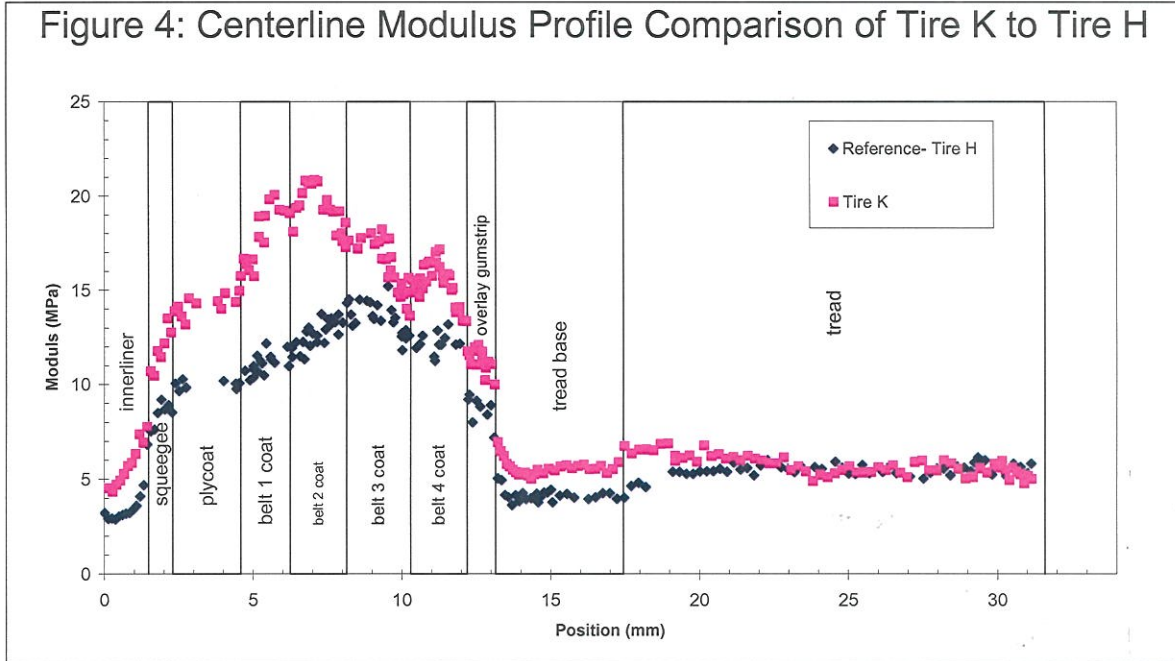
Figure 4: Centerline Modulus Profile Comparison of Tire K to Tire H

The centerline modulus profile of tire K is shown in Figure 4. The results show large modulus increases in the squeegee, plycoat, belt-1-coat, and belt-2-coat compounds. This is probably caused by oxidation. The modulus values are close to those found in tires A and J, which had experienced separations.

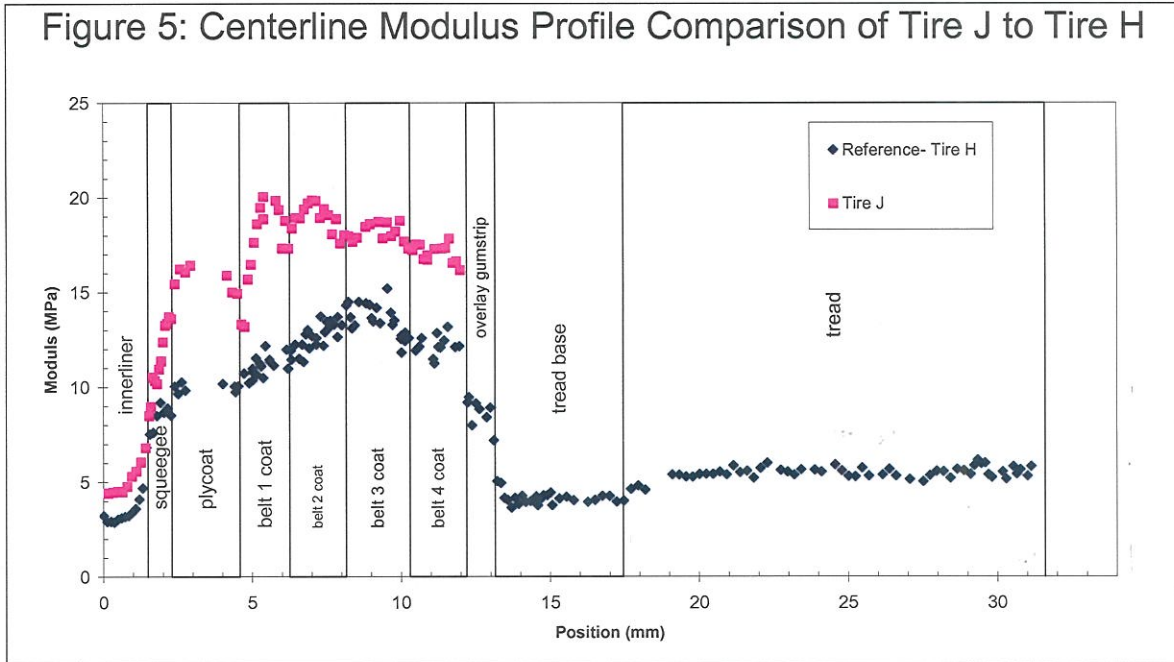
The centerline region of tire J was high in modulus (Figure 5). The overlay plot shows that there were large modulus increases in the squeegee, plycoat, belt 1 coat, and belt 2 coat. The oxidative hardening appears to be close to the cords, suggesting oxygen wicking along the cords. This could be called unusually high level of property deterioration.

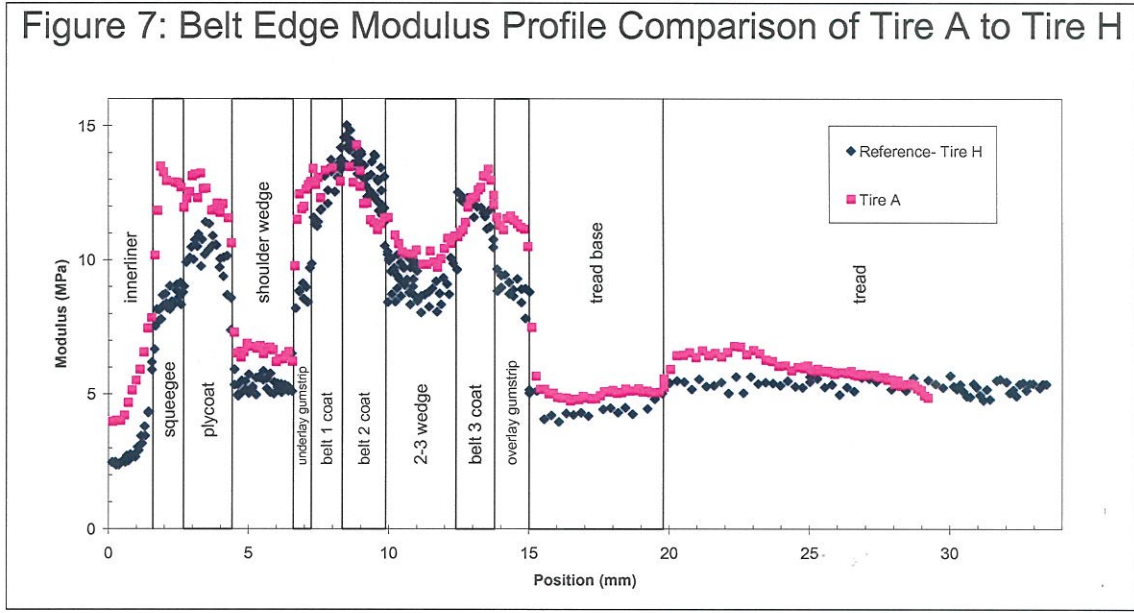
In a comparison plot of Tire A to Tire H, the belt region results indicate oxidative hardening in all components except belt 2 coat (Figure 7). The modulus change in belt-2-coat was probably dominated by mechanical softening.

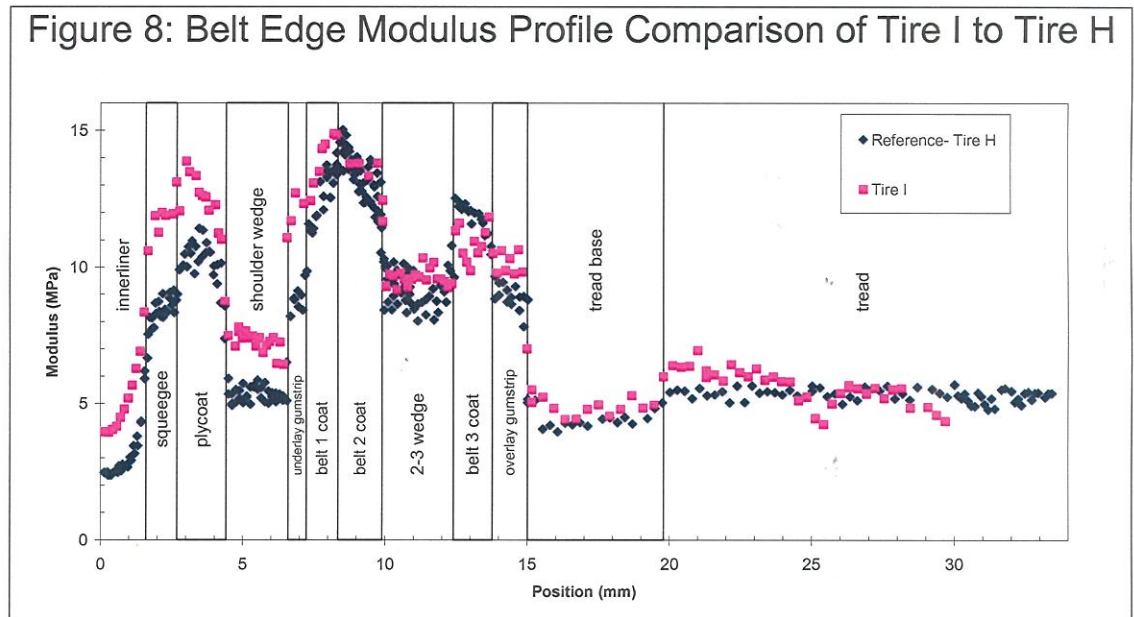
The belt edge modulus profile of tire I is shown in Figure 8. The results were compared to Tire H. Oxidative hardening was observed in all components except belt-3-coat. The modulus change in belt-3-coat was probably dominated by mechanical softening.

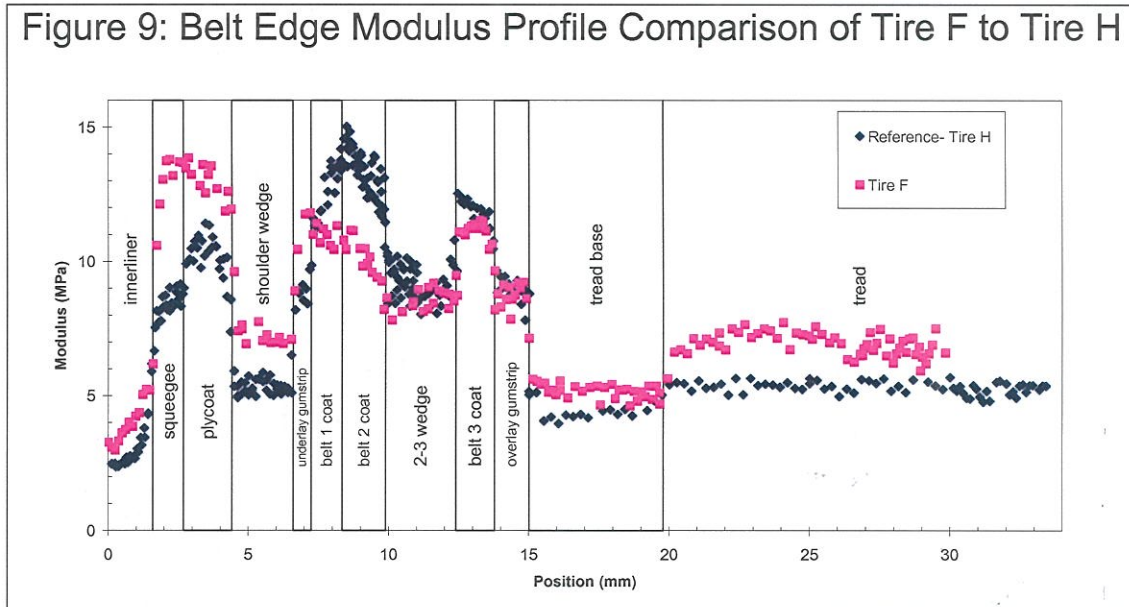
Figure 9: Belt Edge Modulus Profile Comparison of Tire F to Tire H

The belt edge modulus profile of tire F is shown in Figure 9. The results were compared to Tire H. Oxidative hardening was observed in all components except belt-1-coat, belt-2-coat, 2-3 wedge, belt-3-coat, and overlay gumstrip. The modulus changes in those components were probably dominated by mechanical softening.

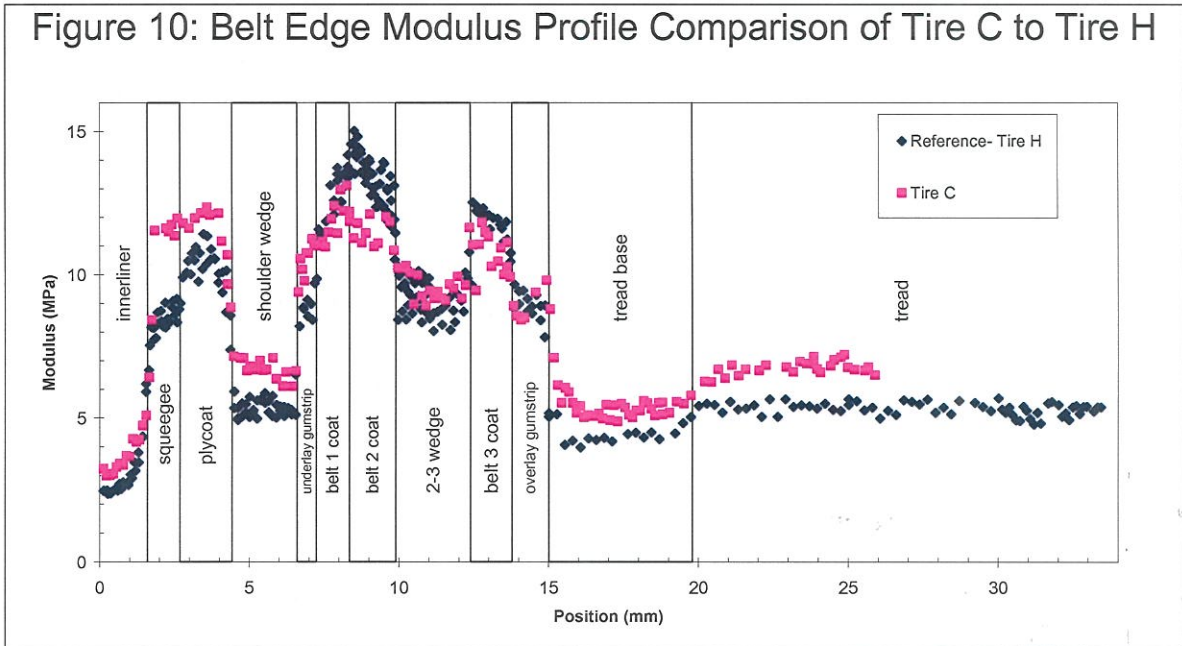
The belt edge modulus profile of tire C is shown in Figure 10. The results were compared to Tire H. Oxidative hardening was observed in all components except belt-1-coat, belt-2-coat, 2-3 wedge, and belt-3-coat. The modulus changes in those components were probably dominated by mechanical softening.
