AKRON RUBBER DEVELOPMENT LABORATORY, INC  
ARDL ENGINEERING GROUP  
2851 GILCHRIST ROAD, AKRON, OHIO 44305  
PHONE: 330-7946600 FAX 330-7946623

## - TIRE FORENSICS REPORT -

PN 67722  
Purchase Order DTNH22-06-P-08366

**SUBJECT:** Forensic Evaluation on 9 Toyo Tires.

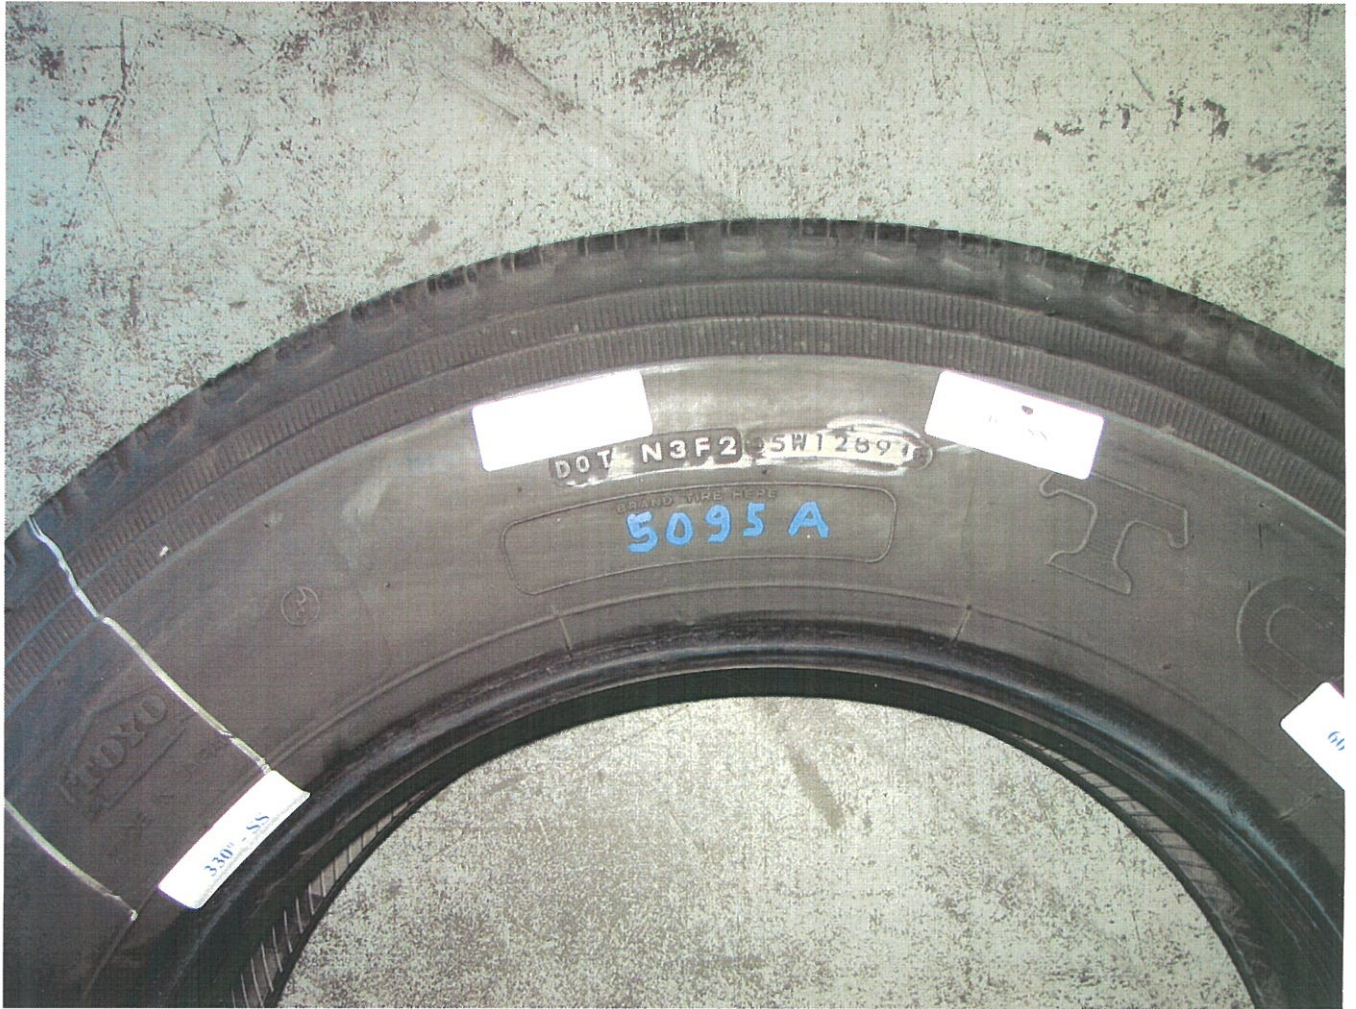
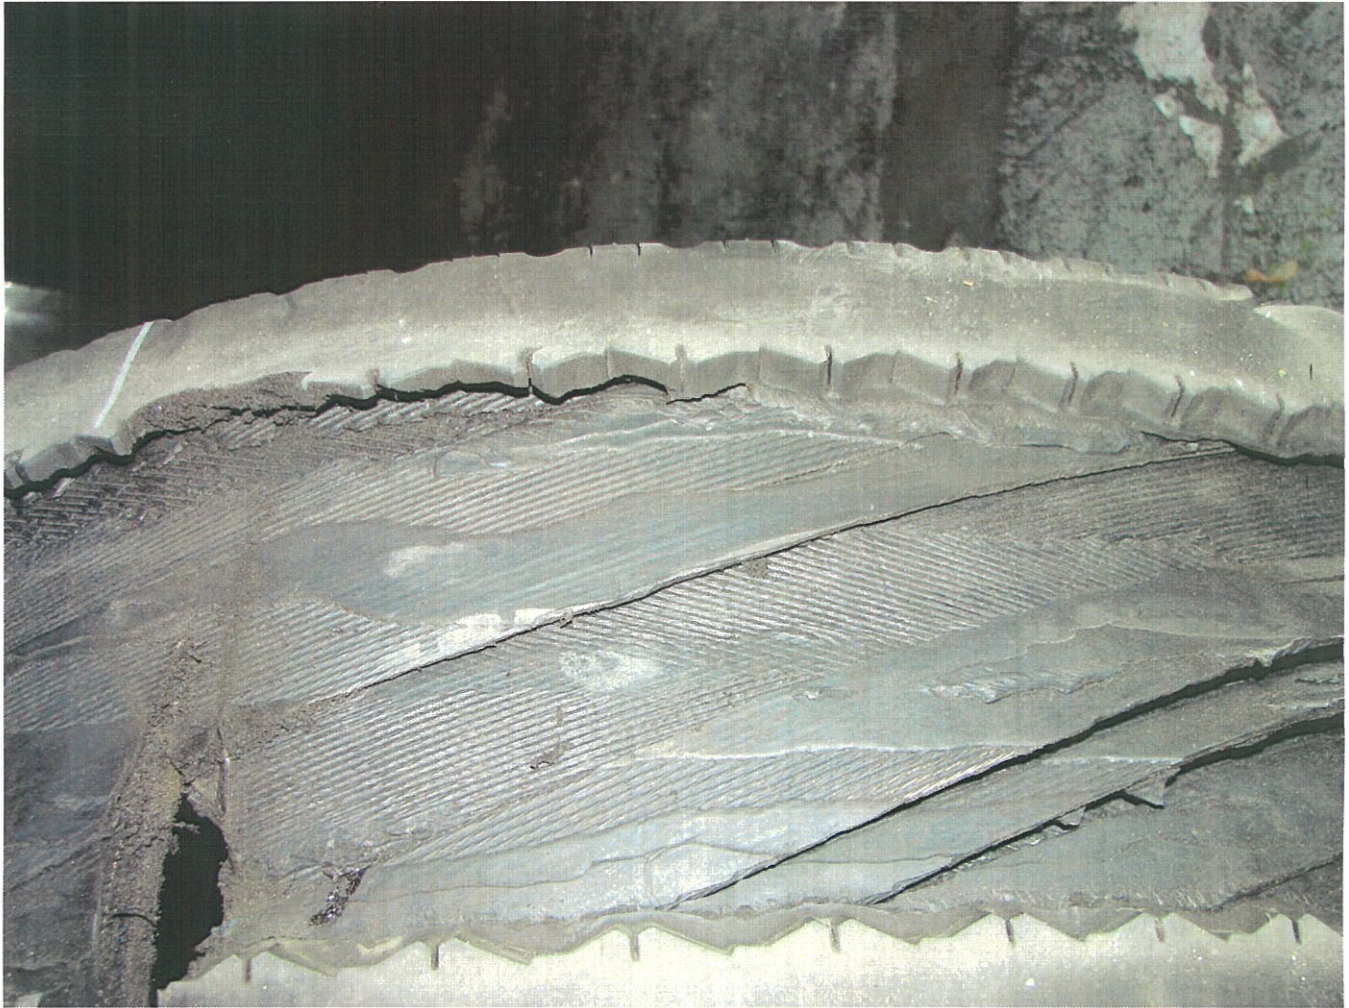
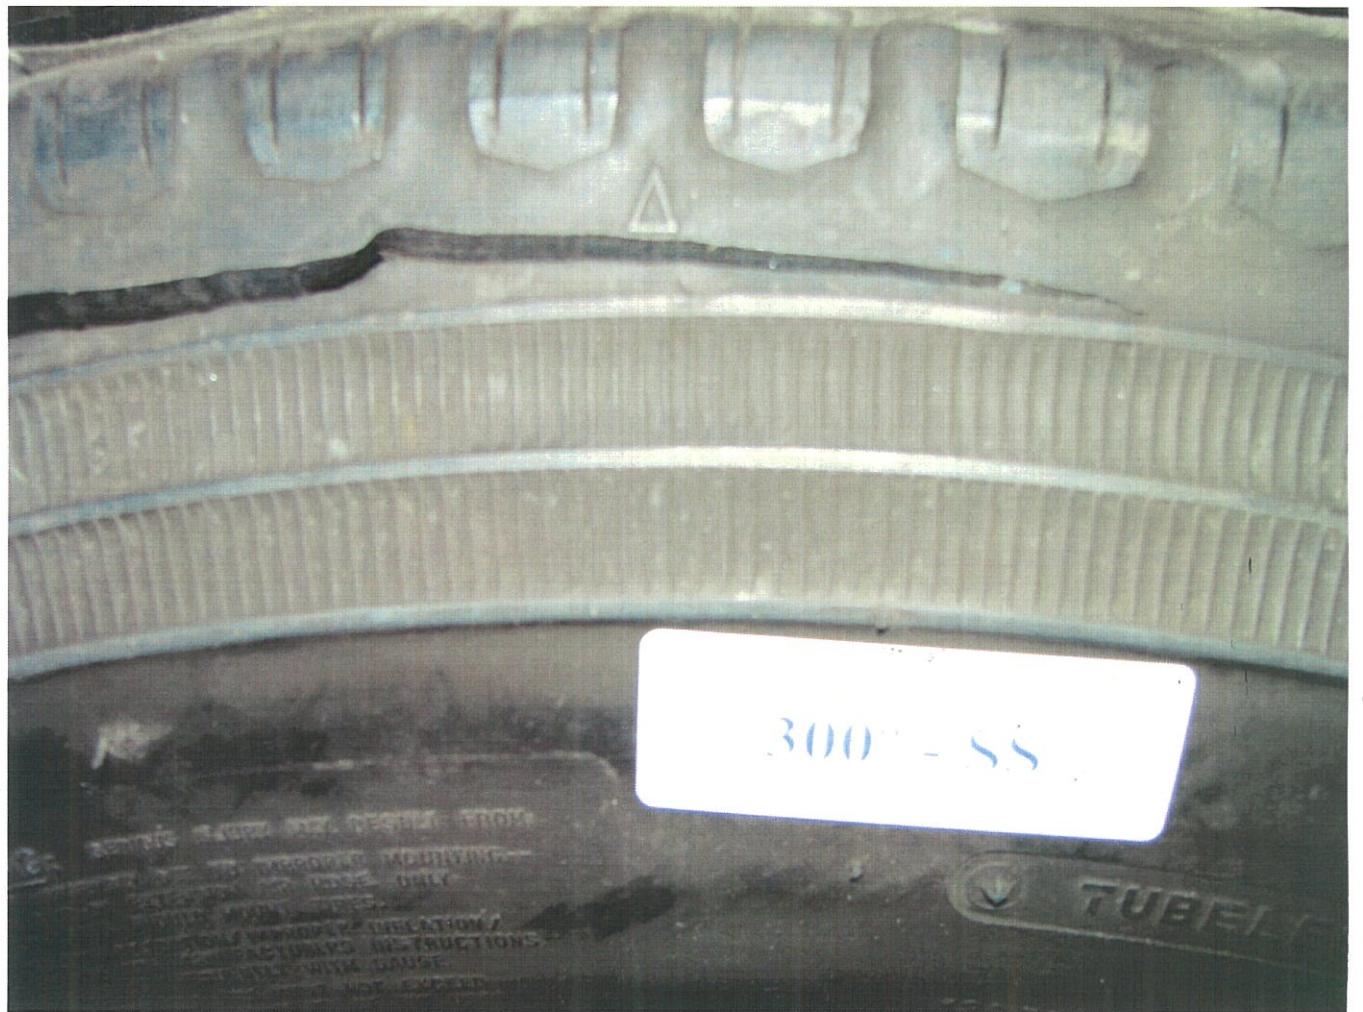
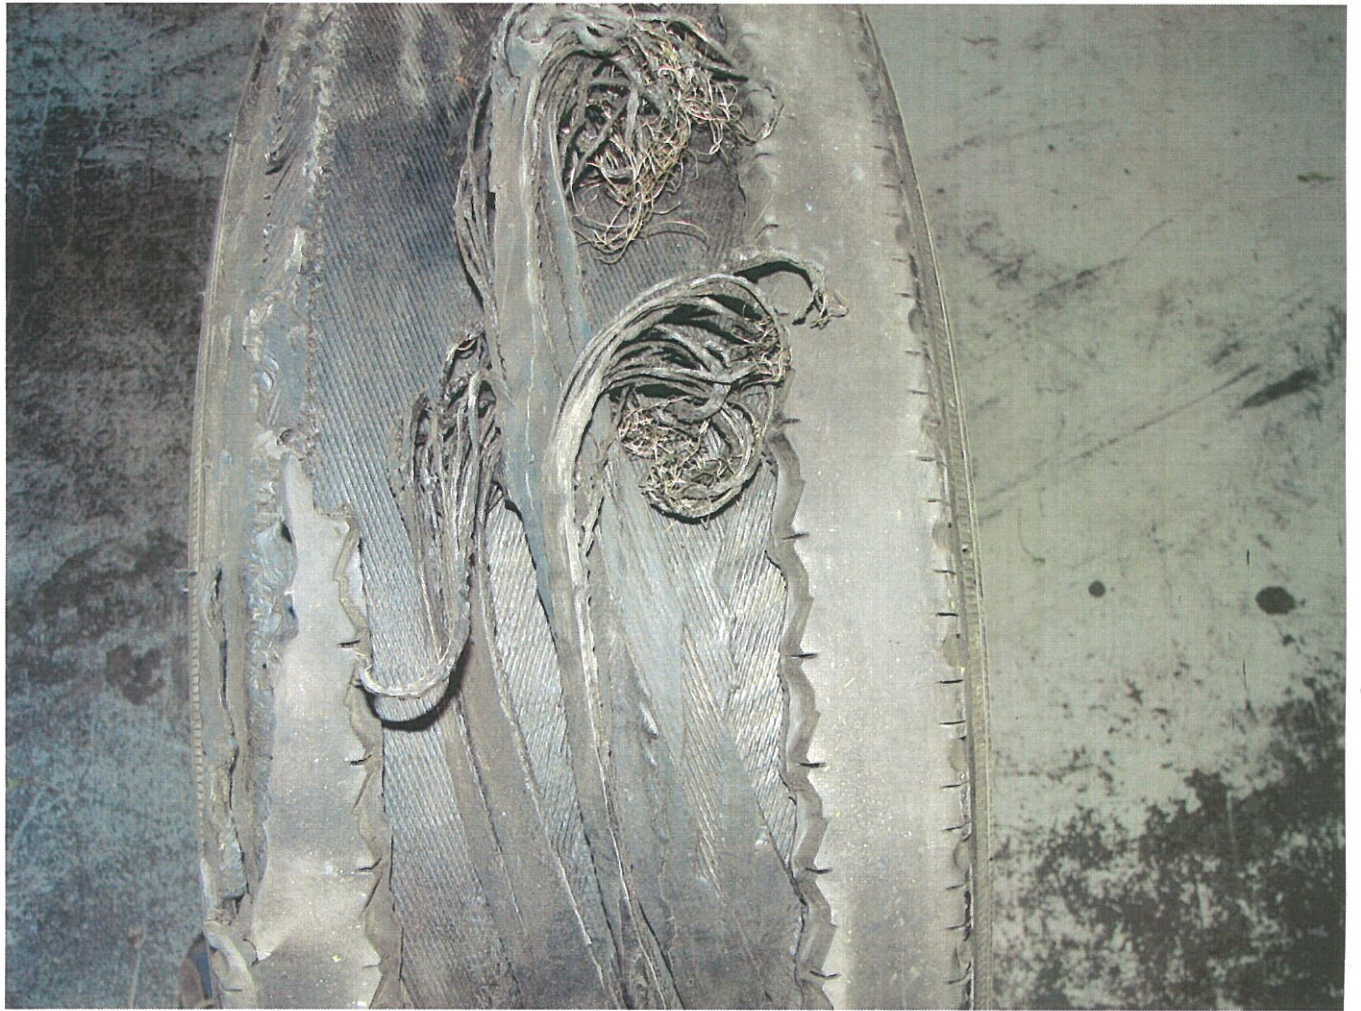
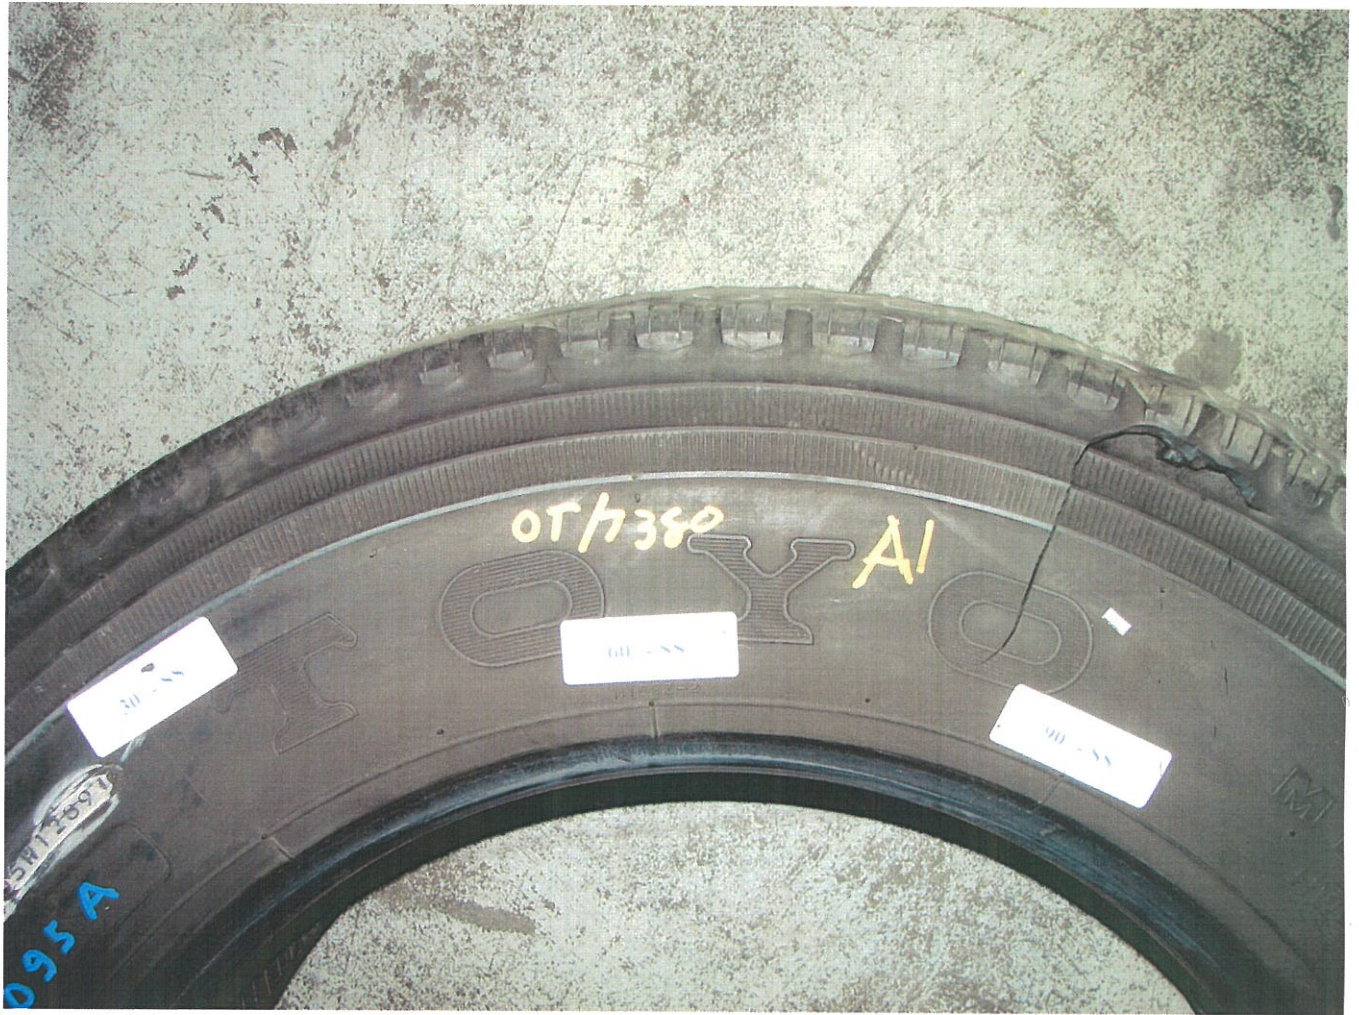
# Appendix A - INSPECTION- Tire A – OBSERVATIONS AND IMAGES

Rubber between steel belt 0 and 1	Visible	Visible	Visible	Visible	Visible	Visible	Visible	Visible	Visible	Visible	Visible	Visible
Steel belt 1	Visible	Visible	Missing	Missing	Missing	Visible	Visible	Visible	Visible	Visible	Visible	Visible
Rubber between steel belt 1 and 2	Visible	Visible	Missing	Missing	Missing	Visible	Visible	Visible	Visible	Visible	Visible	Visible
Steel belt 2	Visible	Visible	Missing	Missing	Missing	Missing	Missing	Missing	Missing	Missing	Missing	Visible
Rubber between steel belt 2 and 3	Visible	Visible	Missing	Missing	Missing	Missing	Missing	Missing	Missing	Missing	Missing	Visible
Steel belt 3	Missing	Missing	Missing	Missing	Missing	Missing	Missing	Missing	Missing	Missing	Missing	Visible
Rubber between steel belt 3 and 4	Missing	Missing	Missing	Missing	Missing	Missing	Missing	Missing	Missing	Missing	Missing	Visible
Steel belt 4	Missing	Missing	Missing	Missing	Missing	Missing	Missing	Missing	Missing	Missing	Missing	Visible

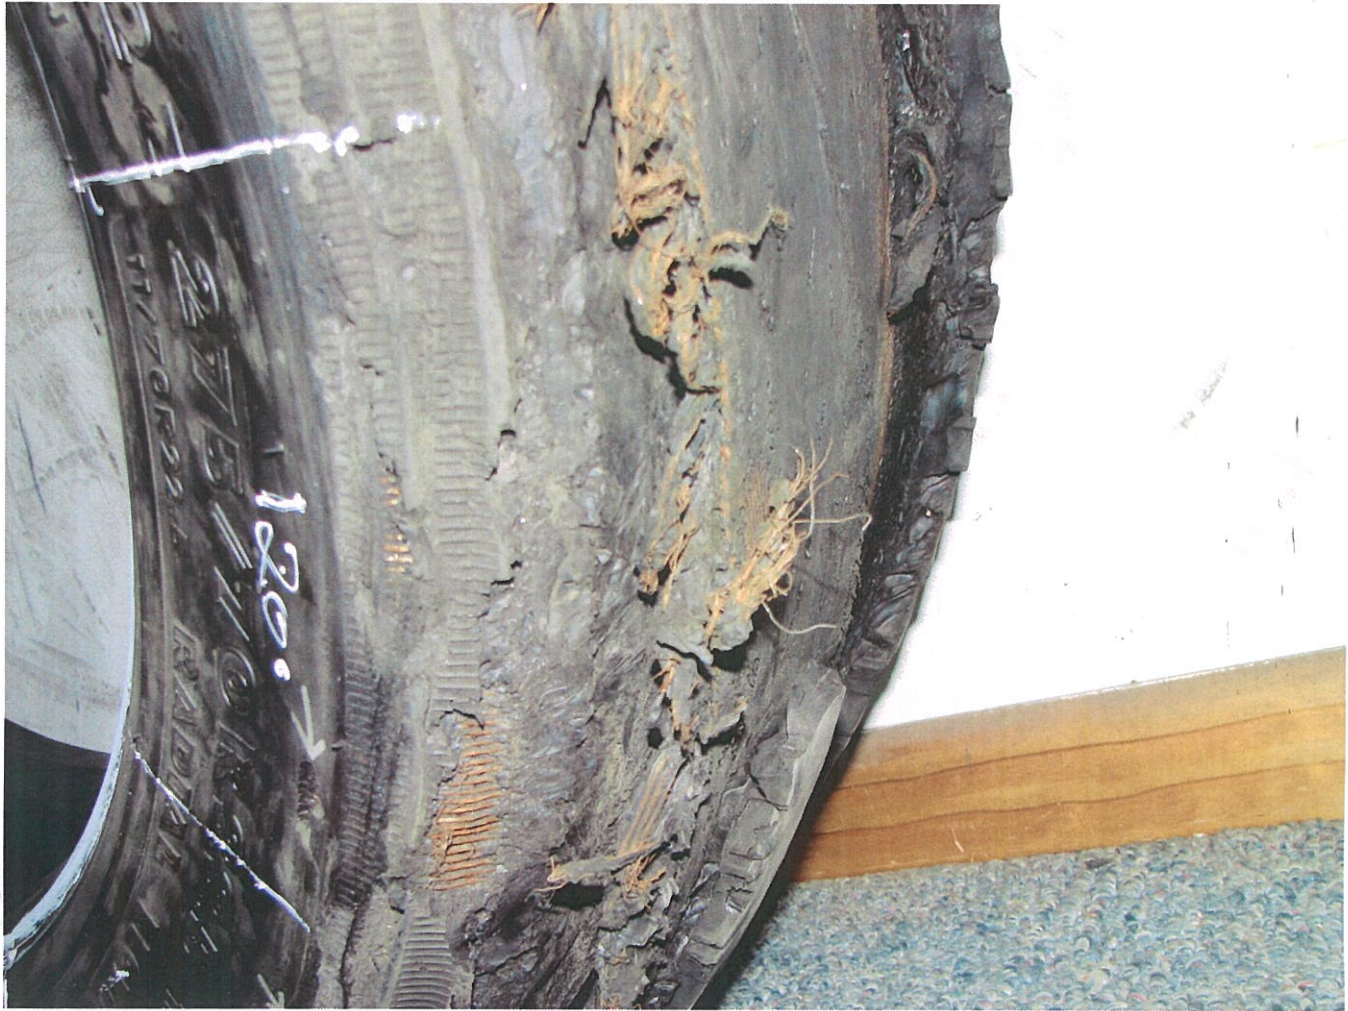
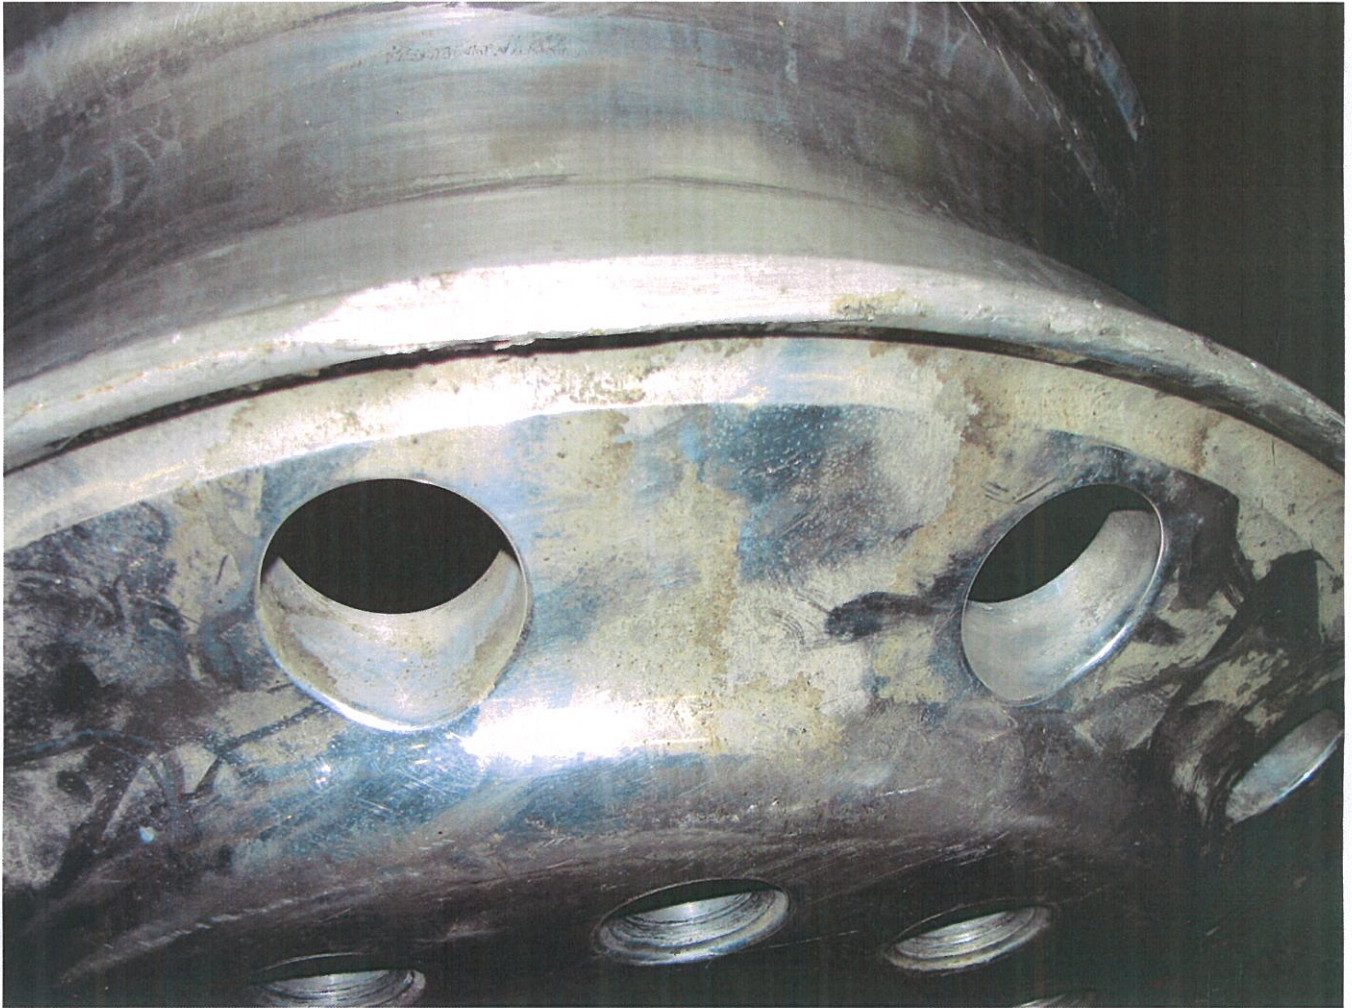
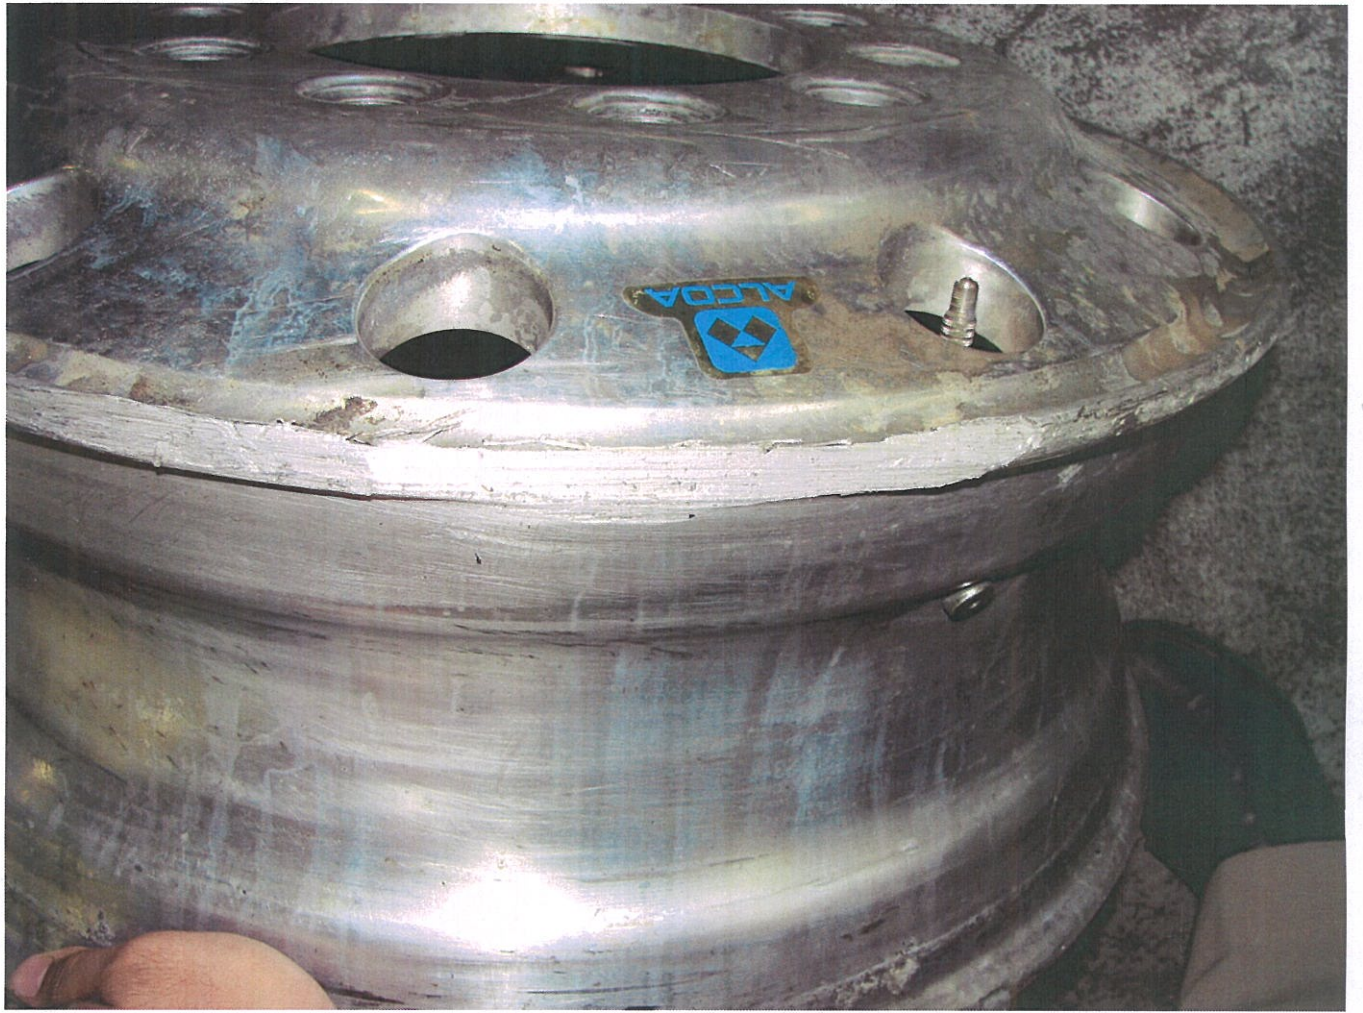
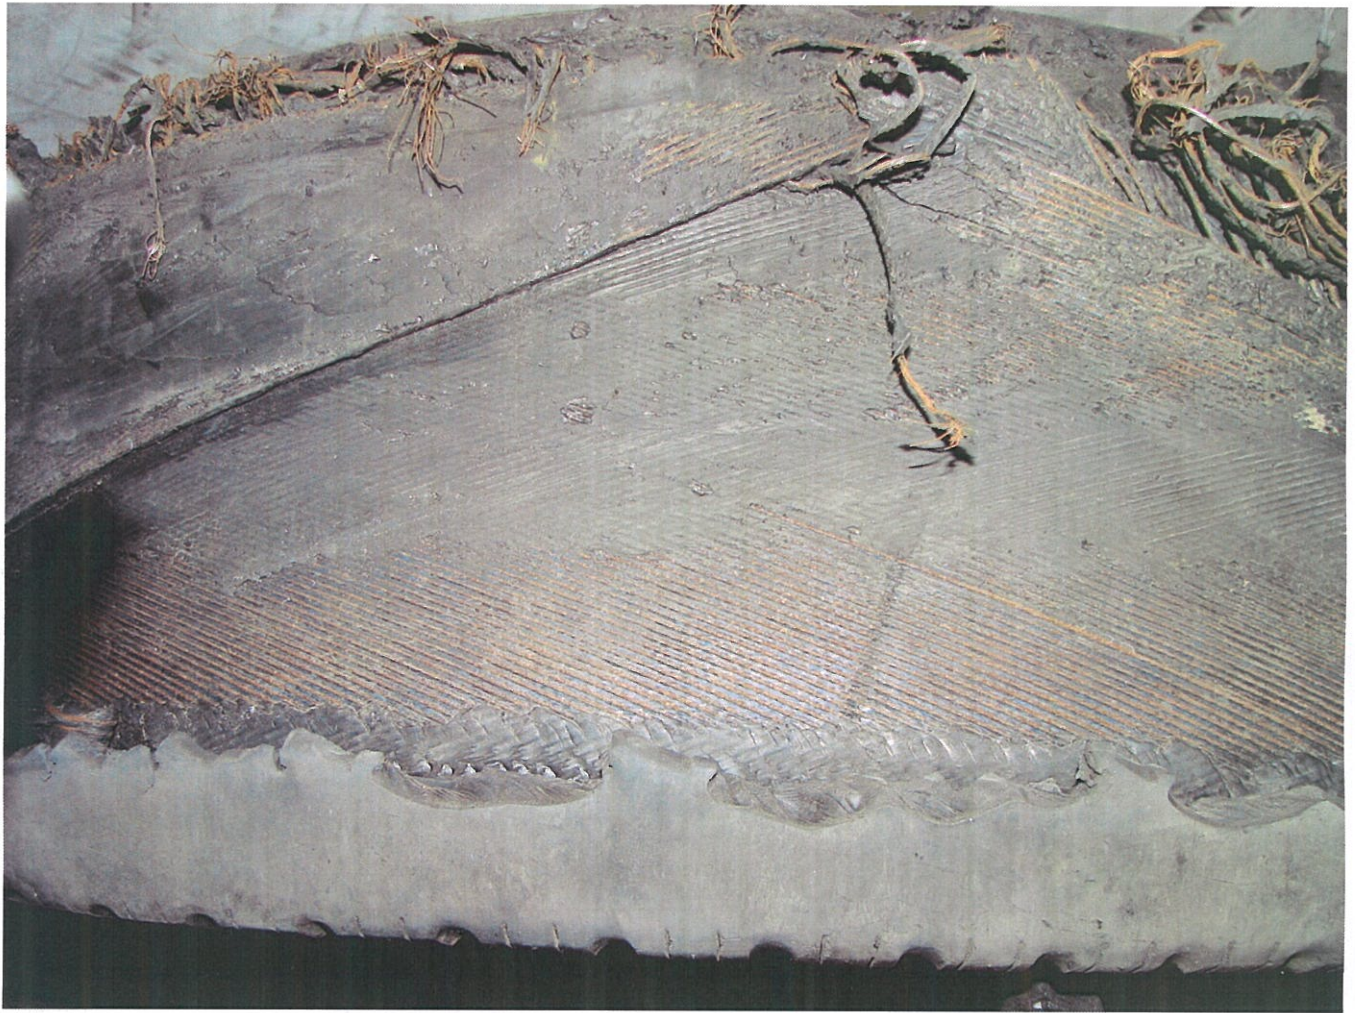
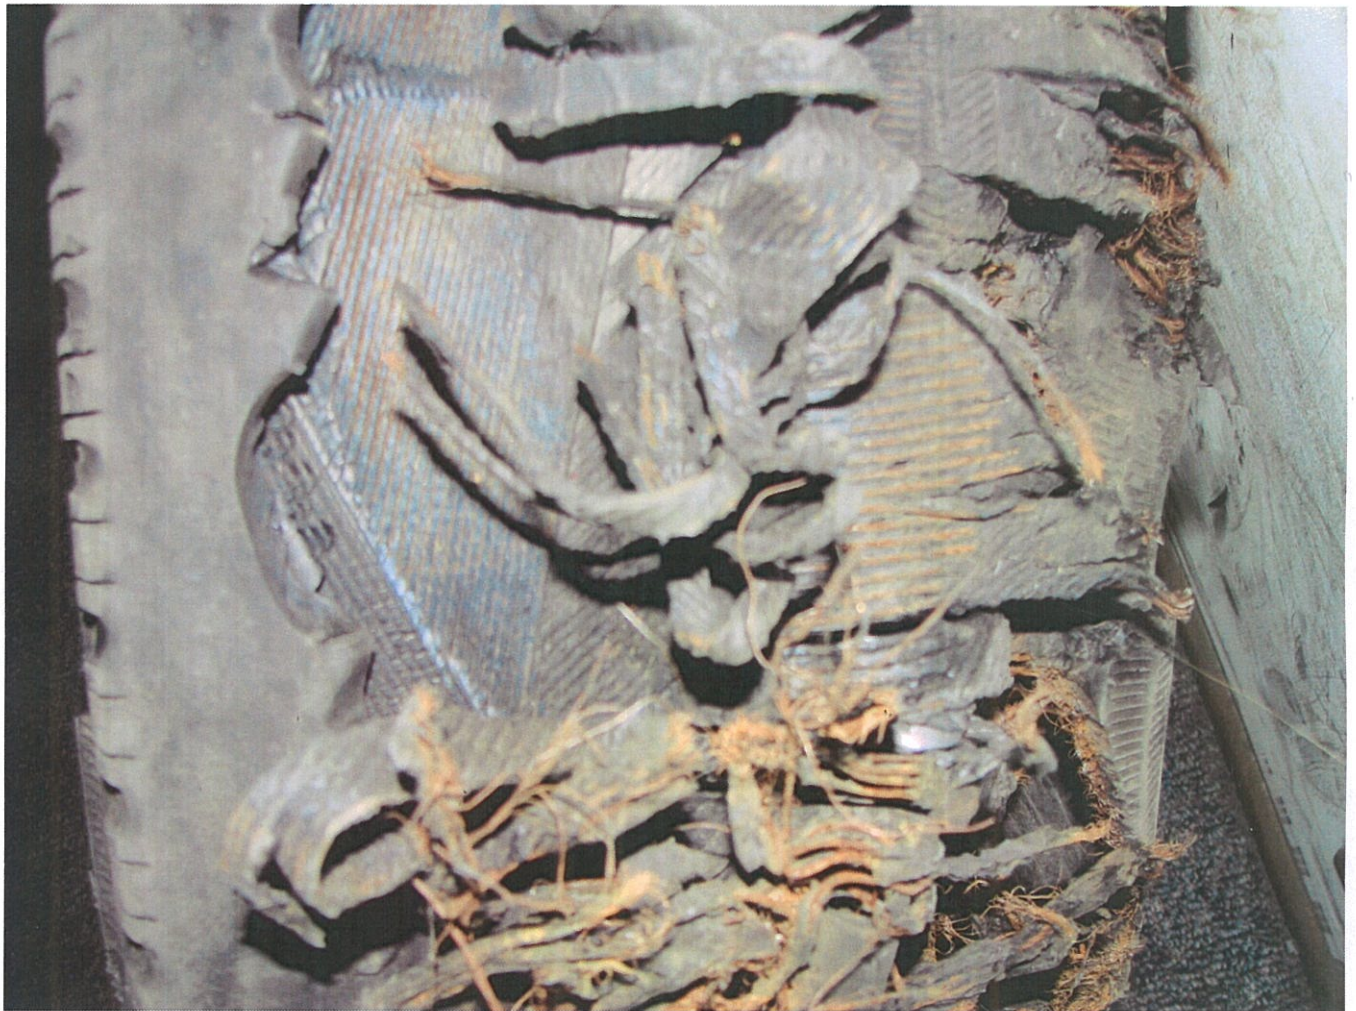
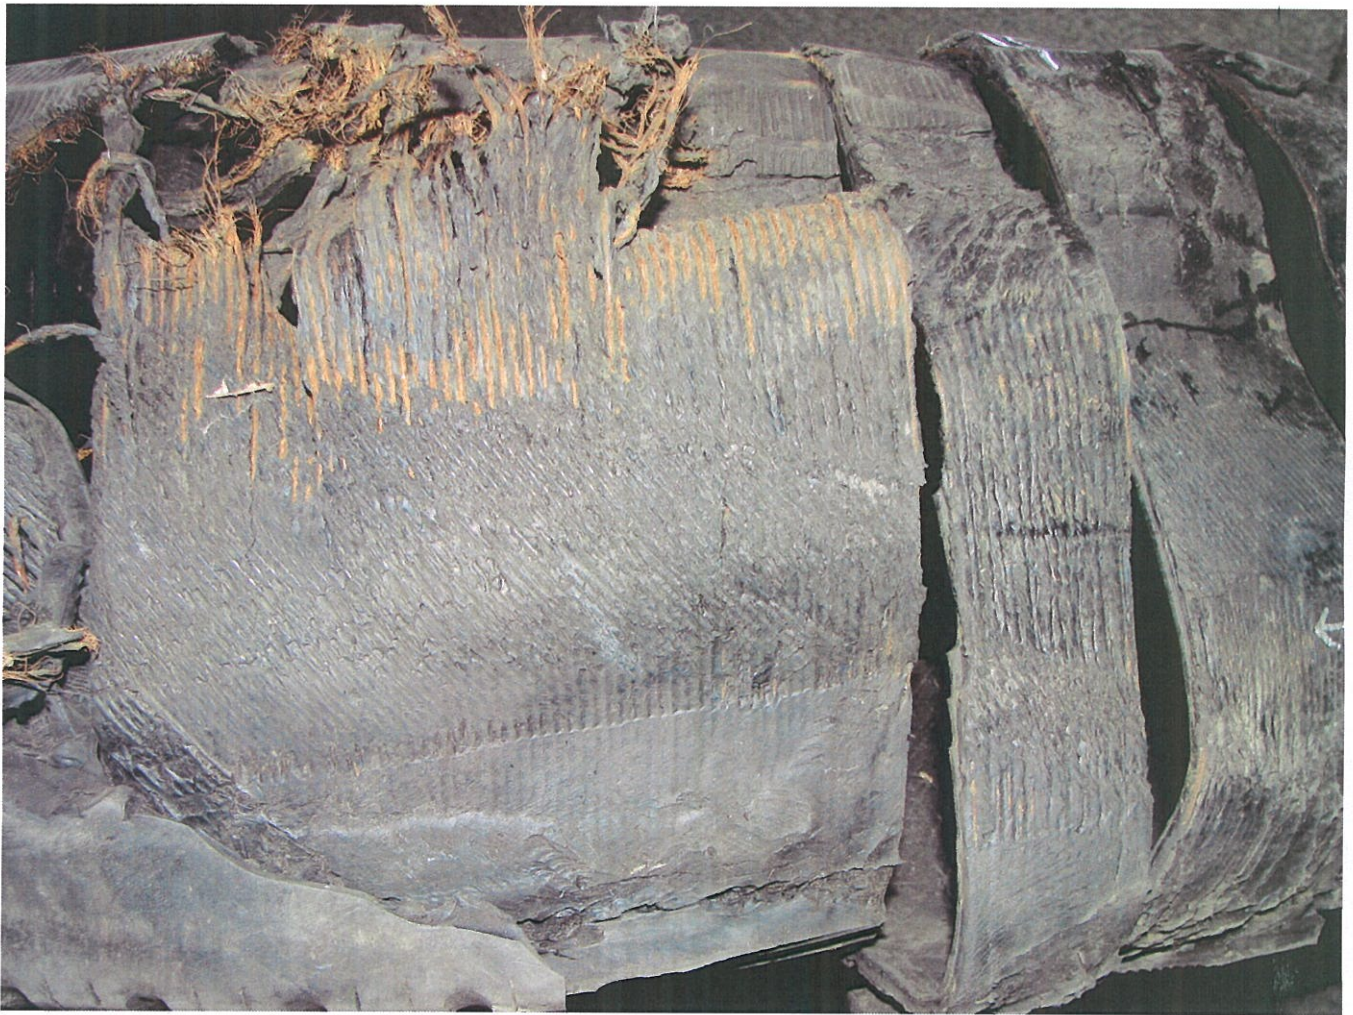
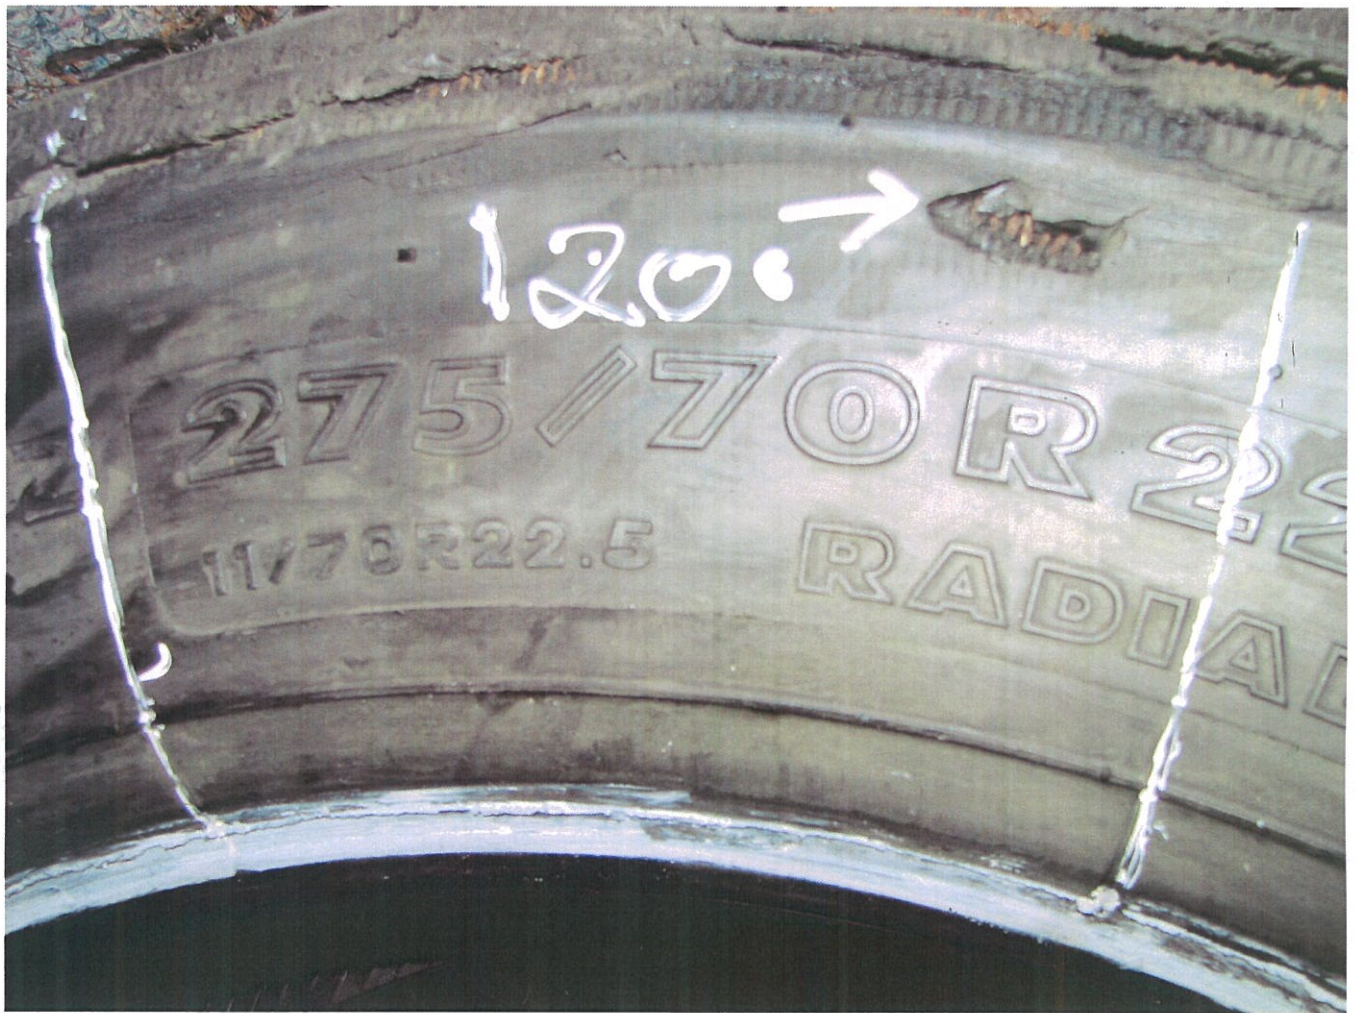
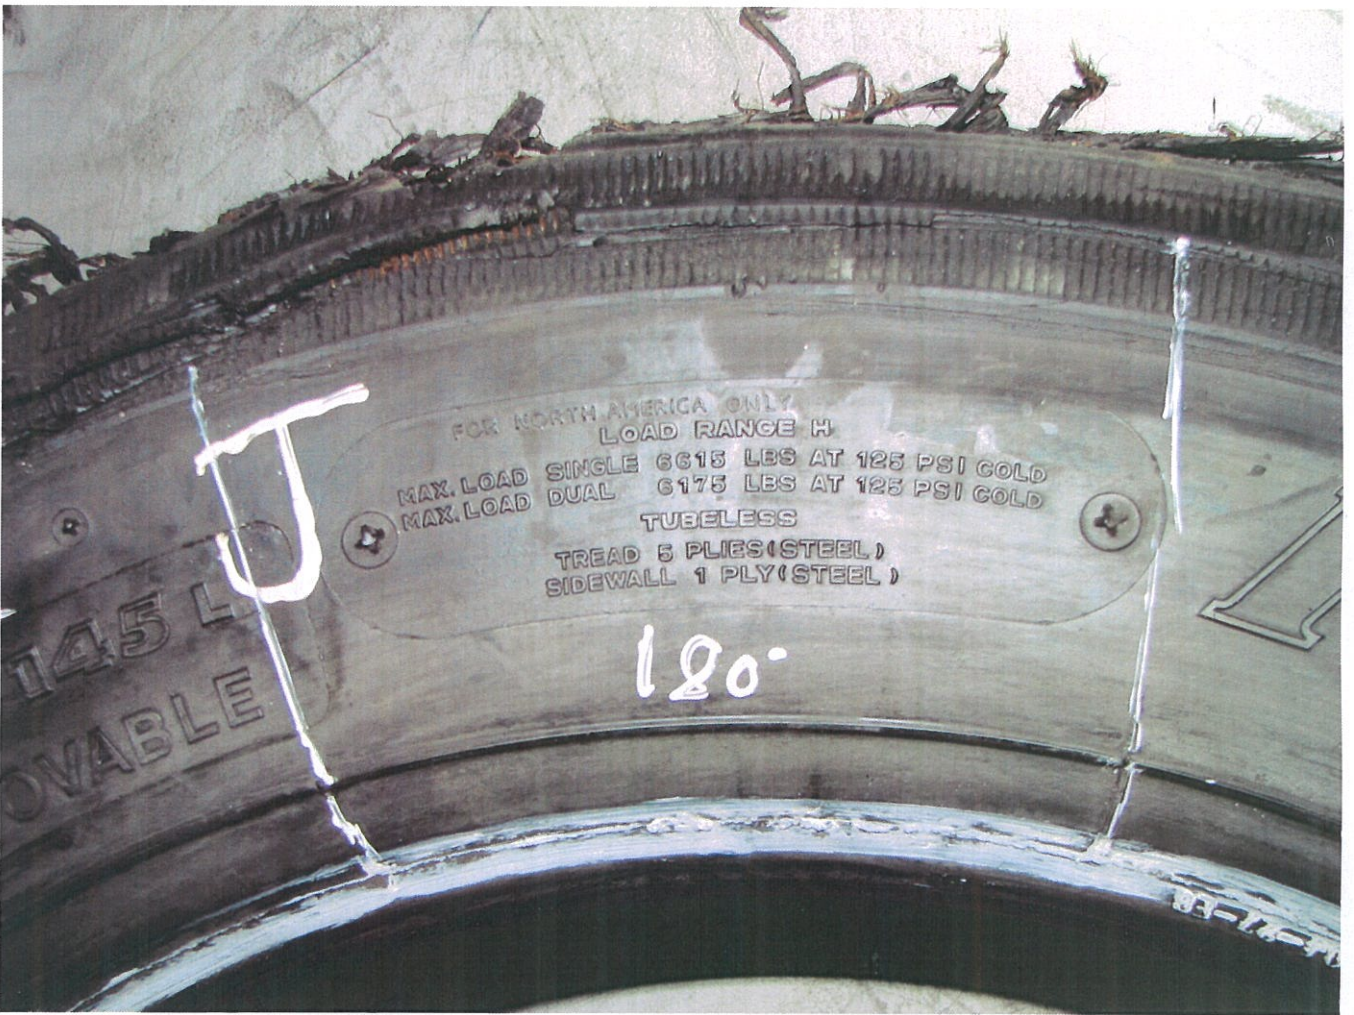
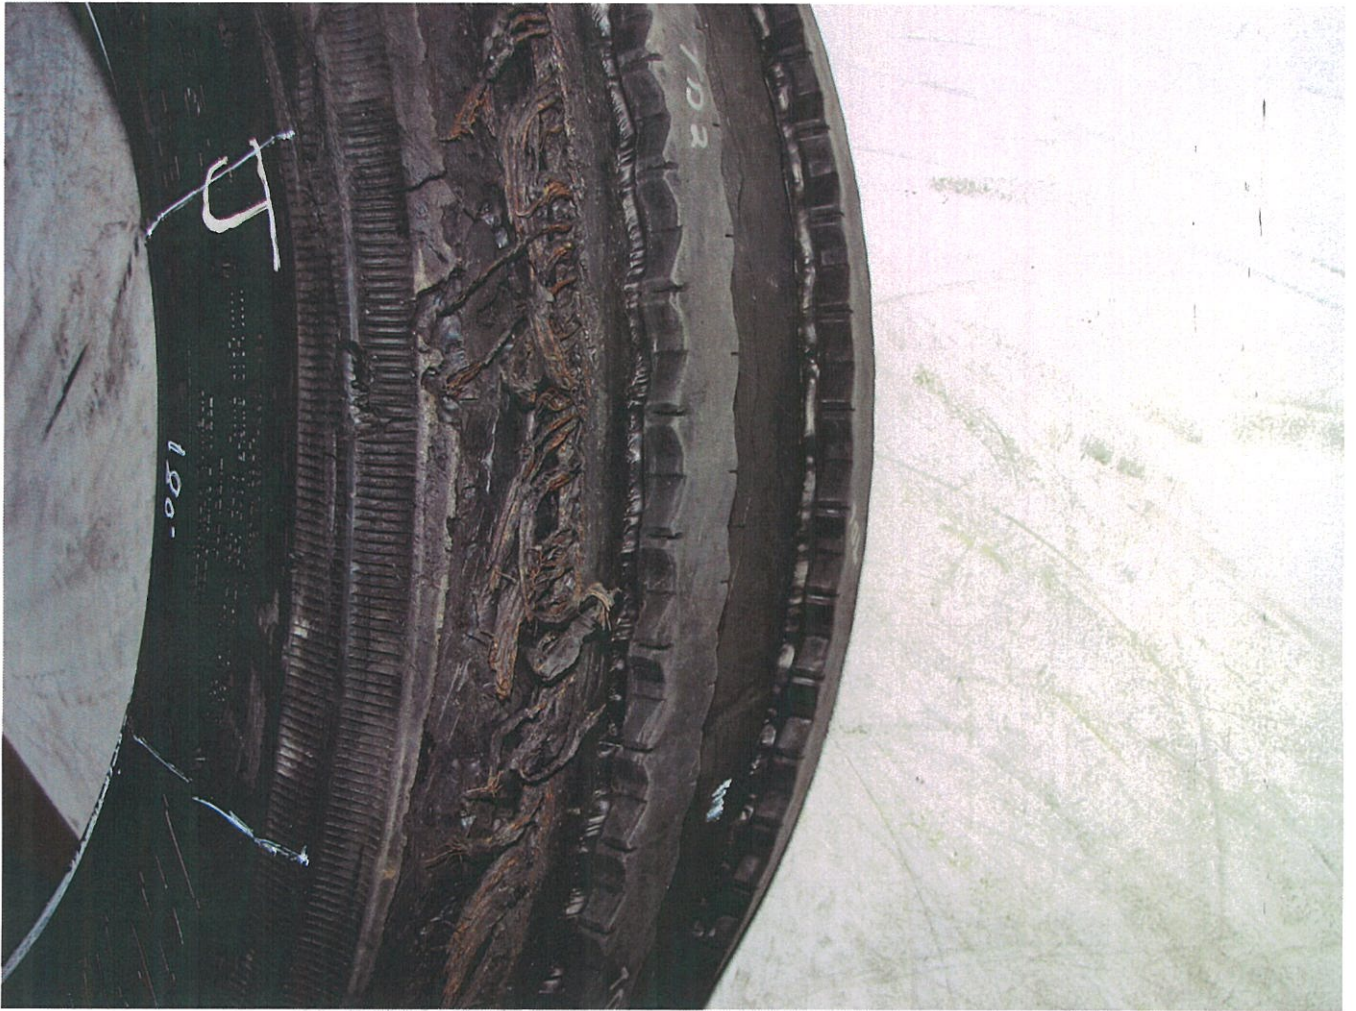
### Tire J – OBSERVATIONS AND IMAGES

Steel belt 1	Missing	Visible	Visible	Visible	Visible	Visible	Visible	Visible	Visible	Visible	Visible	Visible
Rubber between steel belt 1 and 2	Missing	Visible	Visible	Visible	Visible	Visible	Visible	Visible	Visible	Visible	Visible	Visible
Steel belt 2	Missing	Visible	Visible	Visible	Visible	Visible	Visible	Visible	Visible	Visible	Visible	Visible
Rubber between steel belt 2 and 3	Missing	Visible	Visible	Visible	Visible	Visible	Visible	Visible	Visible	Visible	Visible	Visible
Steel belt 3	Missing	Missing	Missing	Missing	Visible	Visible	Visible	Visible	Visible	Visible	Visible	Visible
Rubber between steel belt 3 and 4	Missing	Missing	Missing	Missing	Visible	Visible	Visible	Visible	Visible	Visible	Visible	Visible
Steel belt 4	Missing	Missing	Missing	Missing	Visible	Visible	Visible	Visible	Visible	Visible	Visible	Visible

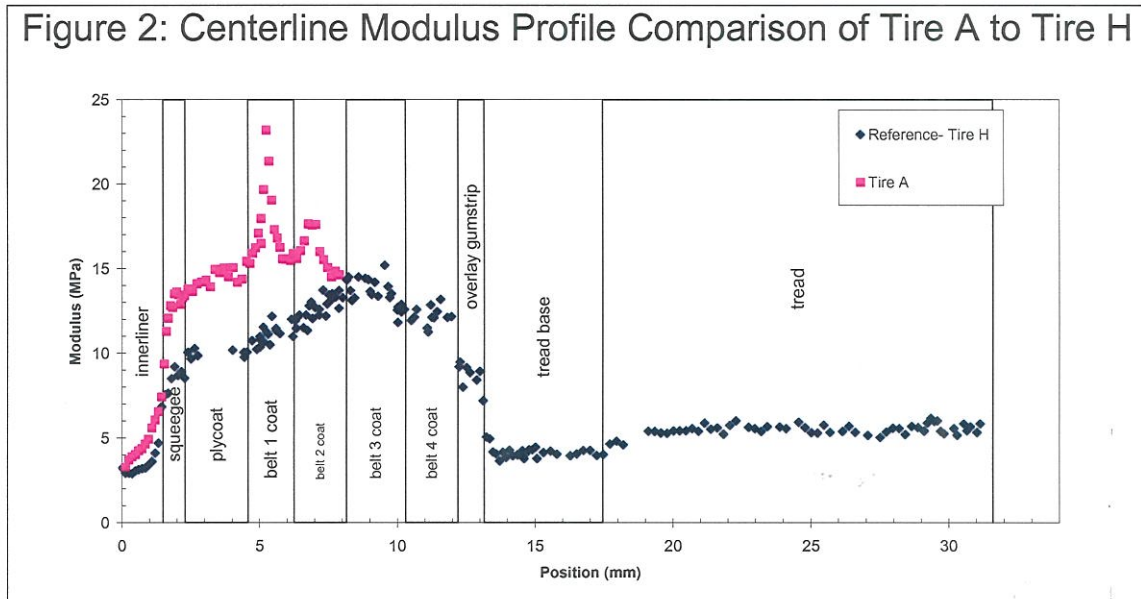
Figure 2: Centerline Modulus Profile Comparison of Tire A to Tire H

In comparison, the centerline region of tire A was much higher modulus (Figure 2). The overlay plot shows that there was very high modulus increase in the squeegee, plycoat, belt 1 coat, and belt 2 coat. The modulus increase is a result of oxidation. This could be called unusually high level of property deterioration.

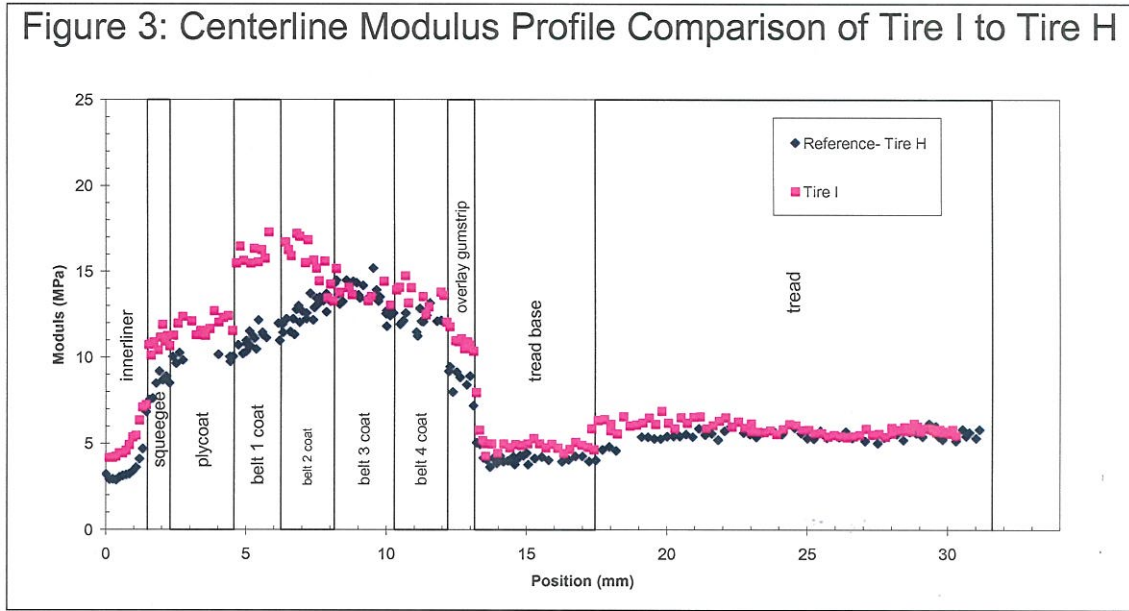
The centerline modulus profile of tire I is shown in Figure 3. The results point to major oxidation in the belt-1-coat and belt-2-coat compounds. This may be associated with high heat and strains in this region of the tire or oxygen somehow reaching this compound (i.e., cord wicking).

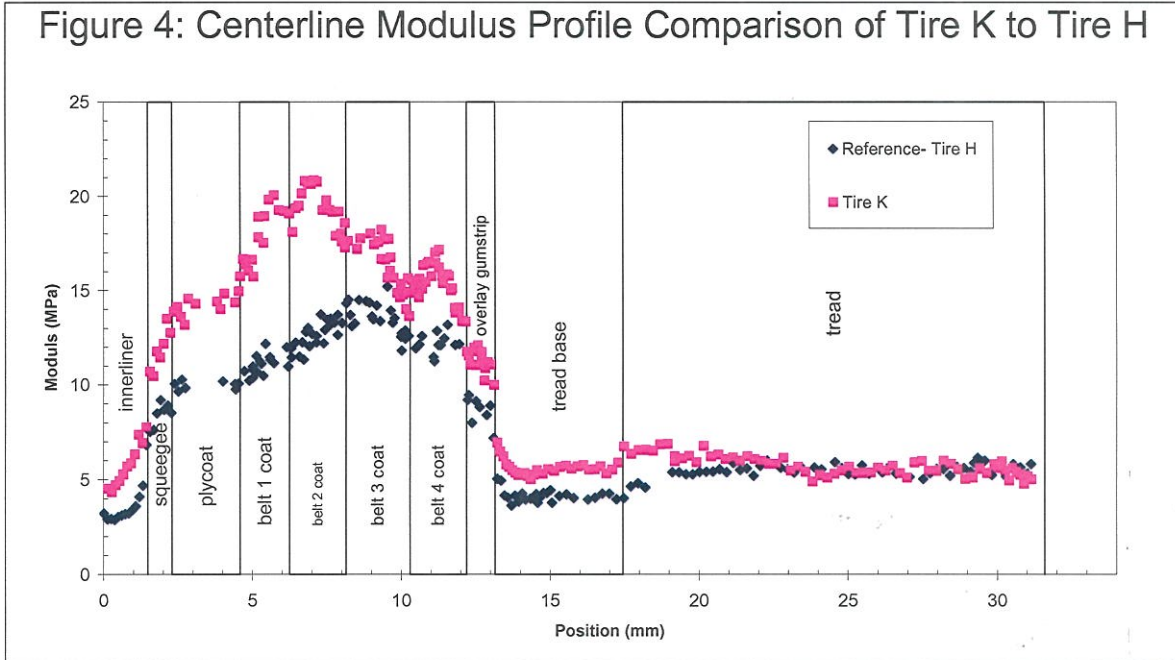
Figure 4: Centerline Modulus Profile Comparison of Tire K to Tire H

The centerline modulus profile of tire K is shown in Figure 4. The results show large modulus increases in the squeegee, plycoat, belt-1-coat, and belt-2-coat compounds. This is probably caused by oxidation. The modulus values are close to those found in tires A and J, which had experienced separations.

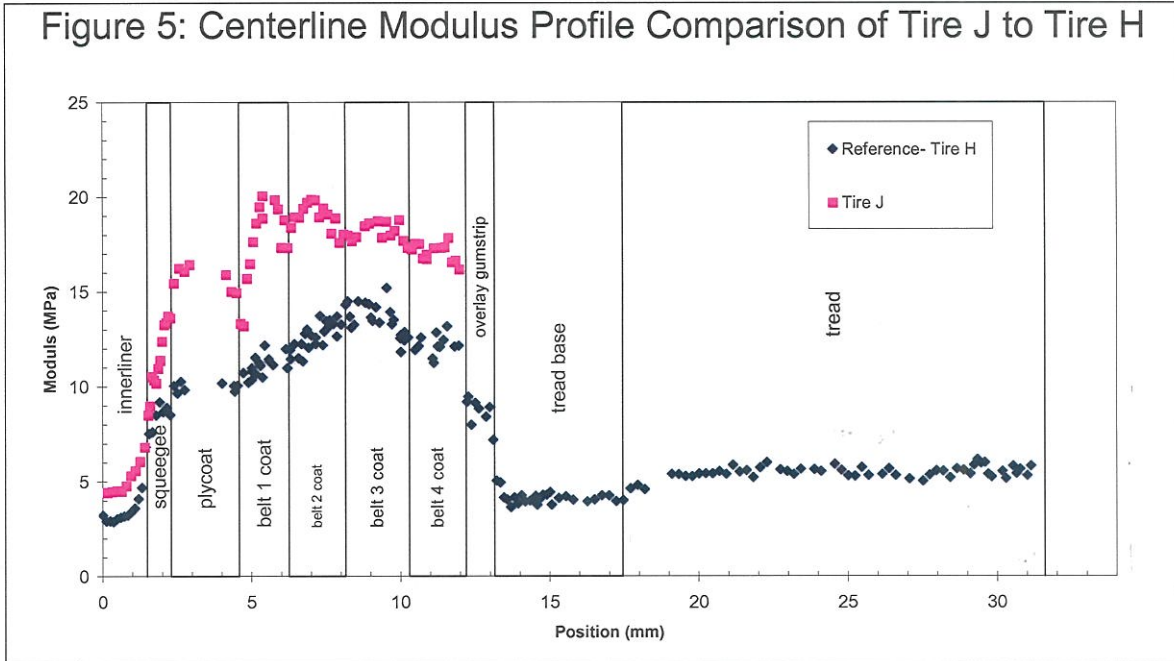
The centerline region of tire J was high in modulus (Figure 5). The overlay plot shows that there were large modulus increases in the squeegee, plycoat, belt 1 coat, and belt 2 coat. The oxidative hardening appears to be close to the cords, suggesting oxygen wicking along the cords. This could be called unusually high level of property deterioration.
