AKRON RUBBER DEVELOPMENT LABORATORY, INC  
ARDL ENGINEERING GROUP  
2851 GILCHRIST ROAD, AKRON, OHIO 44305  
PHONE: 330-7946600 FAX 330-7946623

## - TIRE FORENSICS REPORT -

PN 67722  
Purchase Order DTNH22-06-P-08366

**SUBJECT:** Forensic Evaluation on 9 Toyo Tires.

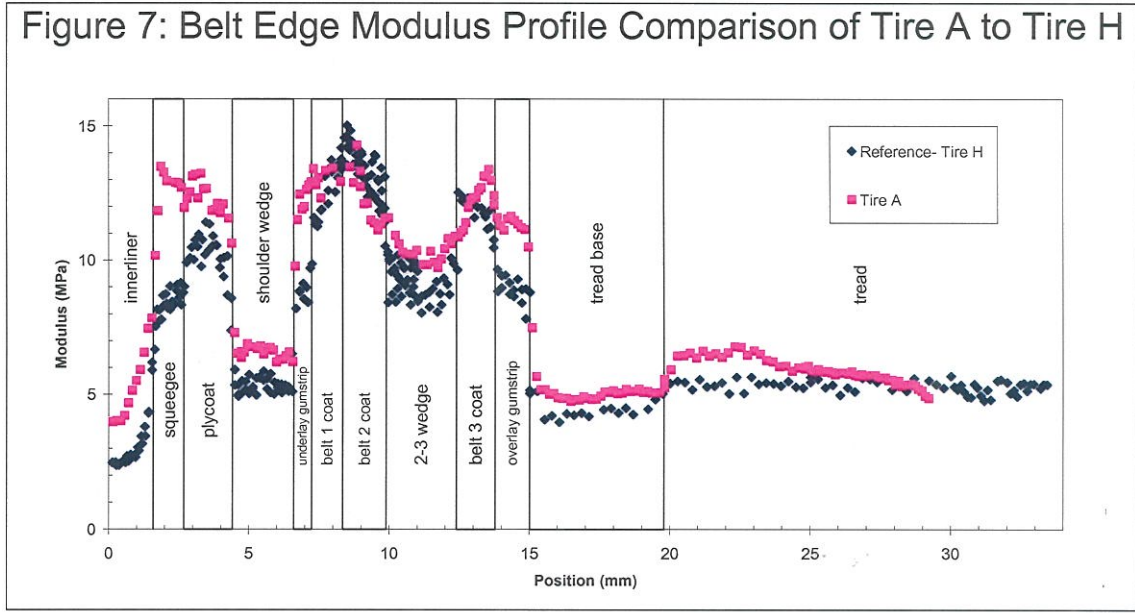
In a comparison plot of Tire A to Tire H, the belt region results indicate oxidative hardening in all components except belt 2 coat (Figure 7). The modulus change in belt-2-coat was probably dominated by mechanical softening.

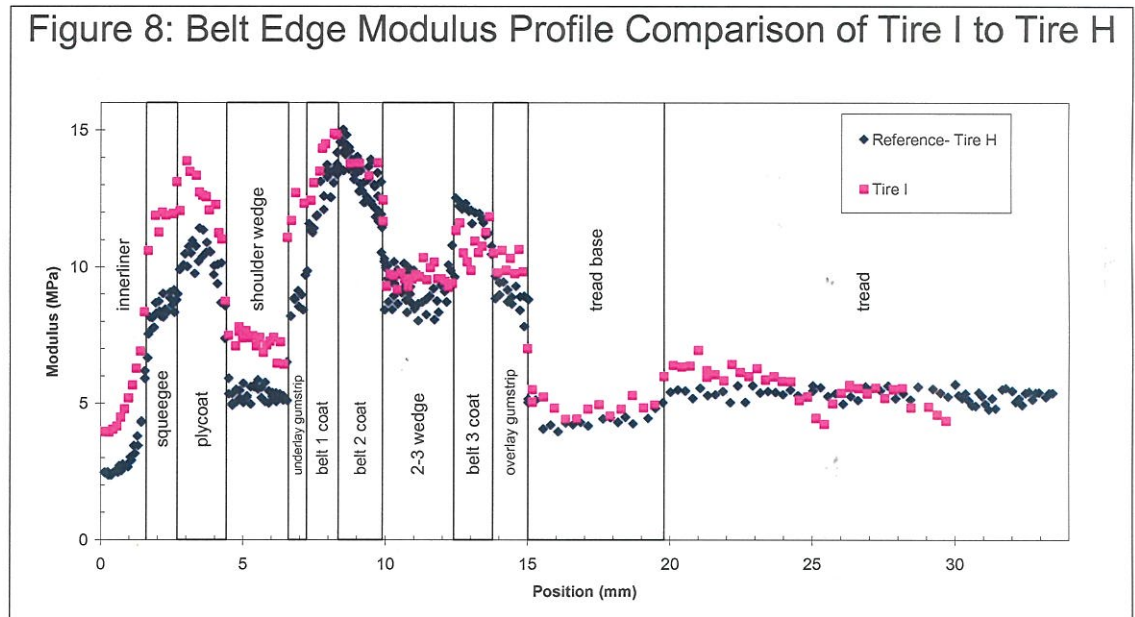
The belt edge modulus profile of tire I is shown in Figure 8. The results were compared to Tire H. Oxidative hardening was observed in all components except belt-3-coat. The modulus change in belt-3-coat was probably dominated by mechanical softening.

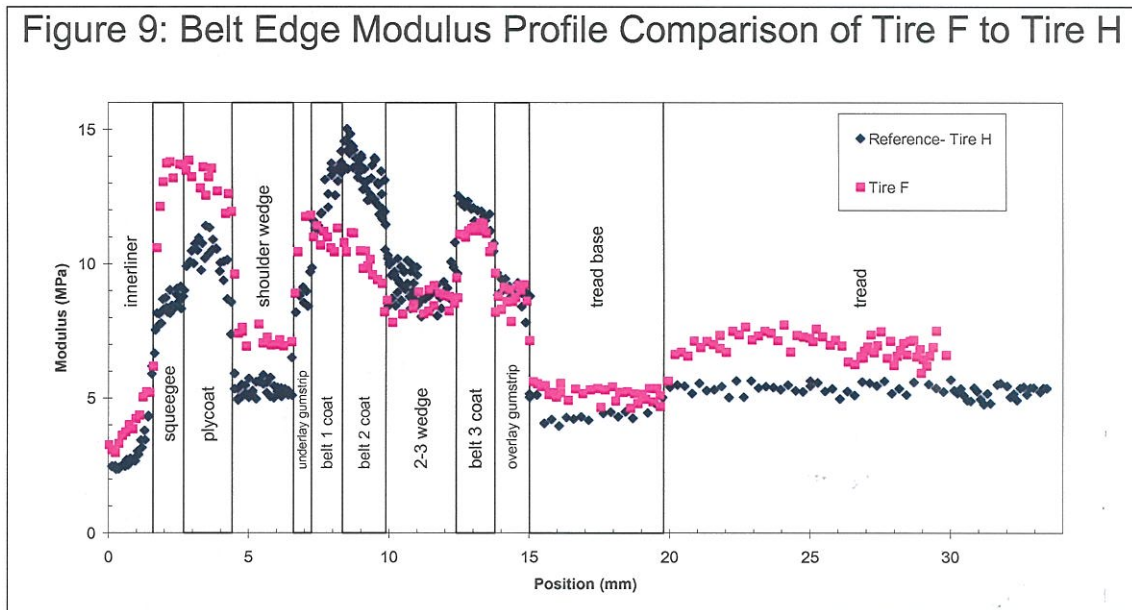
The belt edge modulus profile of tire F is shown in Figure 9. The results were compared to Tire H. Oxidative hardening was observed in all components except belt-1-coat, belt-2-coat, 2-3 wedge, belt-3-coat, and overlay gumstrip. The modulus changes in those components were probably dominated by mechanical softening.

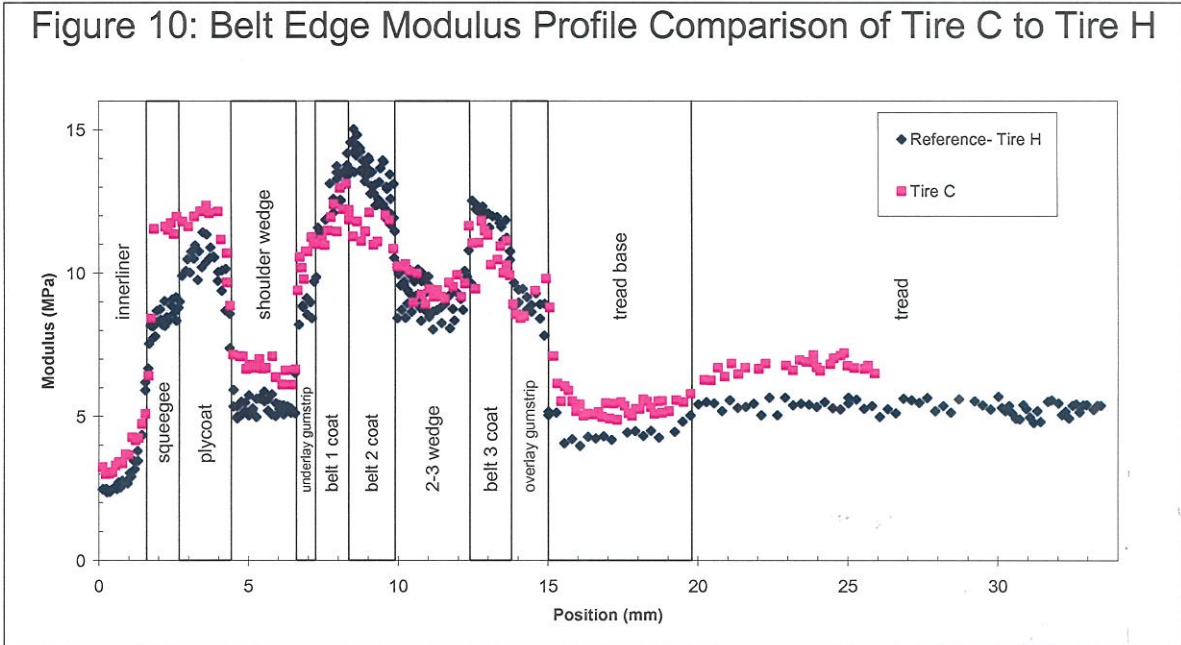
The belt edge modulus profile of tire C is shown in Figure 10. The results were compared to Tire H. Oxidative hardening was observed in all components except belt-1-coat, belt-2-coat, 2-3 wedge, and belt-3-coat. The modulus changes in those components were probably dominated by mechanical softening.
