PETITION

Under the Code of Federal Regulations Part 552-Petitions for Rulemaking, Defects, and Noncompliance Orders, I am submitting this petition to request the NHTSA to remedy a failure of my 1999 Ford Contour (VIN 1FAFP66LXXK228330) to comply with Federal Motor Vehicle Safety Standard 208 Occupant Crash Protection.

Eric Moening's
1999 Ford Contour (VIN 1FAFP66LXXK228330)
Instrument Panel Warpage

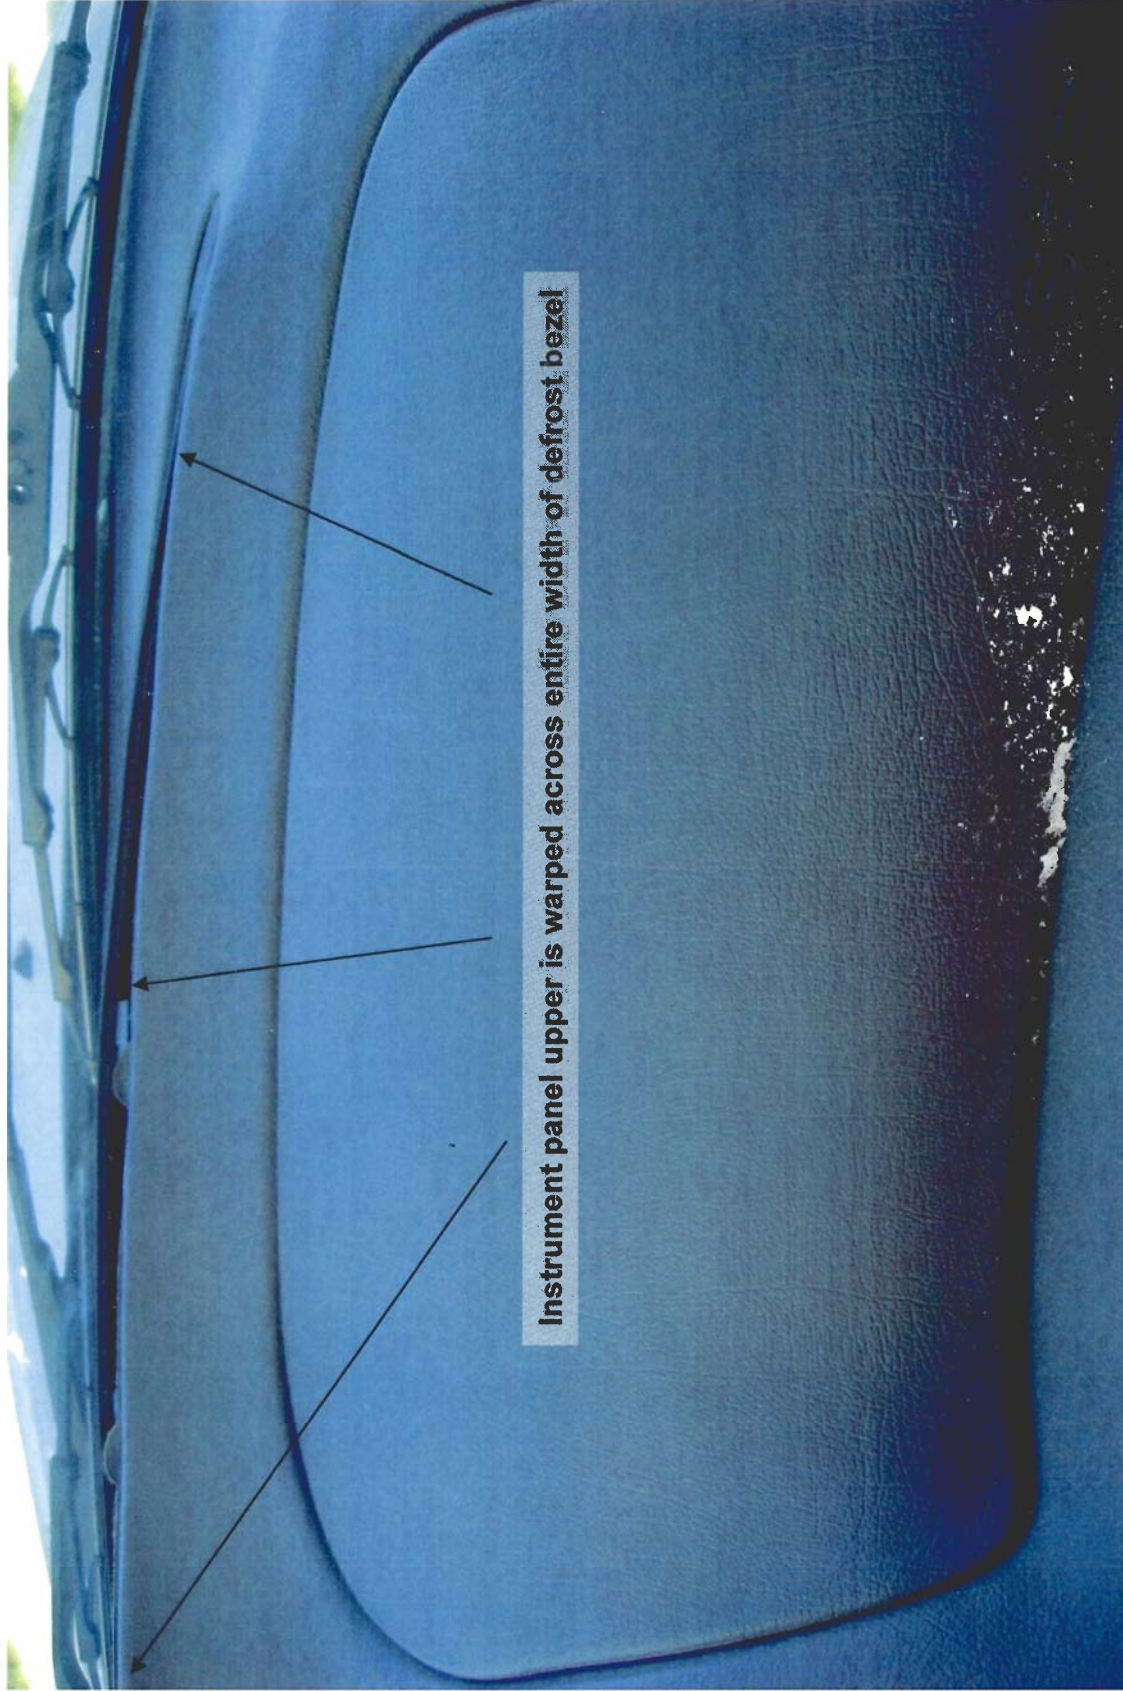
Attachment B

Instrument panel upper / passenger air bag door

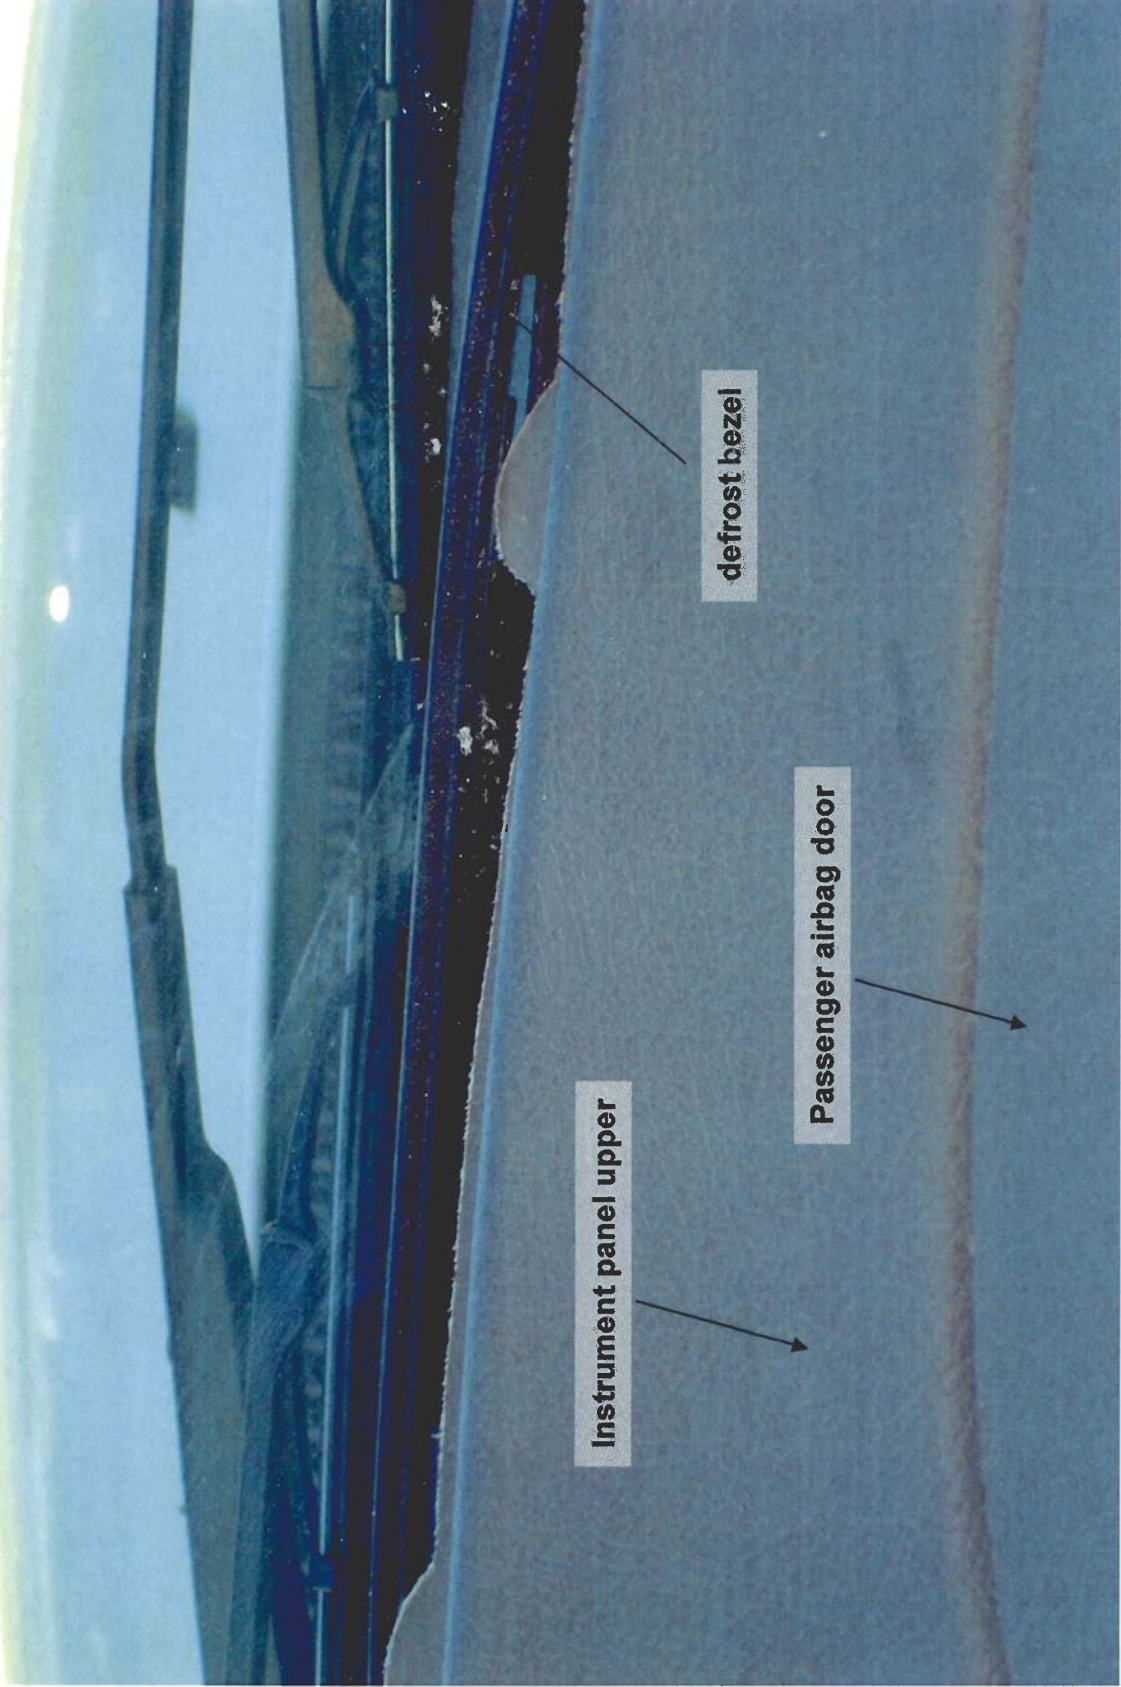
Instrument panel upper / loose defrost bezel

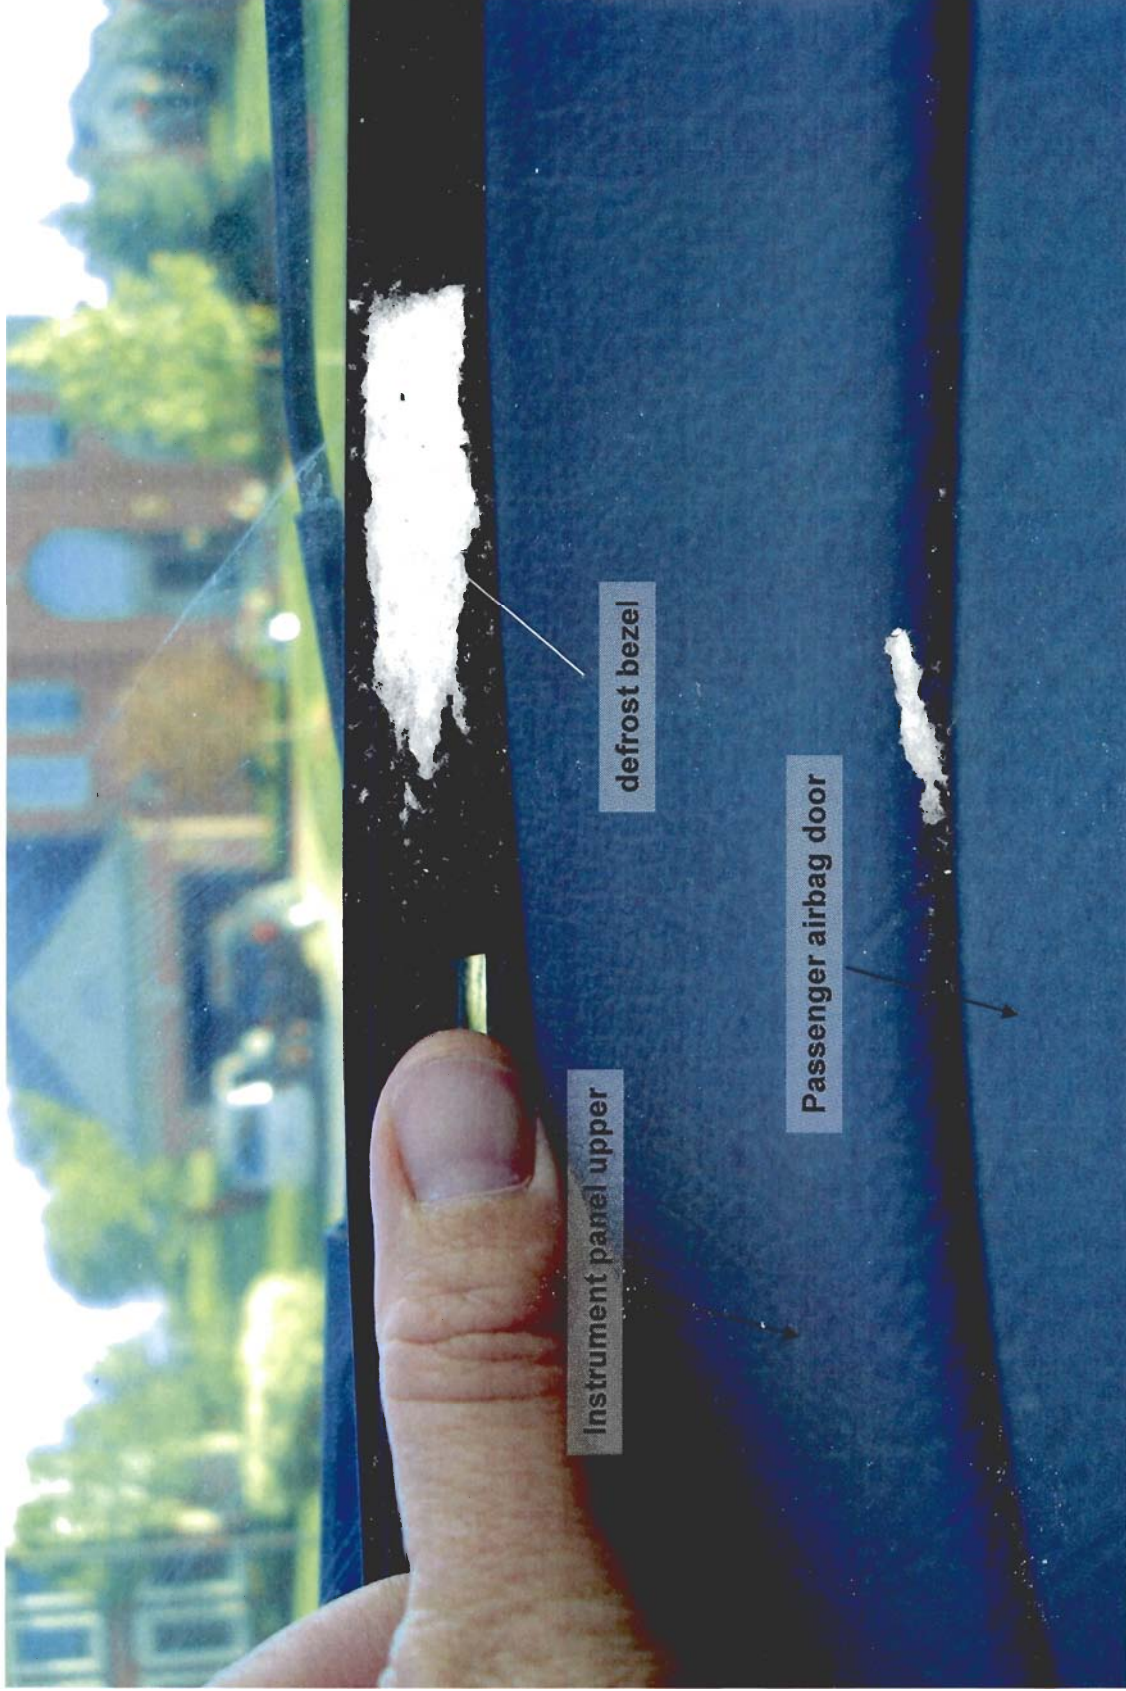
Instrument panel upper / loose defrost bezel

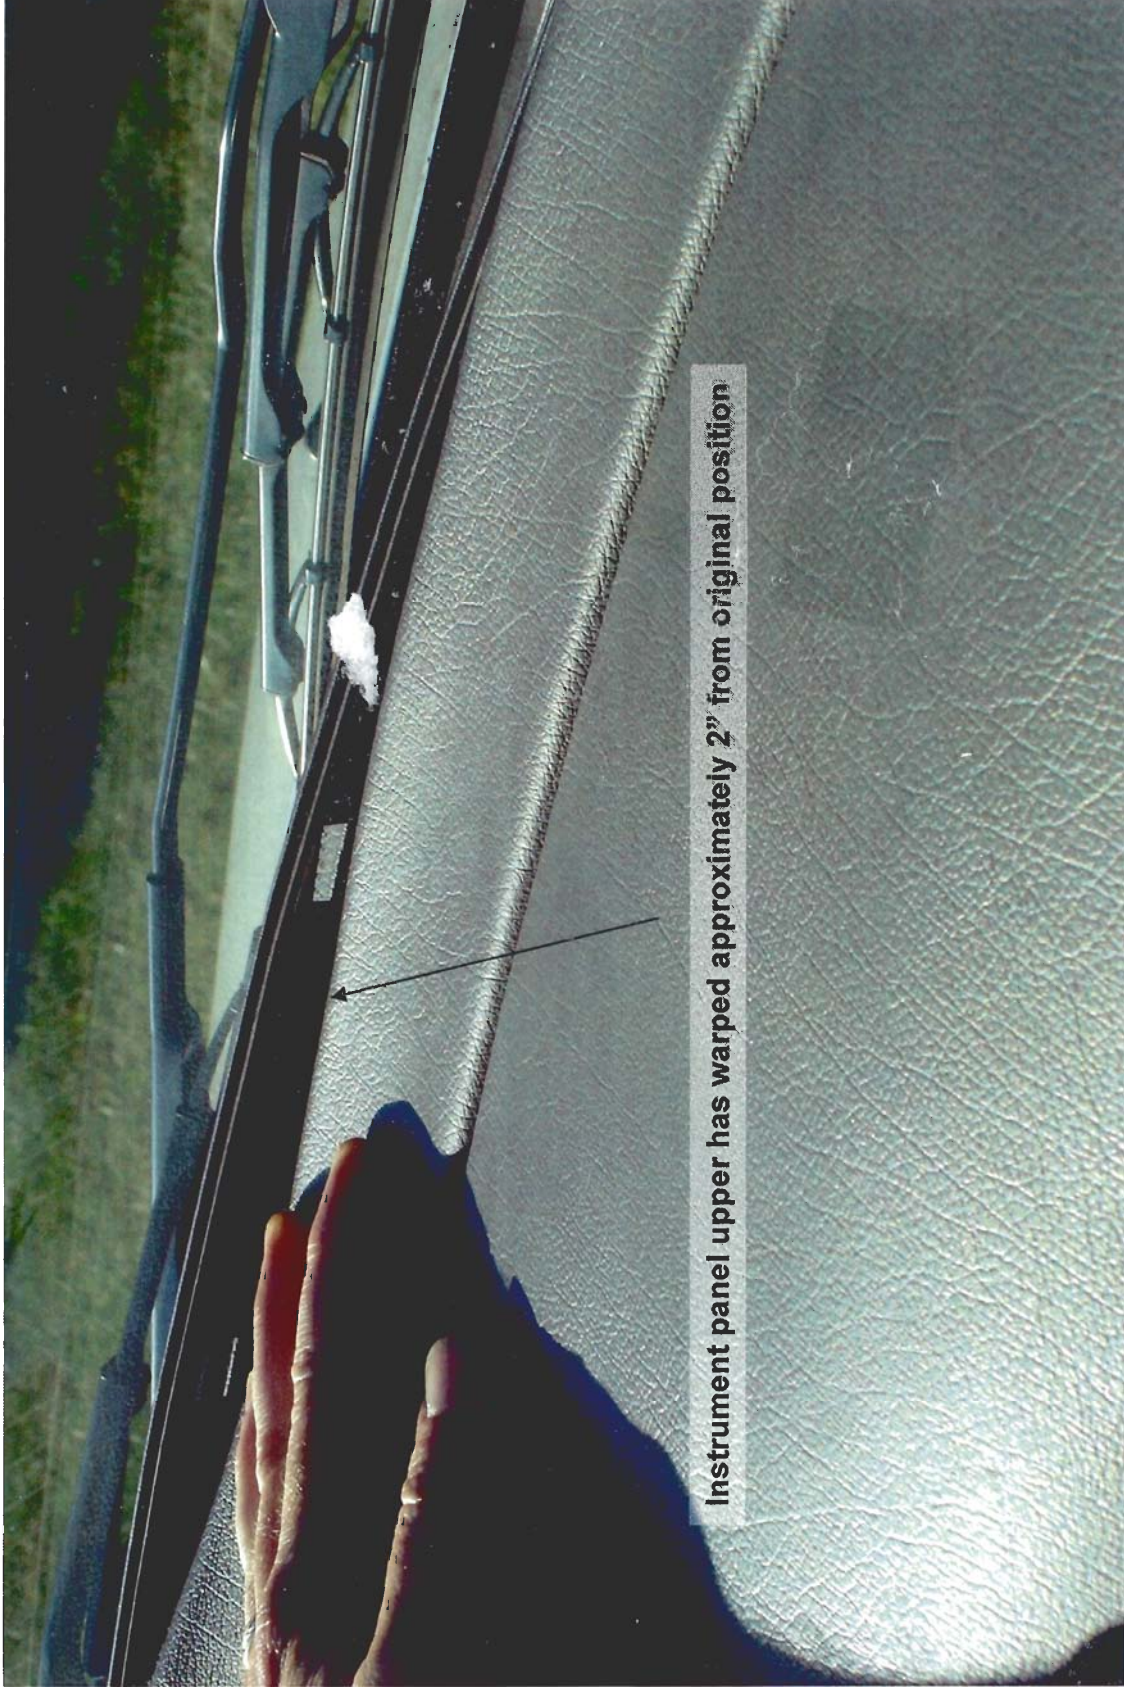
Attachment E

Instrument panel upper has warped approximately 2" from original position

Instrument panel upper / loose defrost bezel

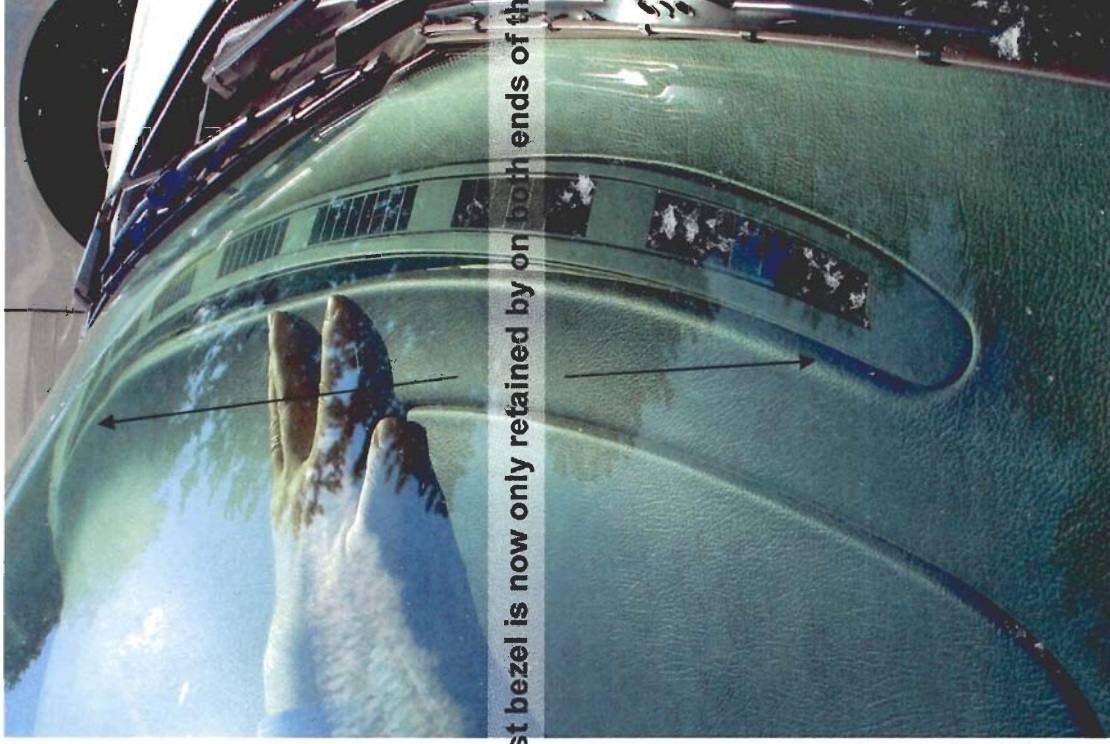
Due to warpage, the defrost bezel is now only retained by on both ends of the instrument panel upper

Instrument panel upper / loose defrost bezel

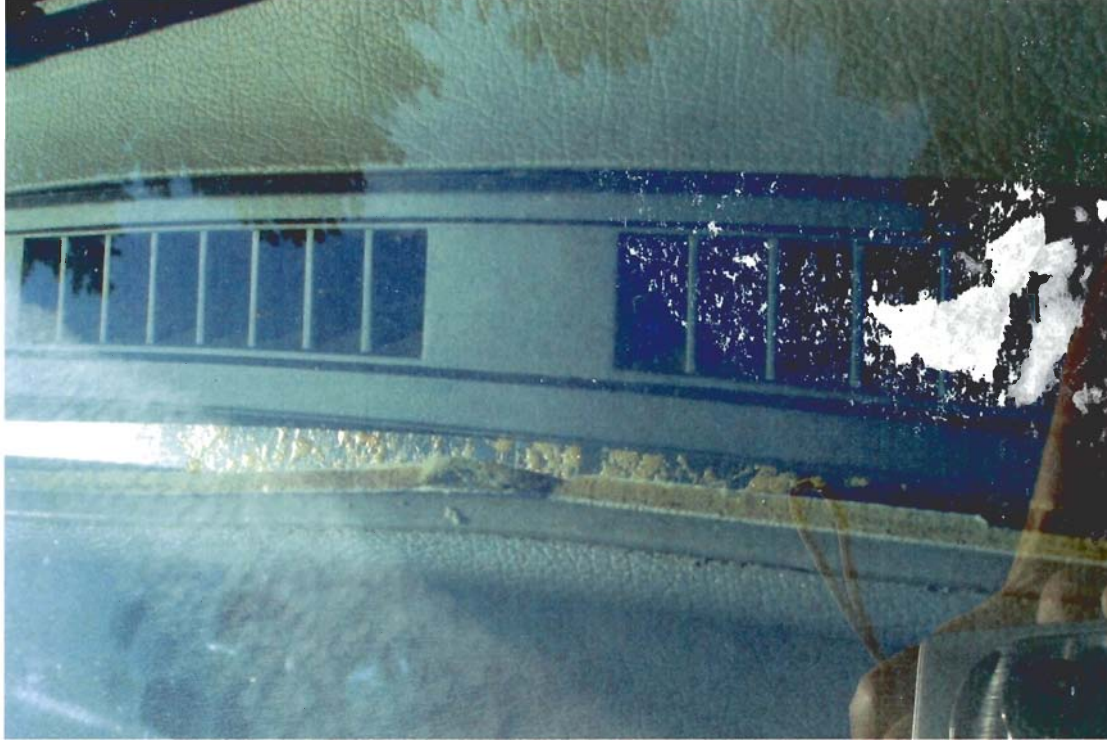
Attachment G

Instrument panel upper / loose defrost bezel closeup
