U.S. Department
of Transportation
**National Highway
Traffic Safety
Administration**

ODI RESUME

Investigation: EA 06-001
 Prompted By: PE05-052
 Date Opened: 01/20/2006 Date Closed: 12/01/2006
 Principal Investigator: Peter C. Ong
 Subject: Sunroof Glass Failure

Manufacturer: General Motors Corp.
 Products: 2004 - 2006 Cadillac SRX with Ultraview type sunroofs
 Population: 47,232

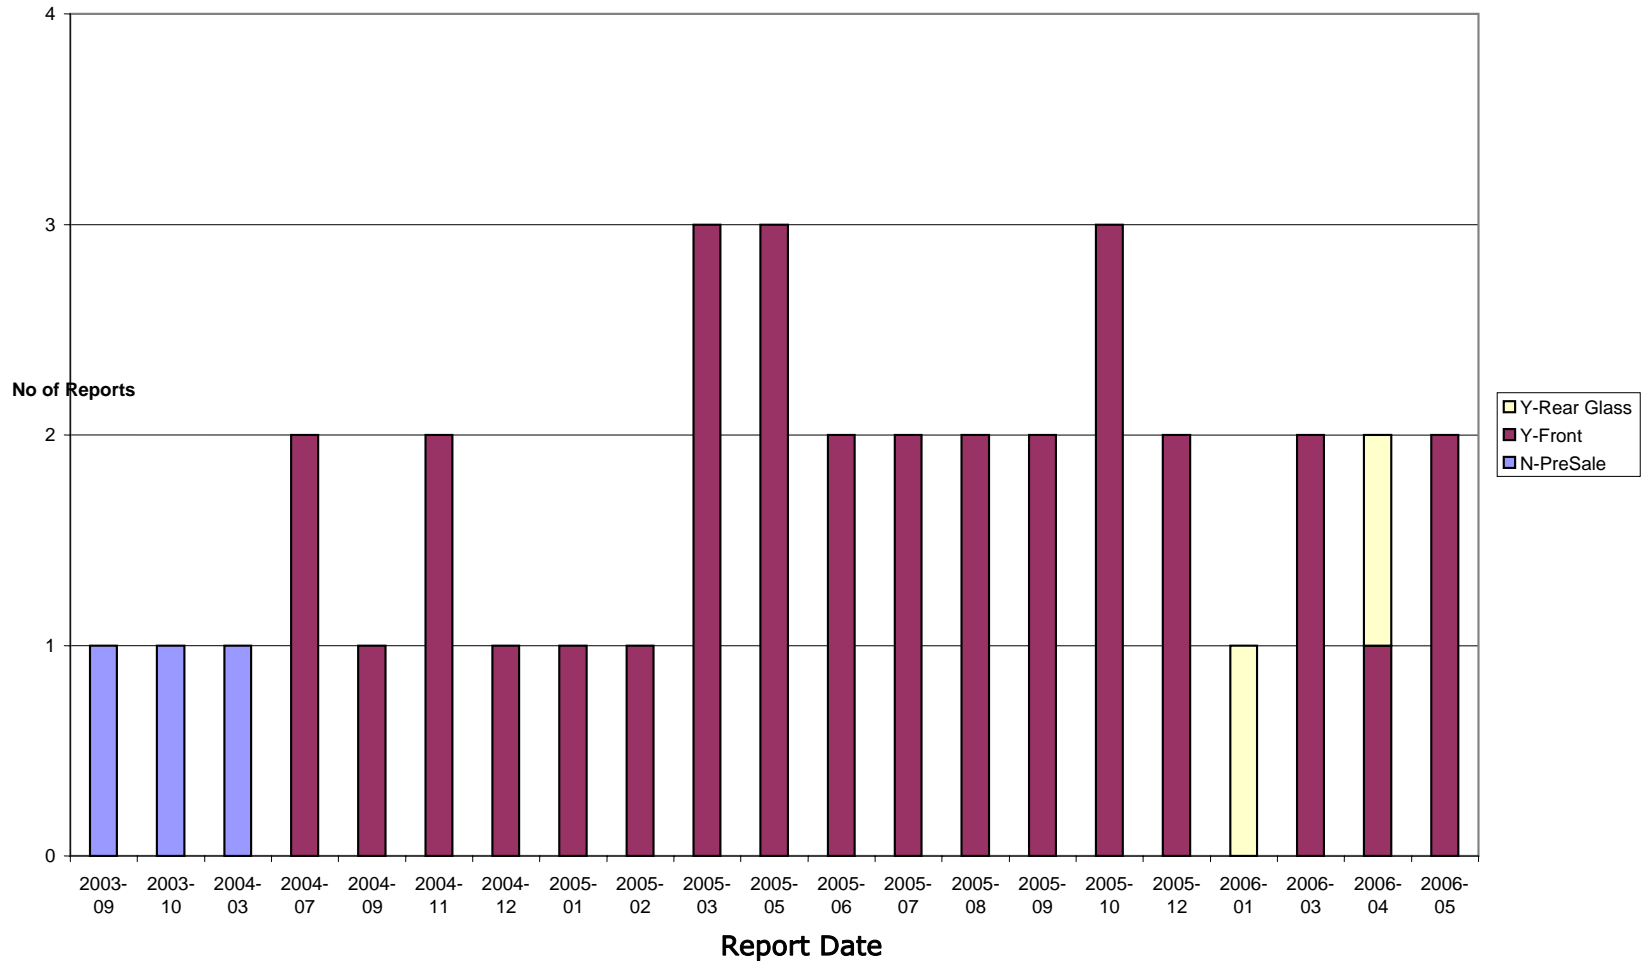
Figure 4. Report Trend by Report Date
Reports (as of 06/2006)

ODI SRX Vehicle Analysis: Figure 4 shows the 37 unique owner complaints and warranty claims plotted by report date. The data indicate no concentration of incident reports by report date, and no environmental/seasonal factors. Figure 5 shows these reports by build month. The reporting trend by build month shows a small (single digit) number of reports for any particular month and these appear to be randomly distributed. The time-to-failure (months in service) trend was also random in nature and ranged from one to 25 months of usage (Figure 6) with no concentration of vehicles at a particular service time period. The average number of incidents is approximately 1-2 per month. The combined incident rate from the 37 reports and over the 39,000 sold vehicles is around 70 per 100,000 vehicles per exposure-year.
