## ODI RESUME

Investigation: EA06-004

Subject: Steering wheel and steering shaft bolts

## ENGINEERING ANALYSIS CLOSING REPORT

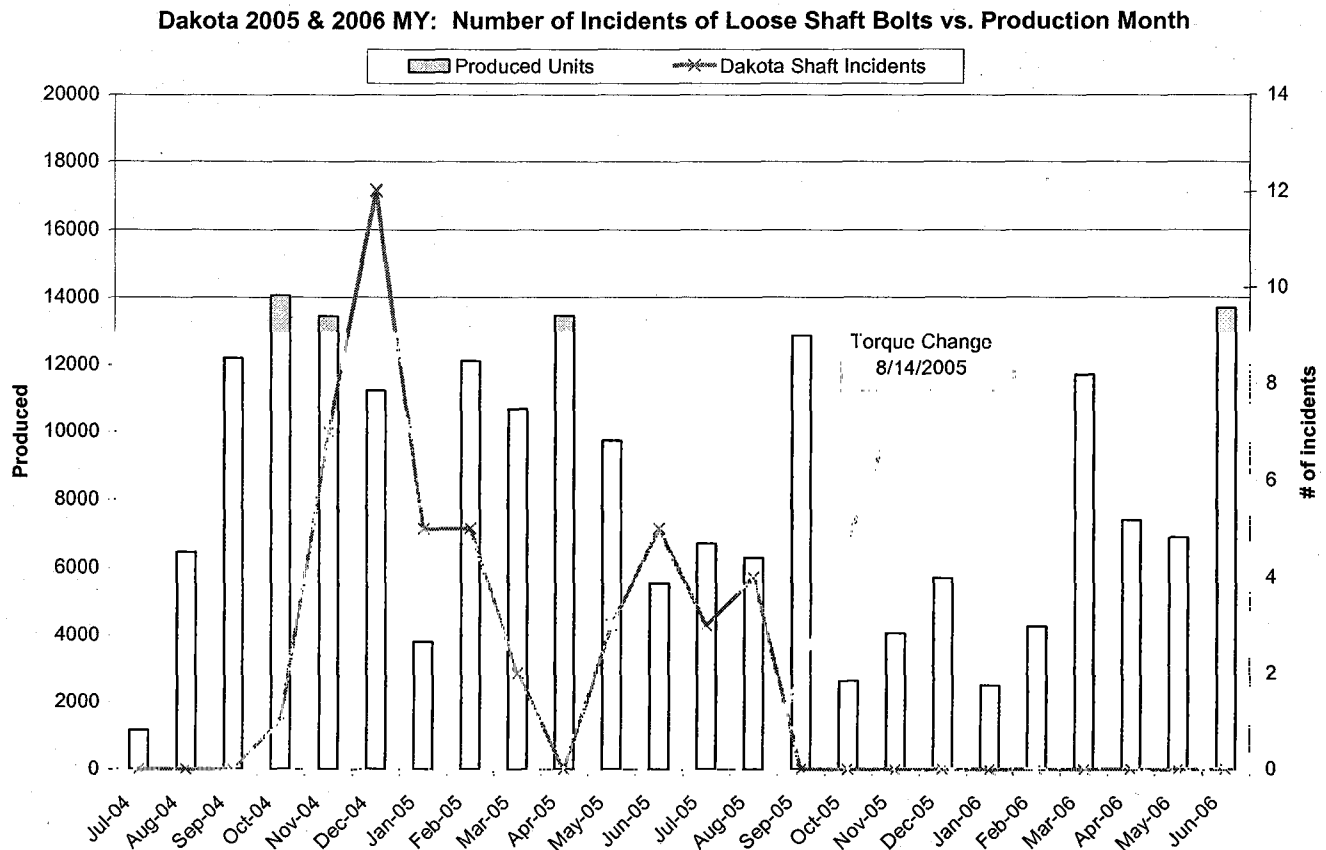
The following graph shows the number of reported incidents by the month the vehicle was built against the number of Dakotas built for that month. There have been no reports of loose or missing bolts in vehicles produced after the torque increase change in August of 2005.

ODI analyzed the 121,314 units built before the production line torque change to determine likelihood of further failures. There are 2 reported instances of a bolt missing and only 1 reported loss of control, which both occurred at relatively low mileages. The complaint failure rate for loose or missing coupling bolts for units built before the torque change is 4.1 per 100,000 units (5 complaints / 121,3114); the warranty claim rate is less than 0.1 percent (42 claims in 113,846 vehicles) for loose or missing bolts in MY 2005 Dakota vehicles. Furthermore, Weibull analysis of the data shows a declining early-life failure trend.

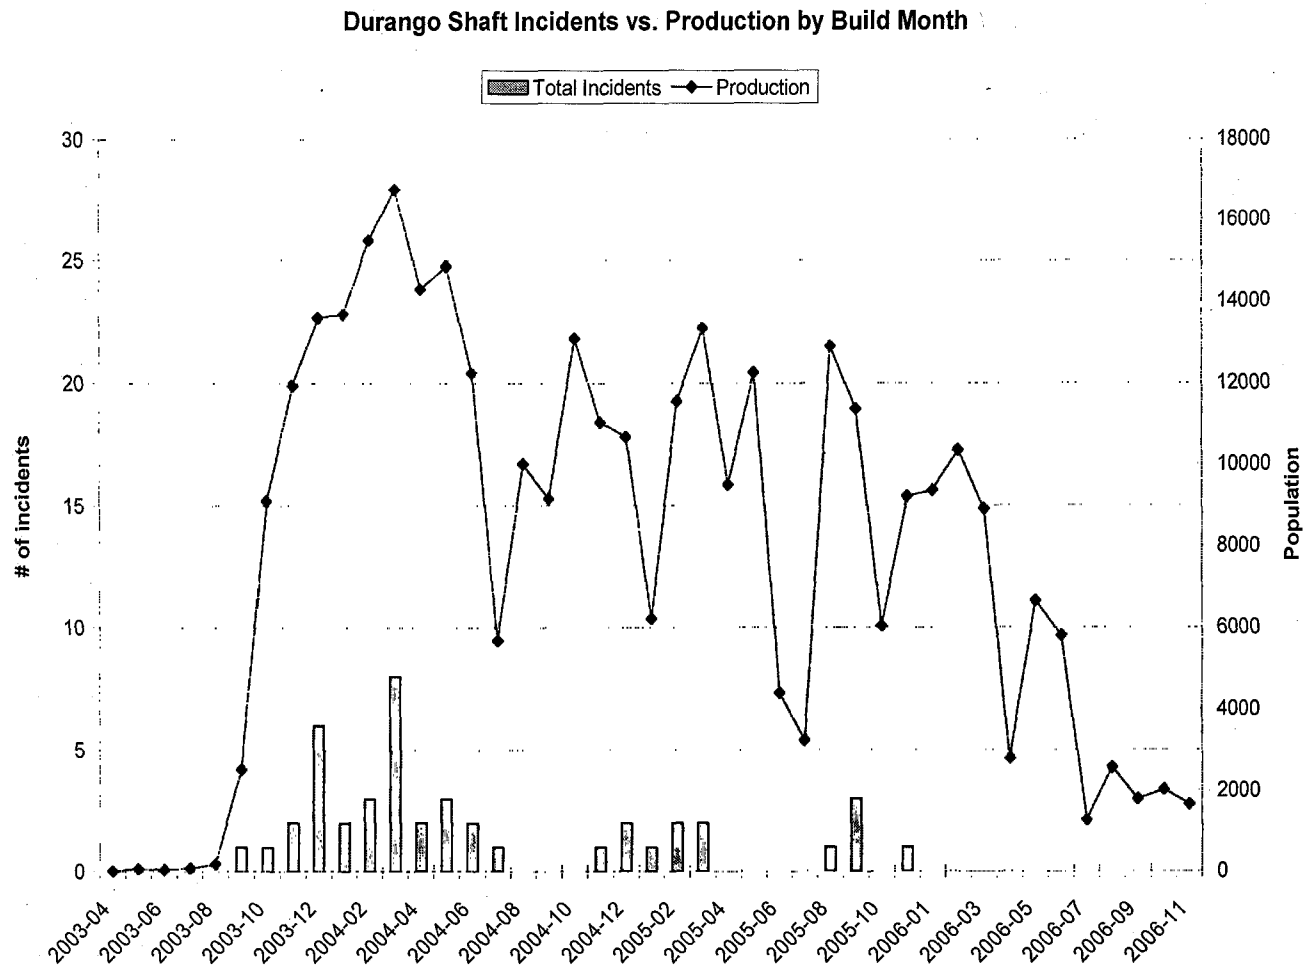
The following chart shows the problem experience associated with the subject Durango vehicles by production month:

There are two reported loss of control incidents, one of which resulted in a crash. That Durango was built in June 2004 and sold in July 2004. Six weeks after purchasing the vehicle, the owner was in the process of making a slow speed left hand turn when the steering stopped responding and the vehicle ended up in a ditch. There were no injuries.

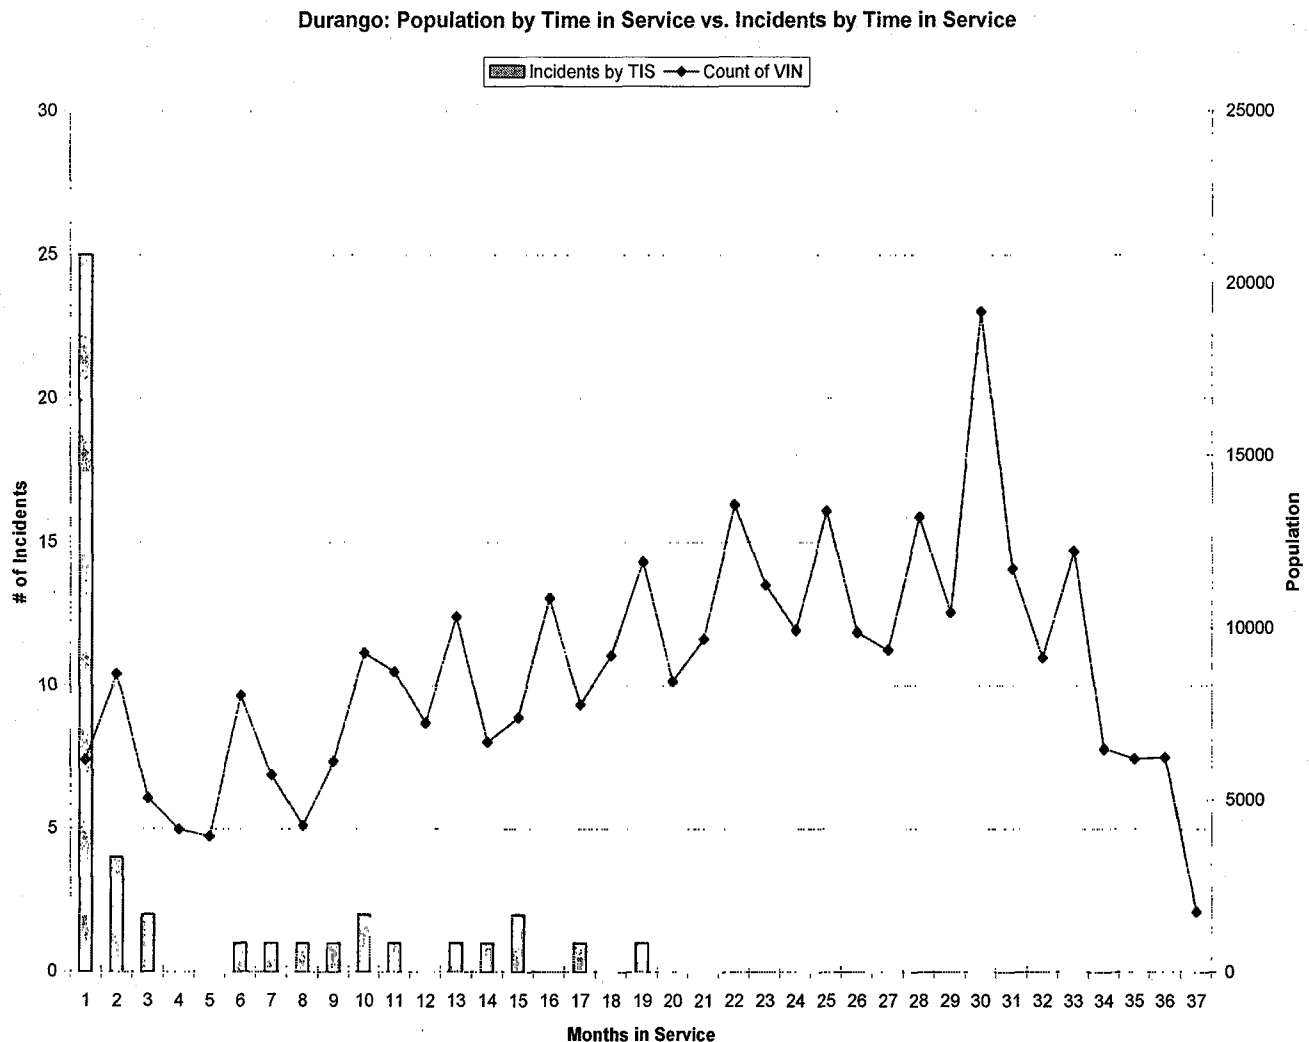
The following chart shows the time-in-service before an event for the Durango intermediate shaft bolt incidents plotted against the fleet service life as of December 4, 2006. The chart indicates that the bulk of the population has moved past the average time in service for an incident to occur.

ODI analyzed the data to determine the likelihood of future failures in MY 2004 through 2006 Dodge Durango vehicles. The failure rate for the Durango intermediate shaft coupling bolts being loose or missing is 3.5 per 100,000 units (9 field reports, 2 complaints to DCC and 1 complaint to NHTSA). The warranty claim rate is 0.01 percent (32 claims in 338,381 vehicles). Weibull analysis of this data indicates that the problem is an early life failure issue and further failures are unlikely.
