# ODI RESUME

Investigation: EA 06-019  
 Prompted By: Consumer Complaints  
 Date Opened: 11/22/2006      Date Closed: 11/07/2007  
 Principal Investigator: Ali Motamedamin  
 Subject: Headlight Failure

Manufacturer: DaimlerChrysler Corporation  
 Products: 2002-2003 Dodge Neon  
 Population: 247,936

Problem Description: Alleged failure of the multifunction switch and/or its wiring harness, resulting in loss of headlights.

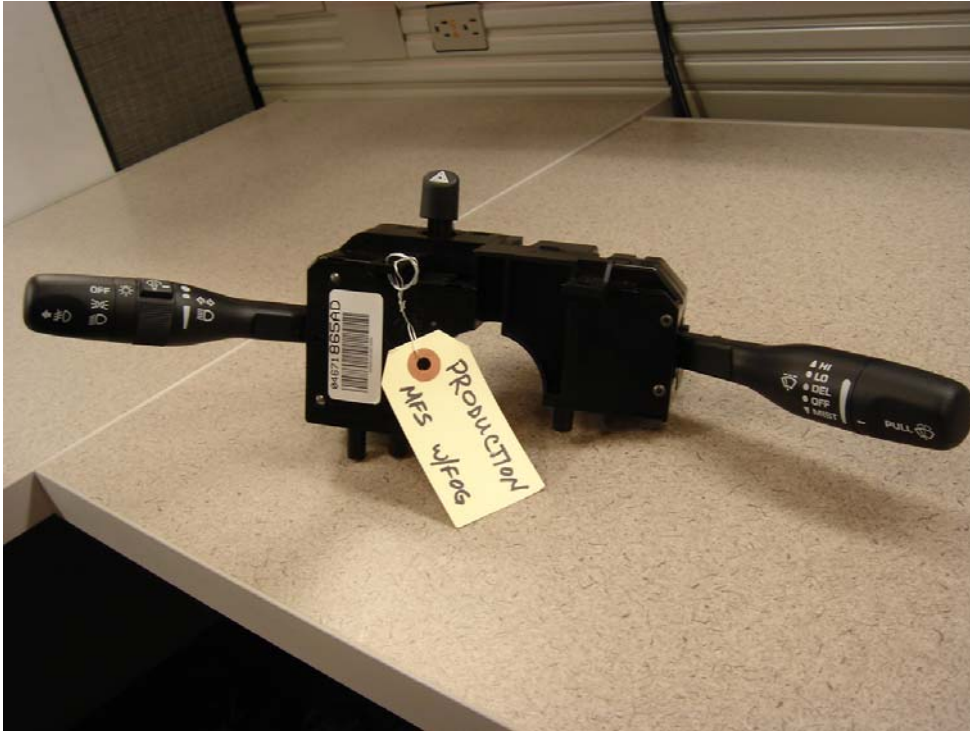
The subject component is the subject vehicles' multifunction switch, which is located on the steering column (Figure 1). The multifunction switch has an external stalk on each side and a button on top for hazard light illumination. The left stalk provides control of exterior parking lights, low beam headlights, high beam headlights, interior lighting operation with a variable dimmer setting, fog lamp operation (only operative when the low beam headlights are active) and turn signal operation. The right stalk provides variable and non-variable wiper controls and washer fluid spray control.

Figure 1: Multifunction Switch

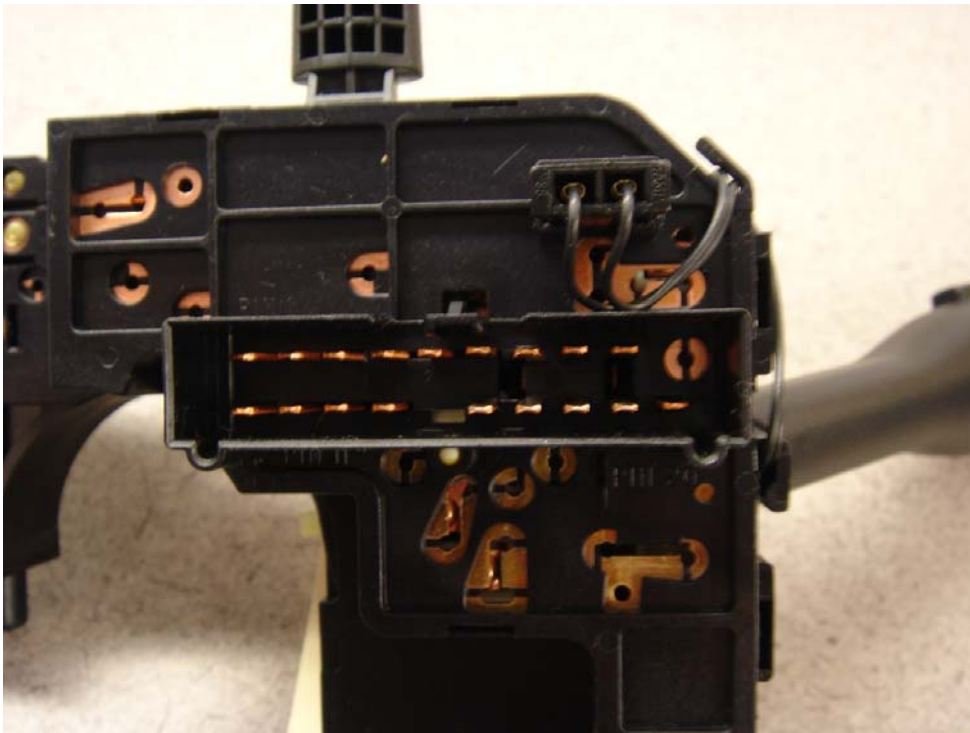
The back of the multifunction switch contains a set of 20 pin contacts (Figure 2) that attach to a connector and a wiring harness located within the steering column (Figure 3). Figure 4 identifies the function of each pin connector.

Figure 2: 20 Pin Contacts

According to information submitted by DCC, the addition of fog lamps increases the current draw through the multifunction switch connector pin number 16 from 8.6 amperes to 15.6 amperes. This increased current causes the grease coating on the contacts for pin 16 to dissipate and can lead to overheating and failure of the multifunction switch. DCC explained the problem as follows: “Temporary higher resistance in the lighting system is caused by dissipation of the electrical grease on the 20 pin connector when the fog lamps are on. In some cases higher resistance can affect headlight operation.”

There was one production modification made to the multifunction switch. The contact plating material of the 20 pin connection was originally made of copper. In May 2003, DCC changed the contact plating material to silver (Mod 1) to minimize grease dissipation and to reduce the possibility of overheating circuits.

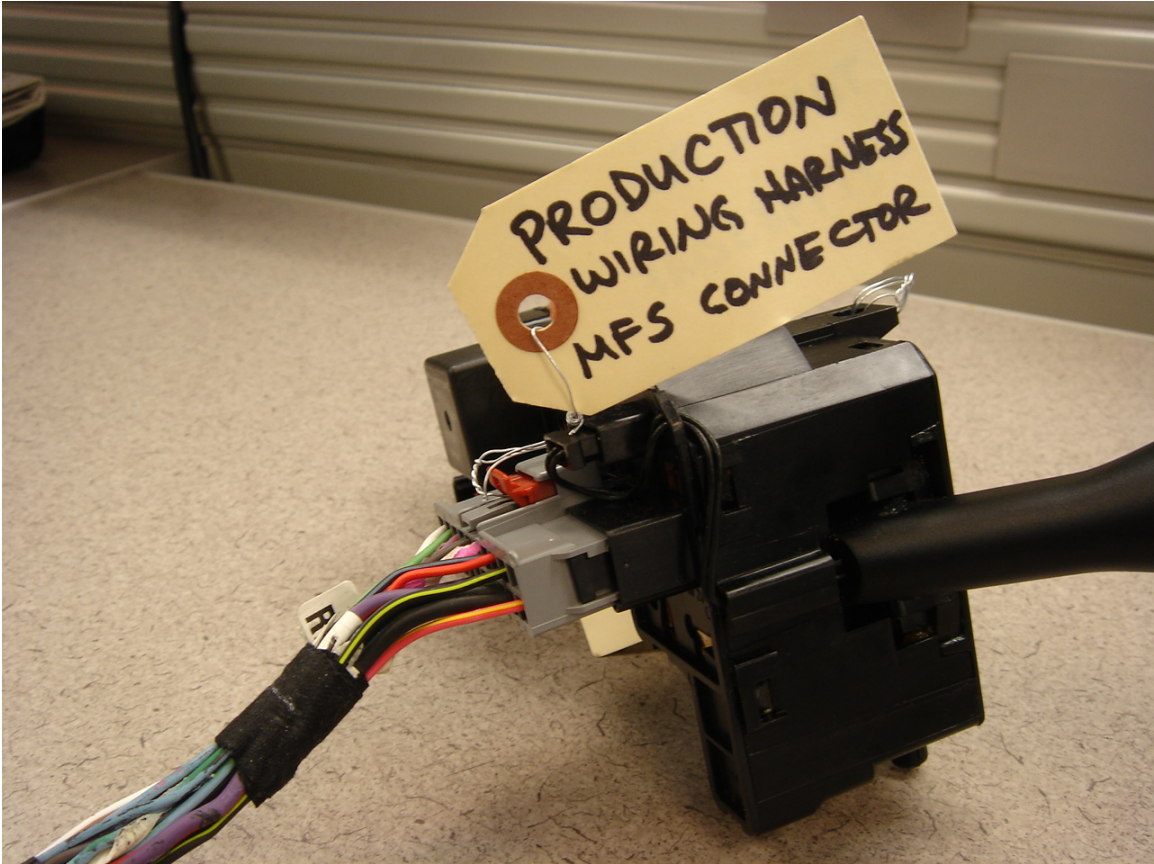
Figure 3: Multifunction Switch with attached connector from wiring harness

The primary cause of headlight failure is excessive heat at the 20 pin connector where the multifunction switch connects to the wiring harness inside the steering column.

DCC did not issue any Technical Service Bulletins regarding the replacement of the entire multifunction switch. However, on December 1, 2006, DCC issued two “Tech Tips” advising technicians to use MOPAR service kit part # 05183442AA, which contains a new connector and wiring kit. This allows technicians to replace the connector on the end of the wiring harness without replacing the entire harness in the steering column.

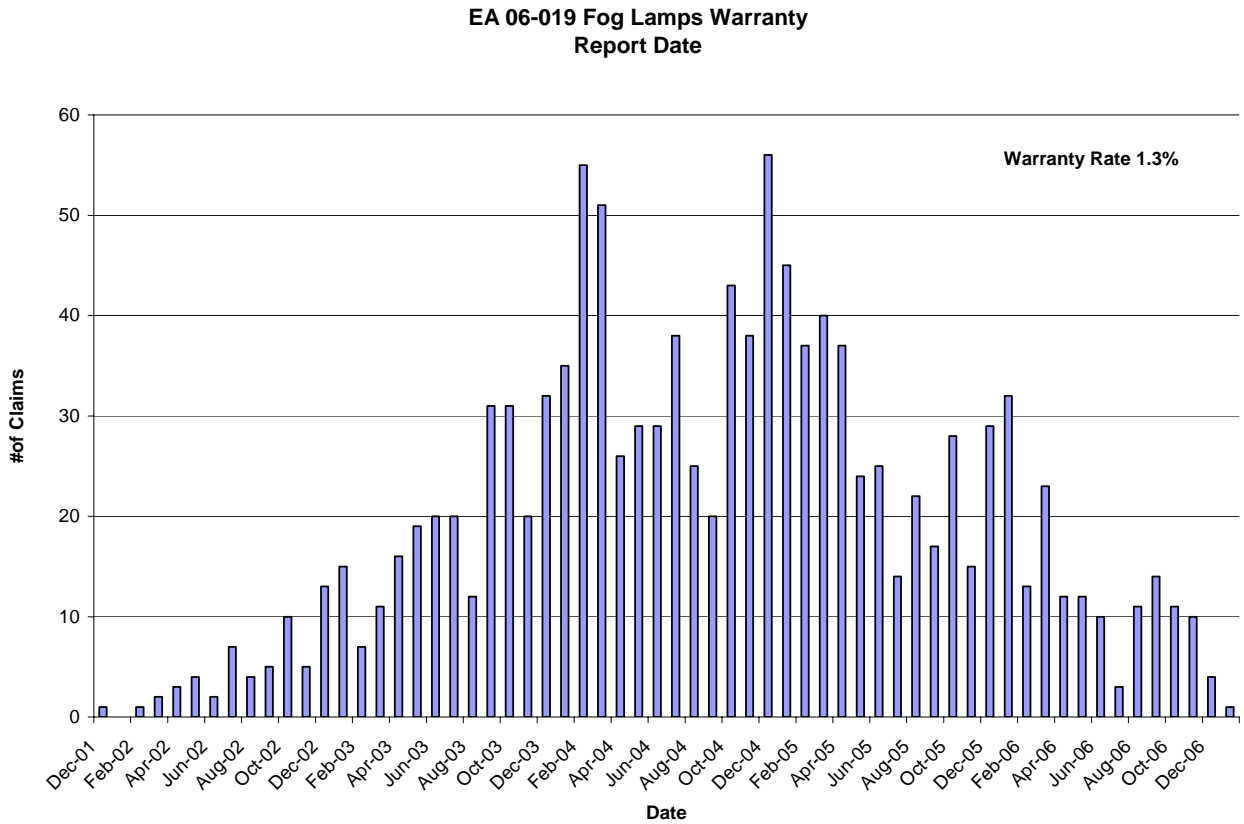
The standard warranty coverage for the subject vehicles is three years or 36,000 miles. DCC received 1,225 claims from December 2001 to January 2007. See Figure 5, which shows the number of warranty claims by repair date. The chart shows that increasing repairs occur during the winter months (shorter daylight hours). Aside from the seasonal rise the chart shows the absence of any overall upward trend. At this point in time, the subject vehicles are beyond normal warranty coverage. However, dealers may offer “goodwill” coverage beyond the normal warranty.

Figure 5: Warranty Claims by Repair Date

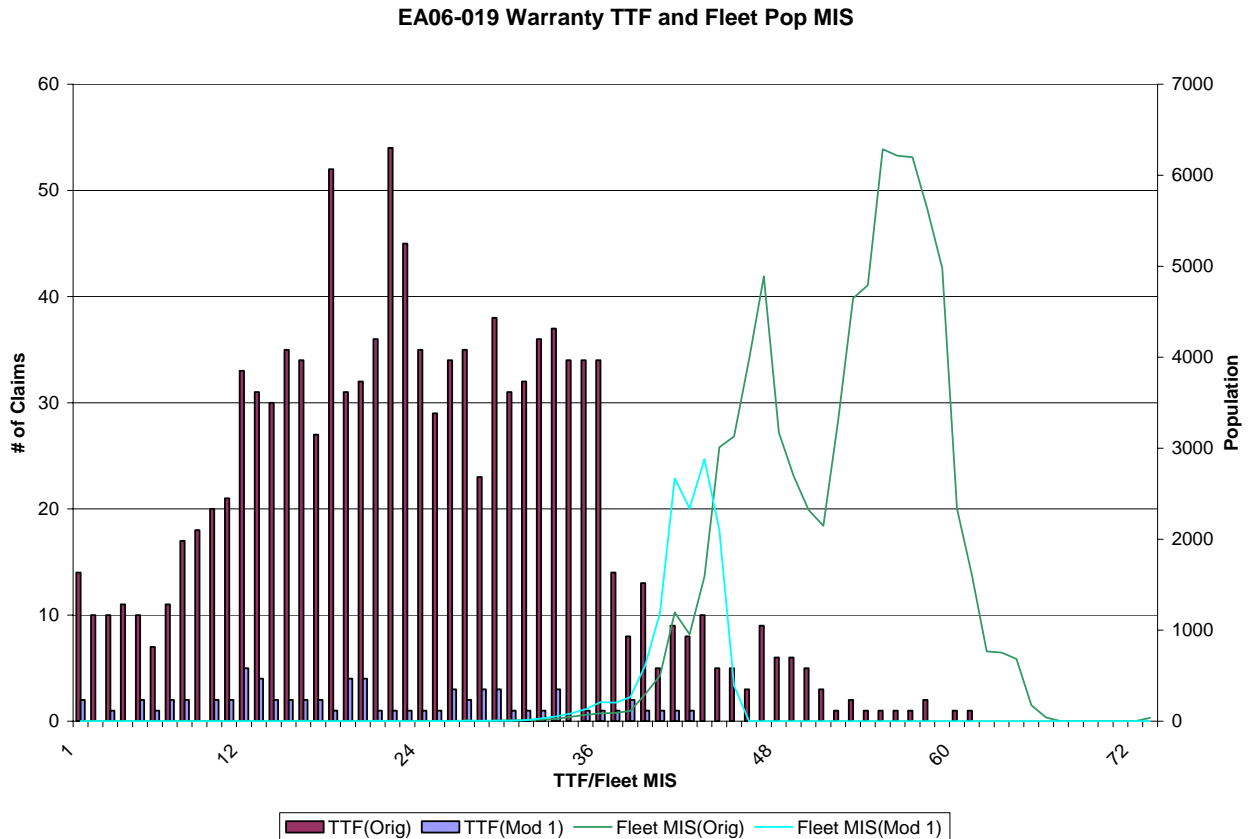
Figure 6 below shows both warranty time to failure (TTF) and the number of claims per months in service (MIS). DCC began to receive warranty claims on this issue early in the vehicle’s product life. Warranty claims continued at a relatively constant level for most of the warranty timeframe. Most of the vehicle population is beyond warranty coverage. The steep drop in claims (TTF) at 36 months supports this observation.

Figure 6: Warranty TTF and Fleet MIS

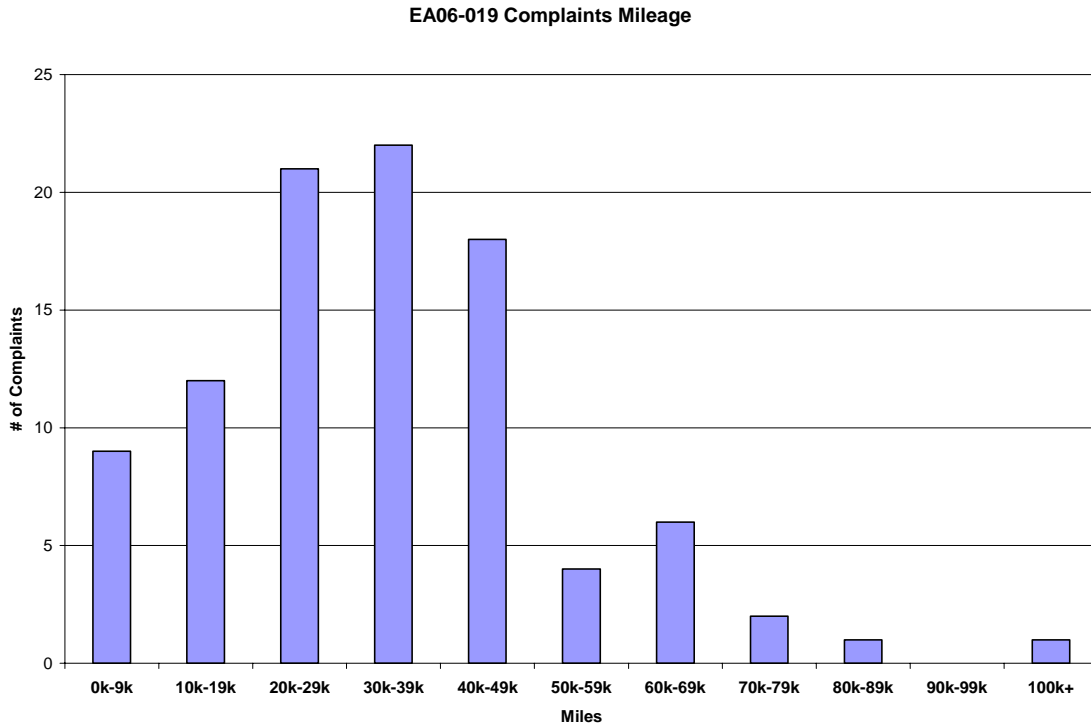
Figure 7 shows the breakdown of complaints by vehicle mileage. The majority of the complaints (72%) are between 10,000 and 49,000 miles. The average mileage at failure for all known complaint vehicles is 33,518.

Figure 7: Complaints by Miles Traveled

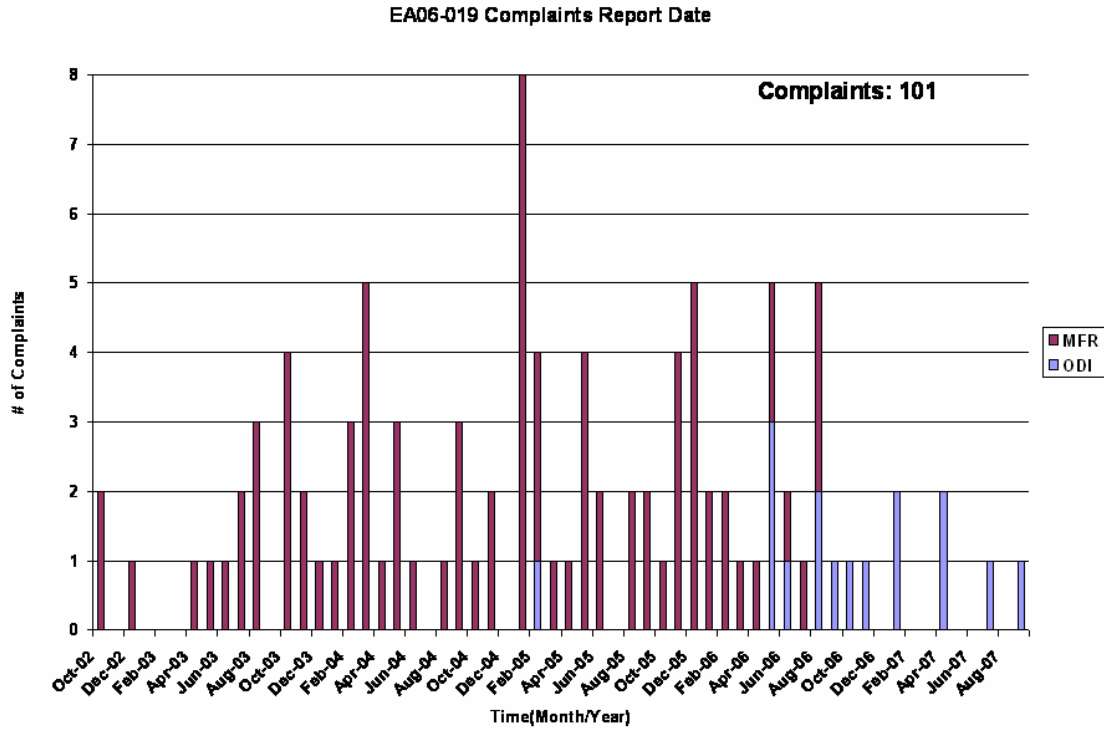
The large majority of the complaints (92%) occurred prior to the last 12 months. See Figure 8. ODI has received only 8 complaints since October 2006. Even though these vehicles are beyond warranty coverage (the loss of warranty coverage and the expense of repairing the connector to the multifunction switch might be motivation for one to complain), the trend in complaints appears to be diminishing. There are no indications from the data given to ODI that the declining complaint trend is likely to reverse.

Figure 8: Incidents by Calendar Month
