ODI RESUME

Investigation: EA 06-003
 Prompted By: PE05-061
 Date Opened: 03/08/2006 Date Closed: 05/22/2007
 Principal Investigator: Michael Lee
 Subject: Front Air Bag Crash Sensor Failure

Manufacturer: DaimlerChrysler Corporation
 Products: 2005-2006 DaimlerChrysler Minivans (Dodge Caravan and Grand Caravan, and Chrysler Town and Country)
 Population: 960,569

Problem Description: Frame rail-mounted front air bag crash sensors can fail due to corrosion. The failure may cause the frontal air bags to deploy late or reduce the driver air bag inflation level in certain types of frontal crashes.

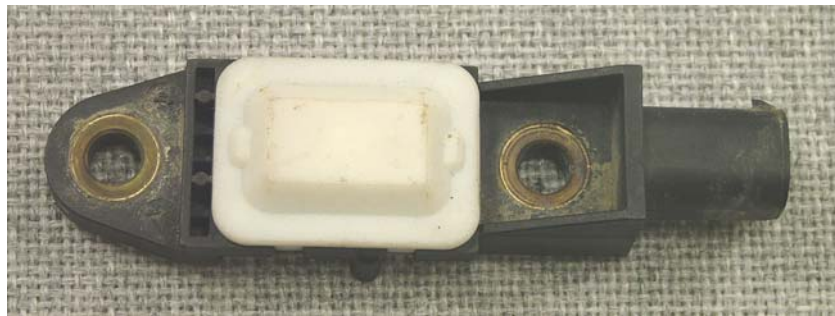
Failed Sensor Analysis. The agency's Vehicle Research and Test Center analyzed several allegedly failed subject components from VOQ complaint vehicles. All sensors examined had brass bushings (no failed steel bushing sensors were available for analysis) that exhibited corrosion. Evidence of corroded metal residue was also found on the plastic portions of the sensor, particularly along its inboard side where the sensor attaches to the frame rail (Photos 1 and 2). The analysis showed that there were electrolytic paths between the bushings and connector pins, and evidence of corrosion on the sensor circuit board and the positive connector pin (Photo 3, connector pins). Cracks and voids were found in the sensor's plastic housing. The cracks appear to be a migration pathway within the sensor housing.

Photo 1. Failed Sensor – Outboard side as installed on vehicle

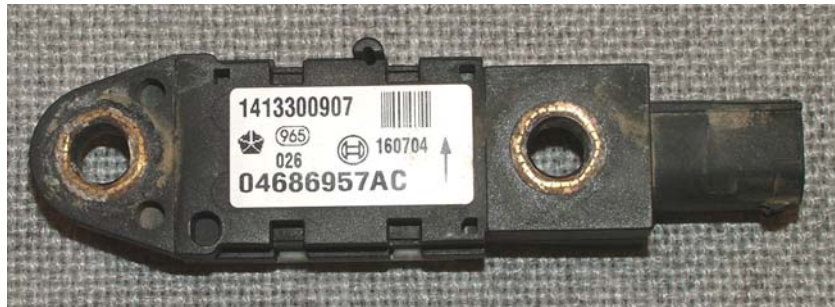
Photo 2. Failed Sensor – Inboard side as installed on vehicle

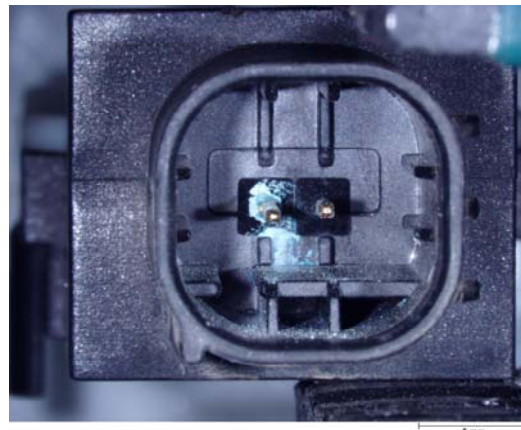
Photo 3. Corroded Connector Pin – Top view of terminal housing

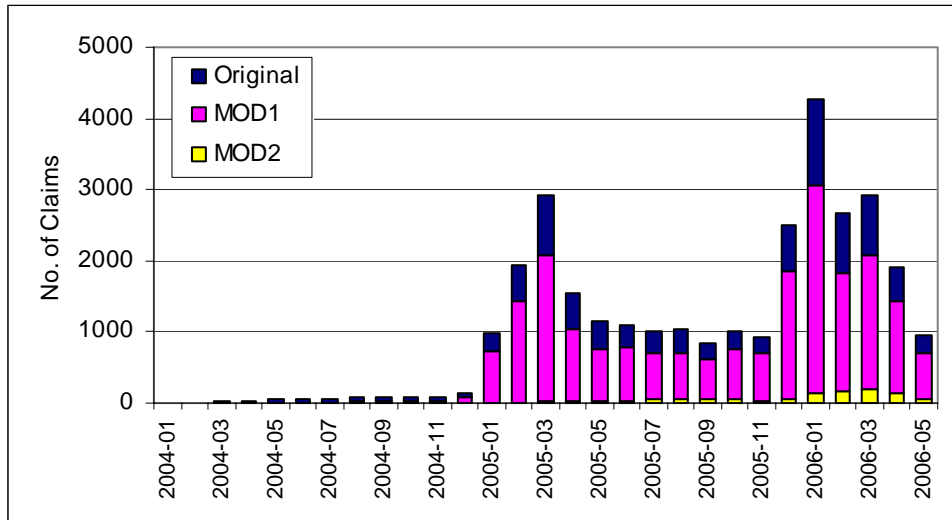
Figure 1. Warranty Claims by Repair Date and Modification

Figure 1 shows warranty claims by repair date and modification.⁶ The graph indicates a continuing warranty claim trend for all versions of sensors.

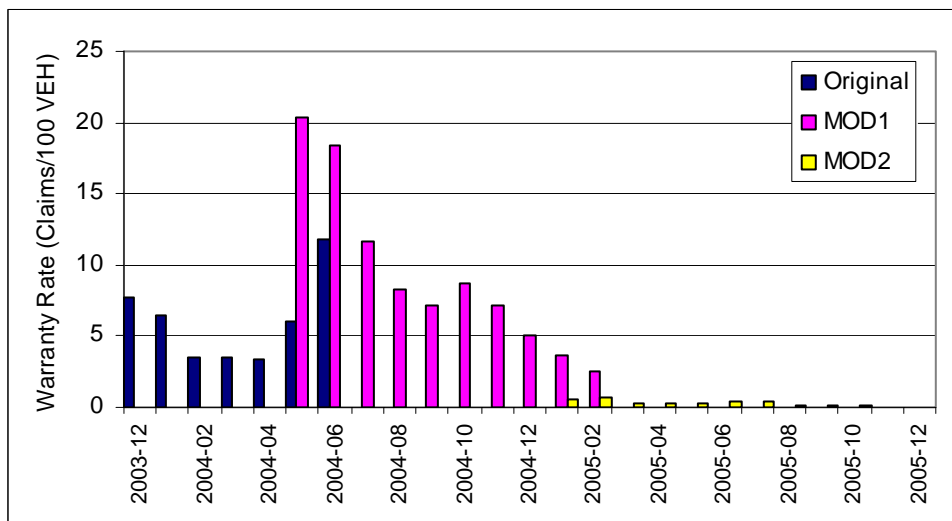
Figure 2. Warranty Rate by Build Date and Modification

Figure 2 shows warranty rate by vehicle build month and modification. The sensor mounting changes (MOD1) do not appear to have reduced the warranty rate of the subject components. In fact, the changes appear to have caused an increased warranty rate for the first two or three production months before reaching the levels prior to the changes. But the use of steel bushings (MOD2) significantly reduced the warranty rate.

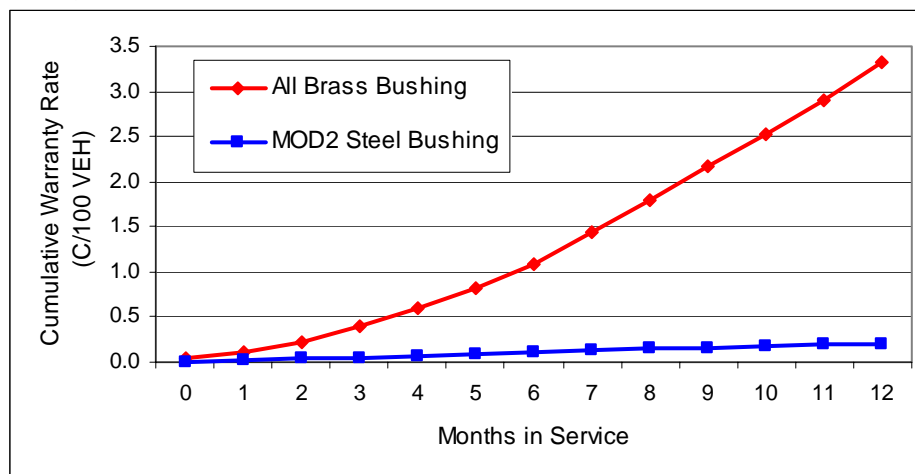
Figure 3. Cumulative Warranty Rate for First 12 Months in Service

The brass bushing sensors have experienced a much longer field exposure than the steel bushing sensors—approximately two years versus less than one year as of mid-2006.⁷ A more accurate warranty rate comparison of the two sensors is to look at the cumulative warranty rate for the first 12 months in service for each sensor population (Figure 3). The graph indicates that the brass bushing sensors have experienced a much higher warranty rate during the same exposure period, 3.32 vs. 0.22 claims per 100 vehicles, at the end of the period.
