U.S. Department
of Transportation
**National Highway
Traffic Safety
Administration**

ODI RESUME

Investigation: EA06-007
 Prompted By: PE06-002
 Date Opened: 05/09/2006 Date Closed: 11/30/2007
 Principal Investigator: Kyle Bowker
 Subject: Fuel Tank Leakage

Manufacturer: Kia Motors America, Inc.
 Products: 1996-2002 Kia Sportage
 Population: 268,137

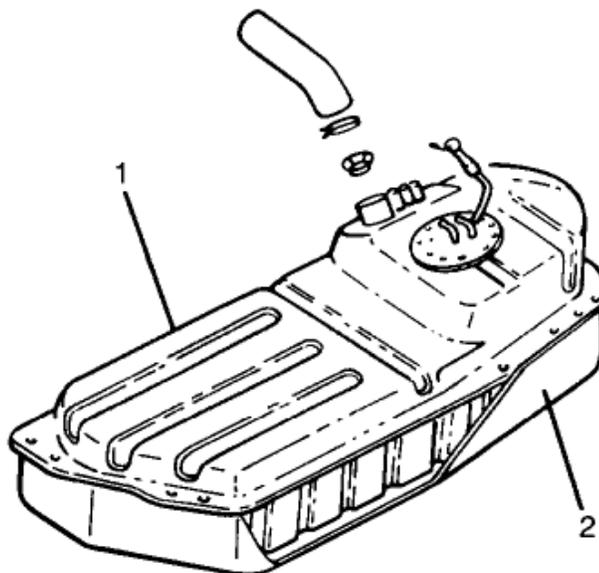
Figure 1: Subject Fuel Tank Diagram

DESCRIPTION OF COMPONENT OR VEHICLE SYSTEM: The subject vehicles are equipped with a steel fuel storage tank mounted longitudinally underneath the passenger side of the vehicle, adjacent to the drive shaft, in front of the rear axle and below the rear seat. The tank is made of a proprietary chromate-processed zinc galvanized sheet steel that has been stamped and welded together. A stamped steel "gravel shield" bolted to the seam flange provides additional protection from flying debris (Figure 1).

FAILURE MECHANISM: The failure mechanism for leakage from the underside of the tank is disruption of the protective PVC coating resulting in corrosion and subsequent perforation. These failures often occurred in areas where five retaining clips for the gravel shield insulation pad are located (and where the protective shield most closely approaches the fuel tank). Kia attributed contact with the retaining clips to undercarriage impacts, possibly while driving off-road, that could push the shield closer to the tank. Water and mud/salt thrown from the road surface collects in the shield and insulation pad a cause corrosion to develop in areas where the PVC coating has been disrupted.

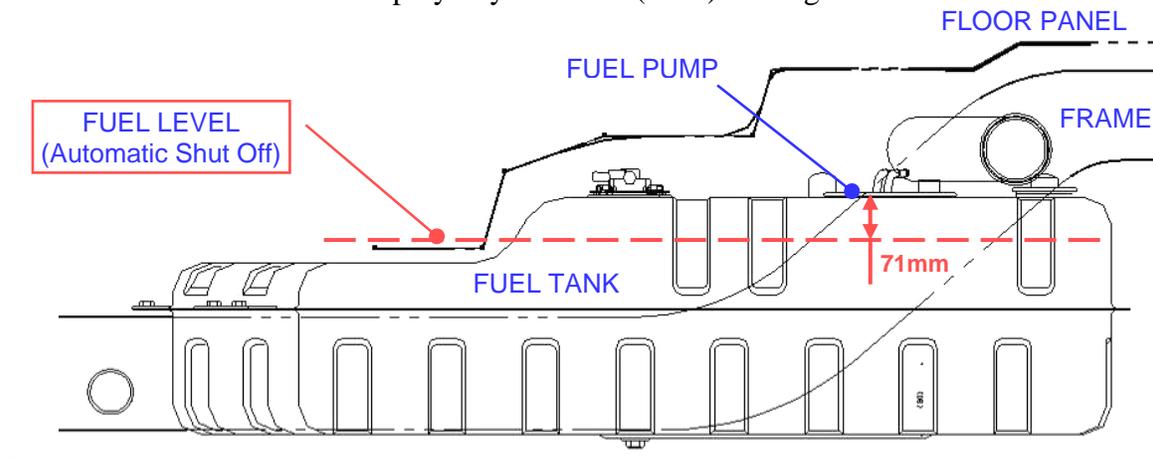
Figure 2: Subject Fuel Tank Fuel Level Diagram

Fuel tank capacity is approximately 57 L (15.1 gal) with approximately 71 mm (2.8 in) of vapor space between the fuel pump mounting plate and the fuel level inside the tank when full (Figure 2). Surface treatments are applied to the exterior of the tank to inhibit corrosion. The exterior upper half of the fuel tank above the welded seam is treated with a proprietary paint-like coating and the exterior bottom half of the fuel tank below the welded seam is treated with a polyvinyl chloride (PVC) coating.

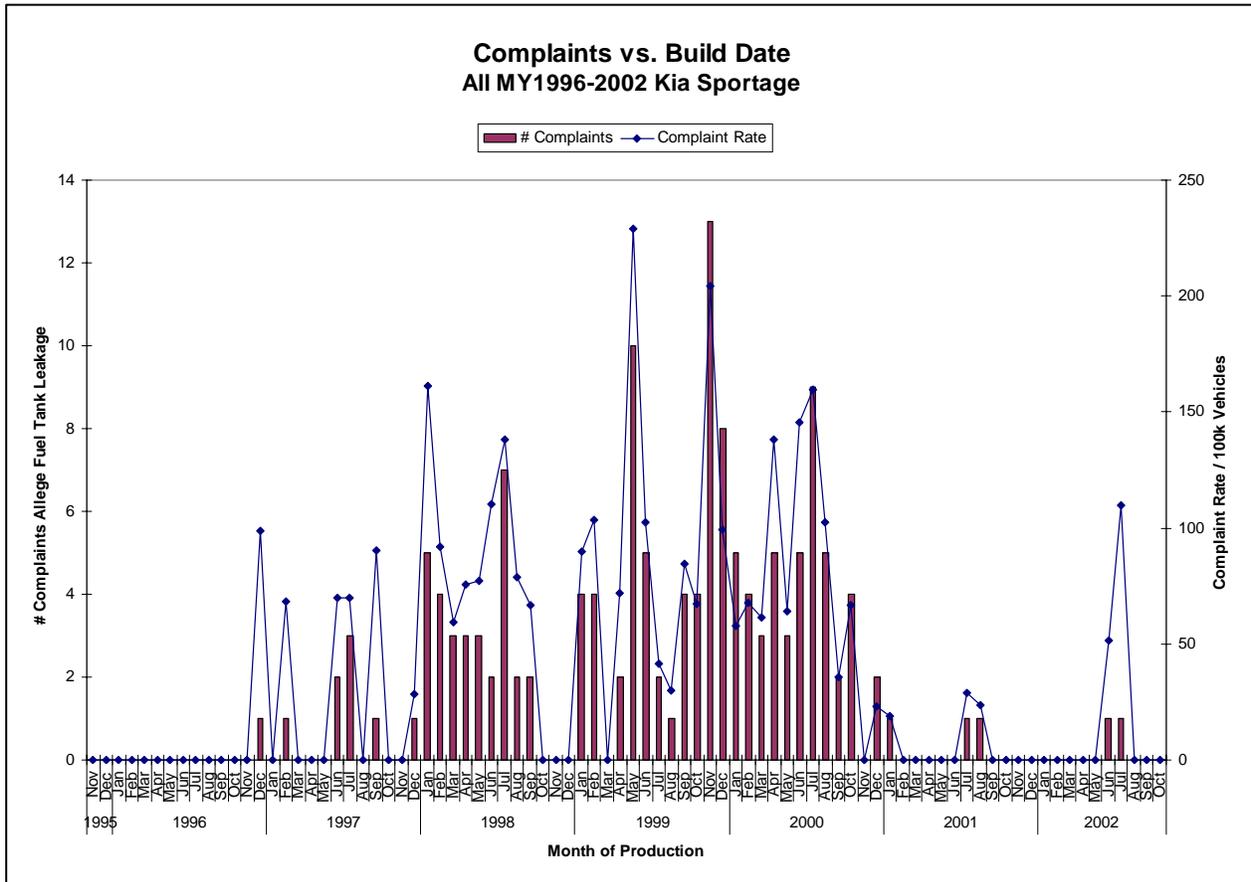
Figure 3: Complaints by Production Month

COMPLAINTS: ODI identified 149 non-duplicative complaints alleging non-crash related fuel tank leakage on the subject vehicles including alleged leakage from the top of the tank (any location above the full level), the bottom (any location below the full level), and/or unknown (see ODI Analysis). The subject complaint rate is approximately 56 per 100,000 vehicles produced (approximately 0.06%). The complaint exposure rate is approximately 7.5/100k/ year. There are no known vehicle fires as a result of the alleged defect. Figure 3 shows the complaints and associated rates by month of production.

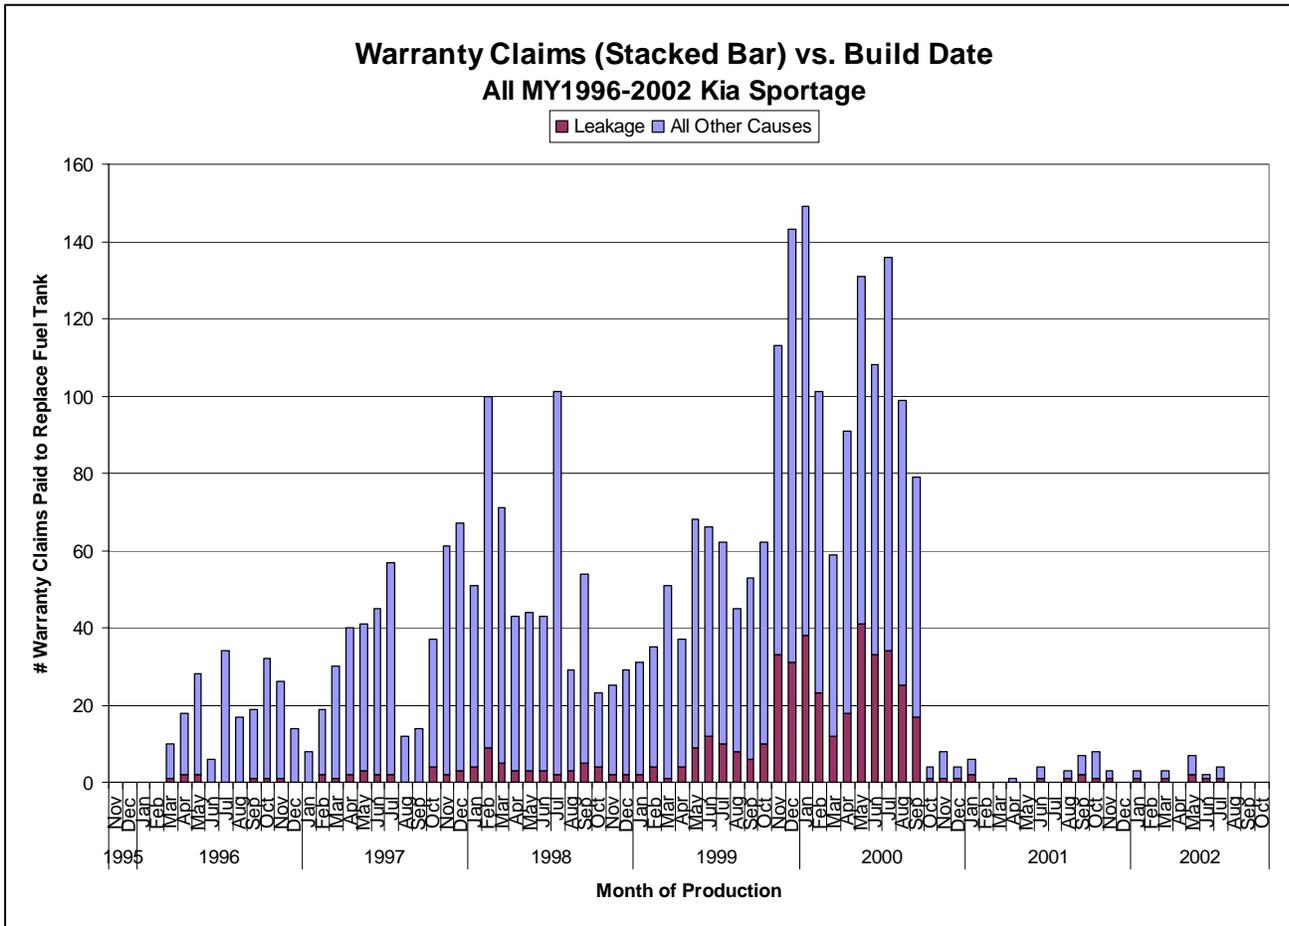
Figure 4: Warranty Claims as a Function of Production Date

period pursuant to a service inspection campaign (SC059) or as an act of goodwill. In total, Kia has paid 391 warranty claims from June 1998 through June 2007 (the date of the last information update from the manufacturer) to repair or replace the fuel storage tank on the subject vehicles due to alleged leakage where the tank was identified as the causal component. The subject warranty rate is approximately 145 per 100,000 vehicles produced (approximately 0.15%). Figure 4 shows warranty claims for tank replacement for leakage and for all other causes by month of production.
