ODI RESUME

Investigation: EA06-010
Prompted By: PE06-009
Date Opened: 06/15/2006 Date Closed: 09/11/2007
Principal Investigator: Stephen McHenry
Subject: Fuel tank punctures

Manufacturer: DaimlerChrysler Corporation
Products: 2004-2006 Chrysler Pacifica
Population: 299,694

Engineering Analysis Closing Report

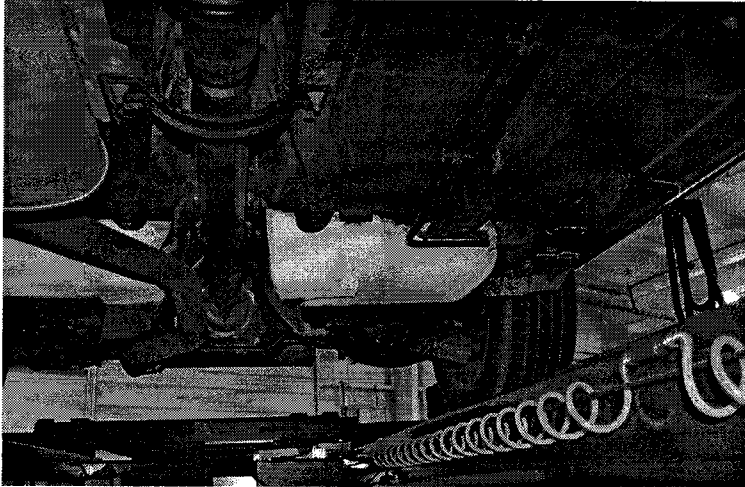
Figure 3: Photo of Nissan Murano driver's side fuel tank without shield (tank has been coated with white latex tape for impact testing purposes).

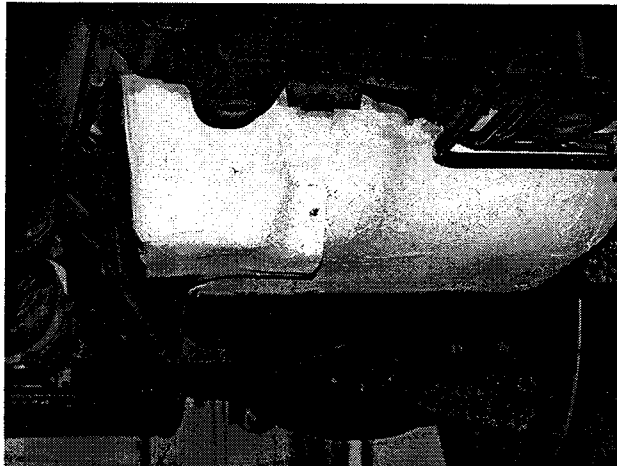
NHTSA's Vehicle Research and Testing Center (VRTC) in East Liberty, Ohio conducted comparative vehicle inspection and testing regarding tank packaging, exposure, and trajectories of objects thrown by the front tires for the Murano and the Pacifica. VRTC found that the trajectories from the front tire point of contact with the road surface to the fuel tank are similar for the Nissan Murano and the Chrysler Pacifica vehicles. However, the VRTC also identified differences between the fuel tanks on the two vehicles in the surface area exposed to impact from objects thrown by the front tires

Figure 4: A closer view of the Nissan Murano tank shows that it is of a design that presents a flatter, taller front face (white latex tape added by the VRTC).

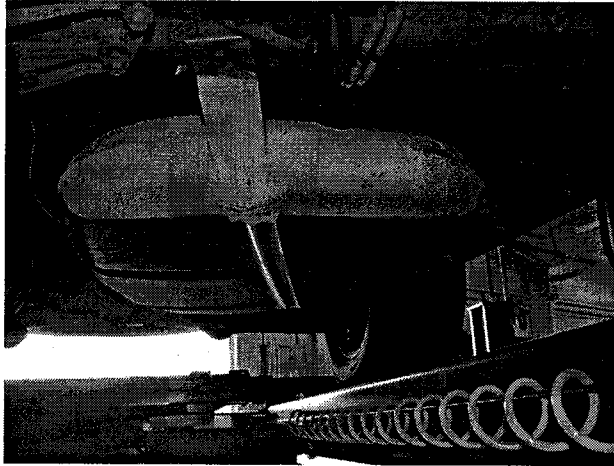
Figure 5: A photo of the driver's side Pacifica fuel tank (white latex tape added by the VRTC).

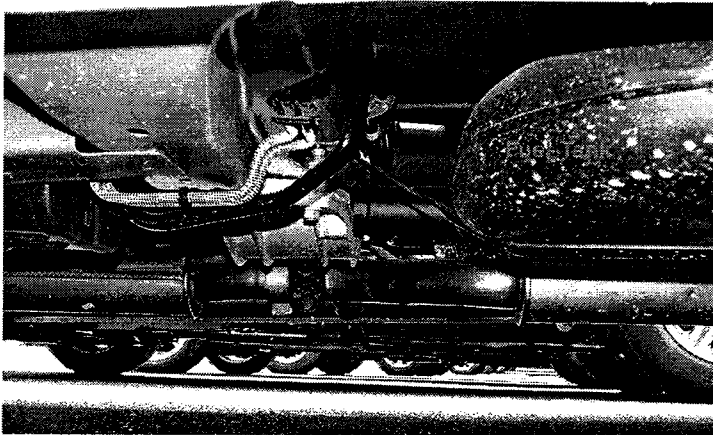
Figure 6: A side view photo of the driver's side Pacifica fuel tank, front of the vehicle to the left.
