# **Engineering Analysis Report**

**EA06-020: Toyota Sienna Power Liftgates**

U.S. Department of Transportation  
National Highway Traffic Safety Administration  
Office of Enforcement  
Office of Defects Investigation

June 2008

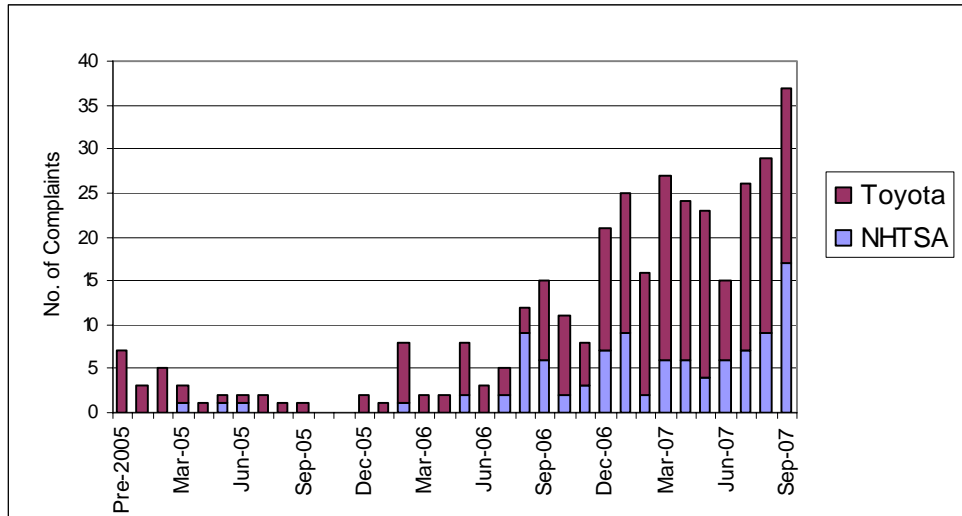
**Figure 1. Complaint Date by Month/Year**

Table 6 shows the total number and rate of complaints reported to NHTSA and Toyota (as of September 2007) that relate to the alleged defect in the subject vehicles by model year. No complaints related to the alleged defect have been reported on MY 2007 Sienna vehicles. Figure 1 shows that reporting of complaints over time indicates an increasing trend.

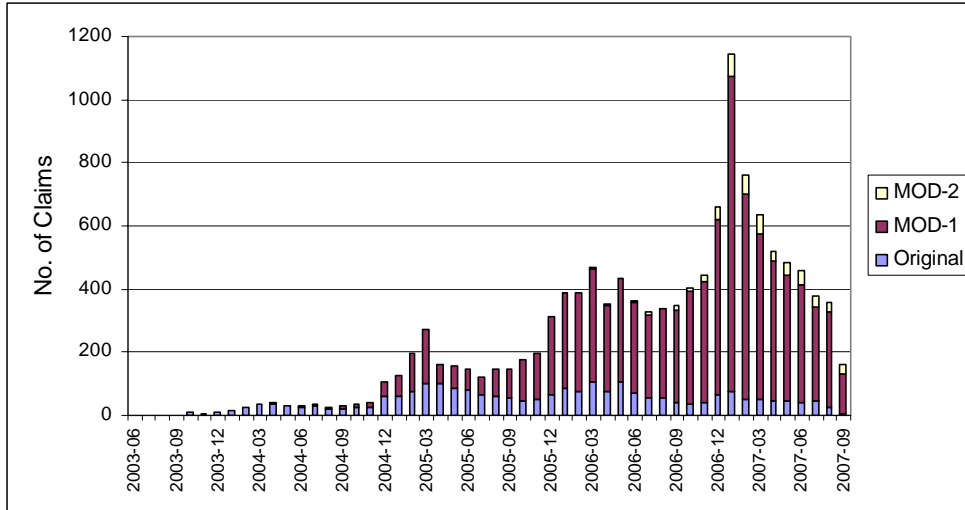
**Figure 2. Warranty Claims by Repair Month/Year**

Figure 2 shows that warranty claims for the subject vehicles have increased over time. Also evident is a seasonal trend with peaks during cold months. The graph shows warranty claims by strut design change<sup>2</sup> and repair date. Most of the subject vehicles were covered by the basic 3-year/36,000-mile warranty period; relatively few subject vehicles had extended warranties.

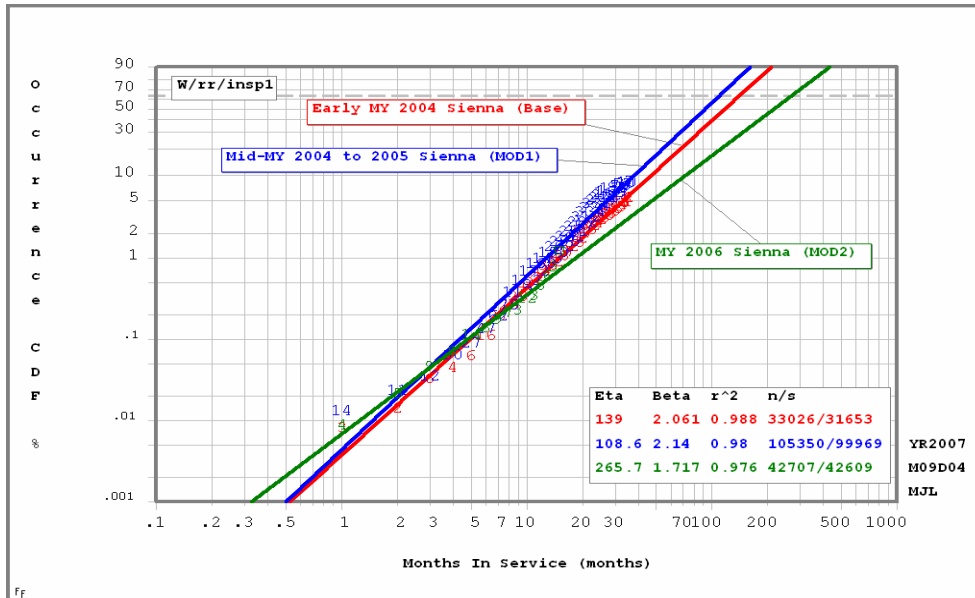
**Figure 3. Weibull Analysis of Warranty Claim Data**

ODI performed a Weibull analysis using Toyota’s warranty claim data for the subject vehicles. Figure 3 shows the result with each version of the strut used in the subject vehicles shown separately. The Beta value or the slope of each line represents the failure rate: the Beta is about 2.1 for both the original and MOD-1 strut designs and it is about 1.7 for MOD-2 strut design.<sup>3</sup> The Weibull analysis indicates an increasing failure trend for each version of the strut.

<sup>3</sup> In Weibull analysis, Beta values greater than one represent an increasing failure rate, Beta values less than one represent a decreasing failure rate, and Beta value of one represents a steady or random failure rate.
