PE06-002
HYUNDAI
4/30/2006
TAB 3 – 7
PART 2 OF 2

Prior model) Sportage fuel tank field rust analysis
(Warranty returned parts A)

Prior model) Sportage fuel tank field rust analysis
(Warranty returned part B)

Large fuel tank warranty certificate

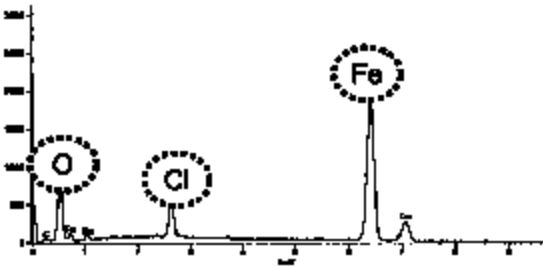
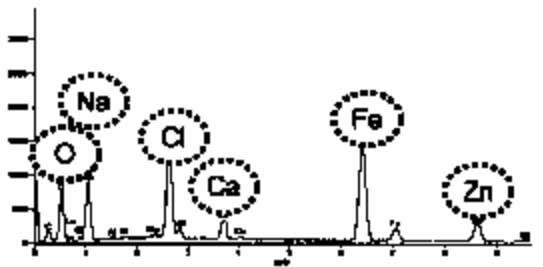
Rust formation analysis result - LWR PNL and DEADENER

C : 8.59 O : 31.69 Na : 1.24 Cl: 4.2 Fe: 54.28wt%
	Deadener part analysis

C : 22.70 O : 24.71 Na: 10.37 Cl: 7.58 Fe: 22.26 Zn: 9.71wt%

※ Chemical elements Cl, CA & NA were detected. Conclusion was reached that salt (NaCl, CaCl₂) caused rust acceleration.

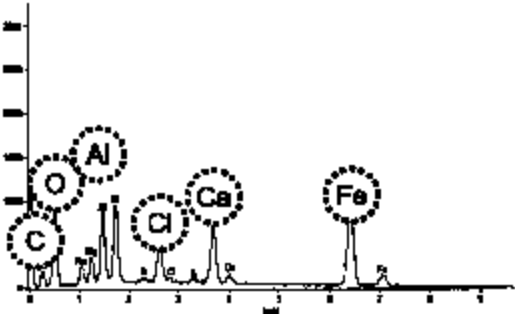
Insulator rust contaminant analysis result

C : 25.65 O : 38.95 Al : 3.70 Si : 3.95 Cl : 2.61 Ca : 4.78 Fe : 15.61wt%

※ Chemical elements Cl, Na & Ca (salt-NaCl, CaCl₂) were detected on the insulation pad. Some rust contamination found where insulation pad contacted fuel tank.

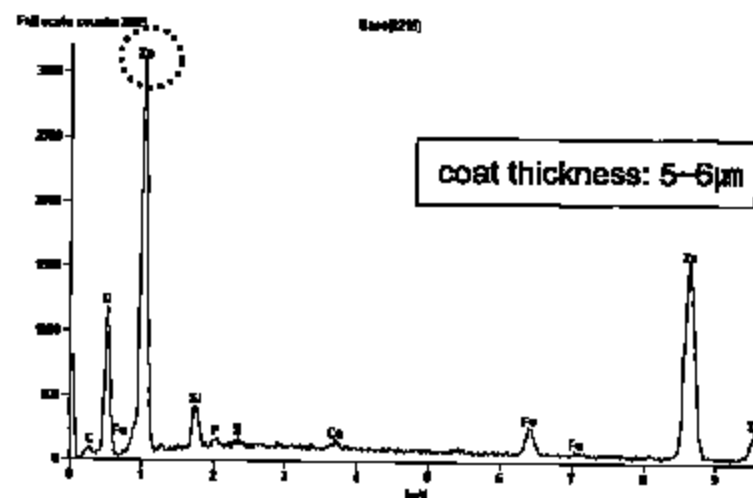
Steel sheet surface treatment analysis result

▶ Inspection of 3 separate areas on side of tank (less corroded area) to measure coating thickness, including coating layer surface SEM element analysis

※ Warranty returned part's chromate layer low thickness(100~200mg/m²) & surface rust verification not possible
Zinc galvanized layer verified as normal, steel sheet material determined as okay
(RSVR CUP outer tank interior fine)

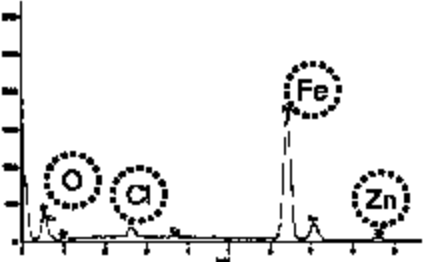
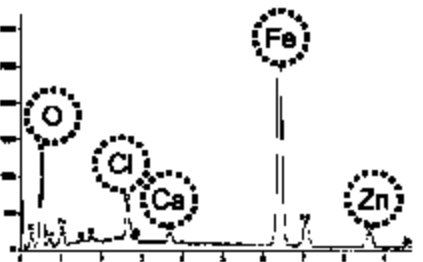
Rust formation analysis result - LWR PNL and DEADENER

O: 21.95 Cl: 2.53 Ca: 0.47 Fe: 70.54 Zn: 4.51wt%
	Deadener part analysis

C : 20.94 O : 29.37 Ca: 0.89 Cl: 2.34 Fe: 38.58 Zn: 7.54wt%

※ Chemical elements Cl, CA & NA were detected. Conclusion was reached that salt (NaCl, CaCl₂) caused rust acceleration.

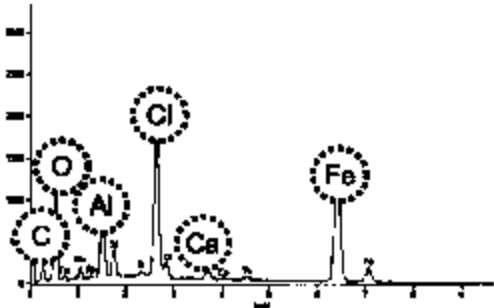
Insulator rust contaminant analysis result

C : 30.62 O : 34.82 Al : 2.86 Si: 1.21 Cl: 8.89 Na: 1.12 Fe: 18.89wt%

※ Chemical elements Cl, Na & Ca (salt-NaCl, CaCl₂) were detected on the Insulation pad. Some rust contamination found where insulation pad contacted fuel tank.

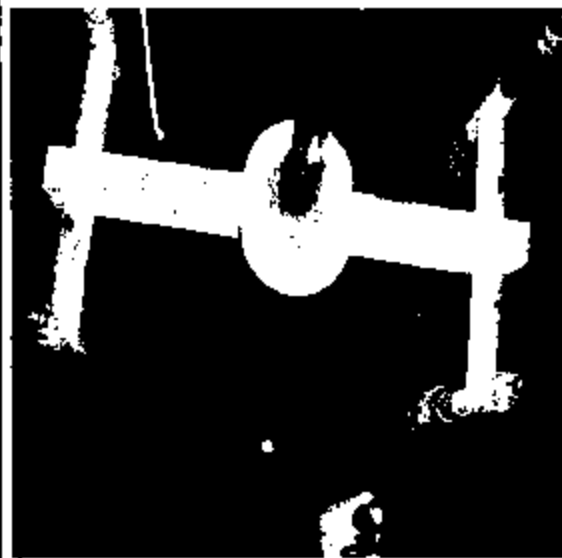
VIN NO. (KNDJA 723XX [REDACTED] 2nd recall

Leakage occurs only in visual identifiable partial rust

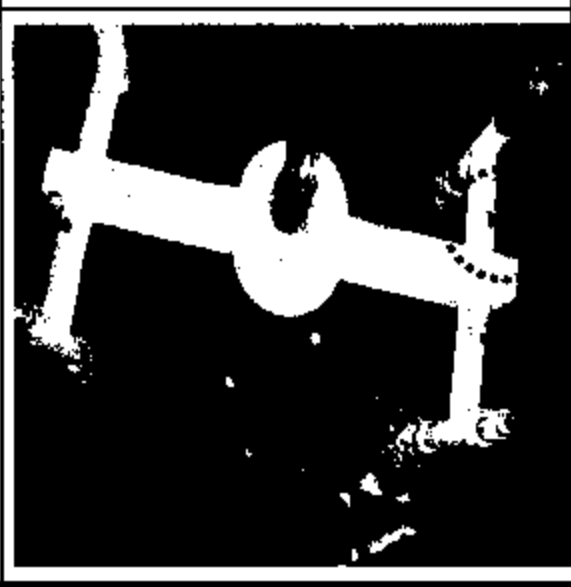
VIN NO. (KNDJA 7239X [REDACTED]

Result Leakage occurs only in visual identifiable partial rust
