**Honda presentation
to
NHTSA Office of Defect Investigation
(00-01M Odyssey coil spring)**

April 20th 2006

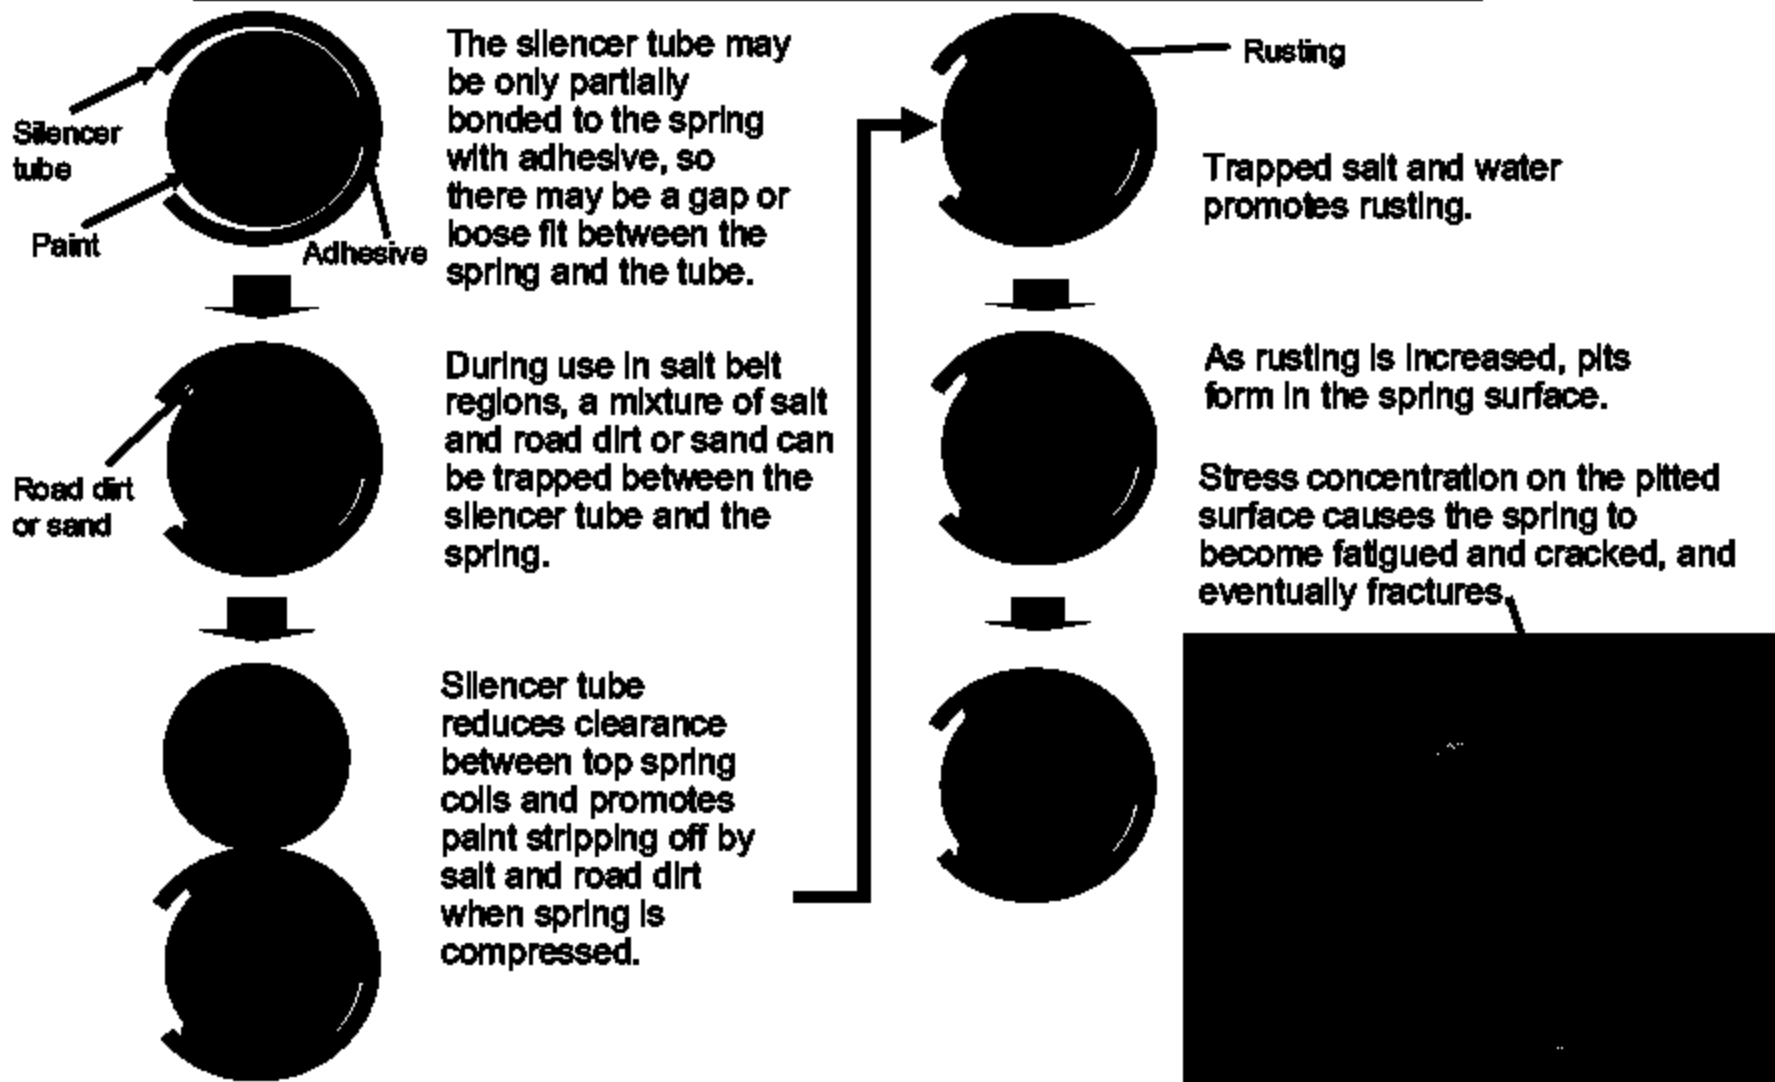
Mechanism of spring fracture by corrosion at the silencer tube of upper spring

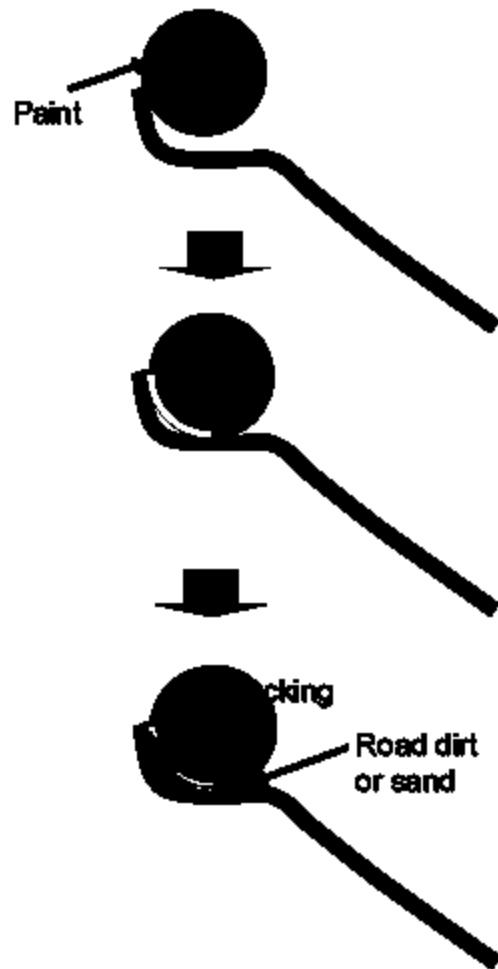
Mechanism of spring fracture by corrosion at the lower spring seat

As the spring moves, it rubs against part of the spring seat, and the paint is stripped off of that portion of the spring.

Road dirt or sand and (salt) water collects on the spring seat and promotes rusting of the spring, which eventually results in fracture.

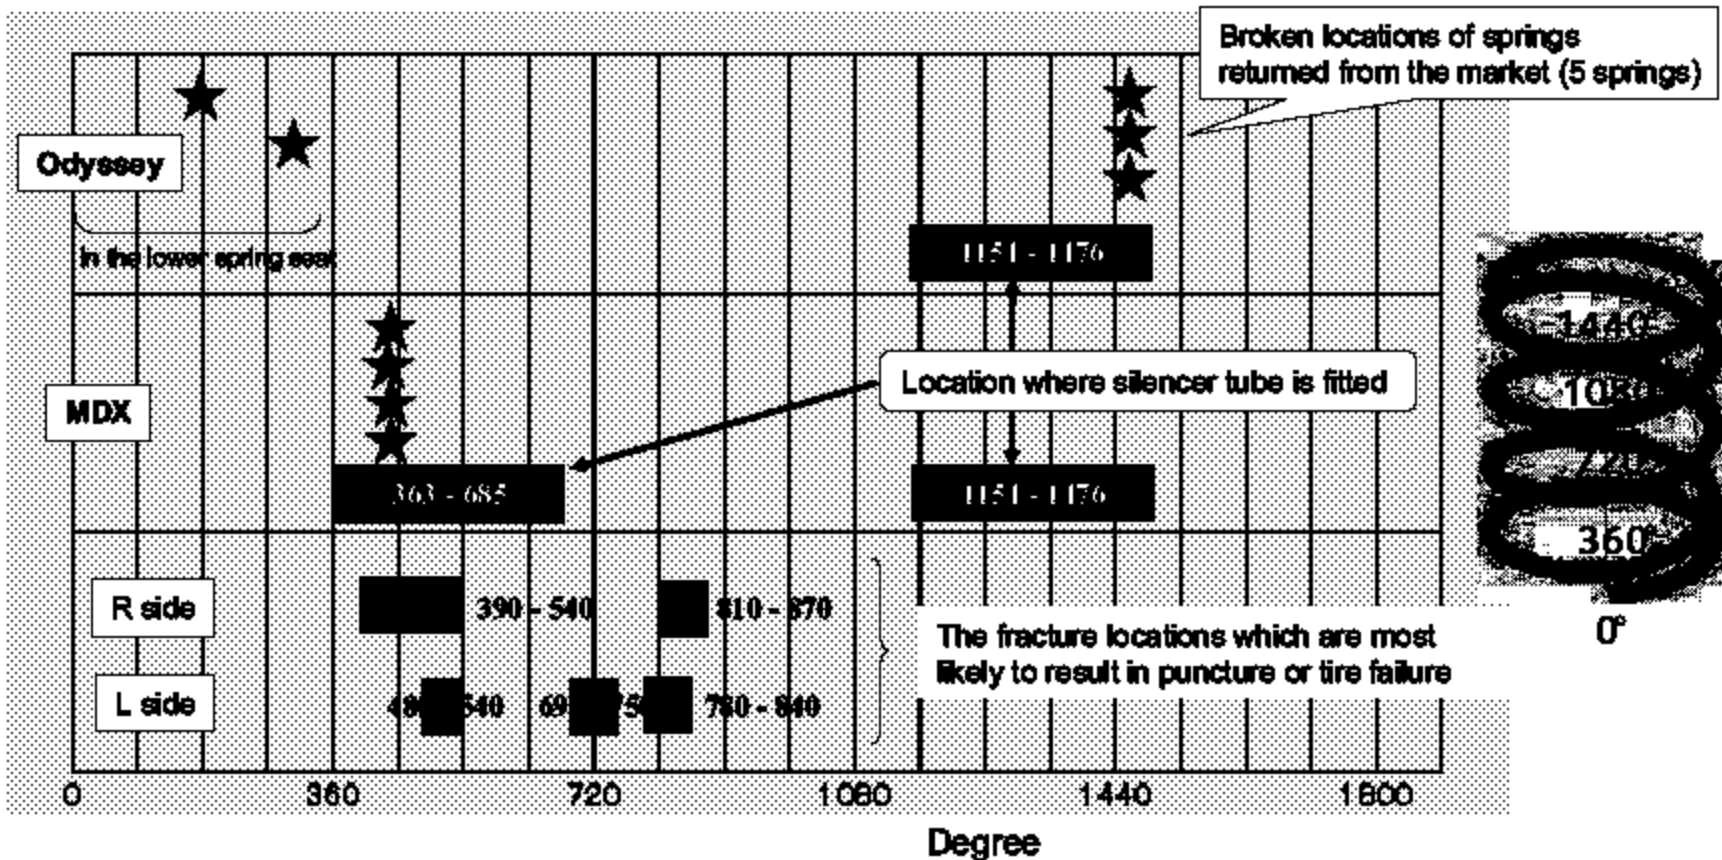
Fracture locations of springs returned from the market and fracture locations which are likely to result in puncture or failure

5 Odyssey springs were returned from the market. Most of the springs showed that the paint on the end coils was removed and that fracture occurred at a location where high stress is applied and road dirt or sand is apt to collect or at a location near the top of the spring where the silencer tube is fitted.

None of the 5 springs were broken at the location which could most likely result in tire failure.
