**PE06-013**  
**VOLVO**  
**5/5/2006**  
**ATTACHMENT**  
**PART 2 OF 3**

Field Report  
Serial # 377511  
 mileage: 14,111 4/8/2005

**Market Quality Report: 7581-572**

**Created Date** 2005-04-28  
**Subject** VHD Wheel Spacer  
**Responsible** GSO Chassis  
**QJ Function Group**  
**QJ Sequence No**  
**Connection/Closed**  
**date**  
**Issuer Name** Warren Spradlin  
**Issuer Mail** warren.spradlin@volvo.com  
**Function Group** 7712  
**Unplanned Stop** Yes

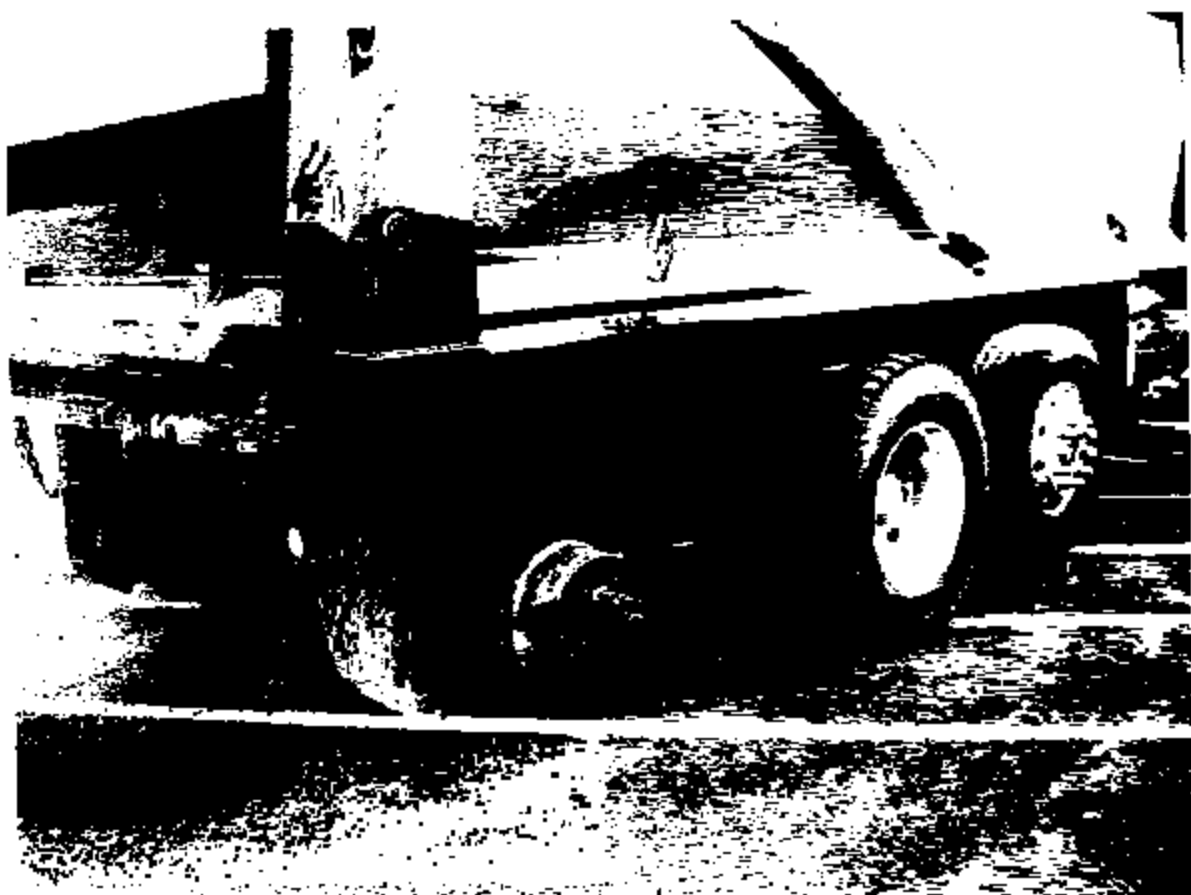
Dealer reports drive wheels falling off. Attached are pictures of the truck as it arrived at the dealership. The F&S rear drives were unseparable. All ten studs were broken off. Brake spider damaged. Truck is fully loaded. Dealer to inspect the remaining wheel nut torques when they are able to get it to where they can get the weight off the chassis to do so. Note: the dealer had removed all wheel spacers prior to delivery of the chassis. They torque wheel nuts to 540 ft. lbs. I will have another set of studs removed and sent to Reliability for metallurgical analysis.
