Supplemental Response Preliminary Evaluation (PE06-042)

2002MY Sportage Engine Cooling Fan

02MY Sportage Cooling Fan Crack, Separation Reconstruction Testing Report

KMC Quality Assurance Team 2

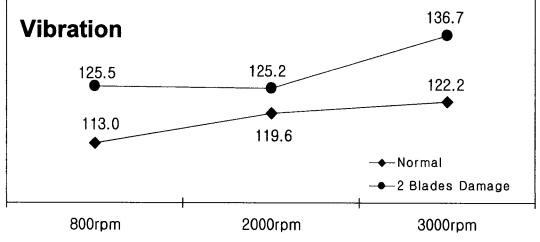
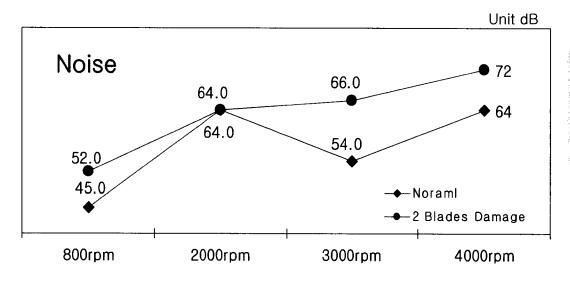
1) Damaged Cooling Fan's effect on steering wheel's vibration and noise

Damaged cooling fan blades (Two Blades) increases steering wheel vibration and noise. Driver can recognize the condition.

▶ At 3,000 rpm condition Vibration: 14.5 dB ↑ Noise: 12 dB ↑ b

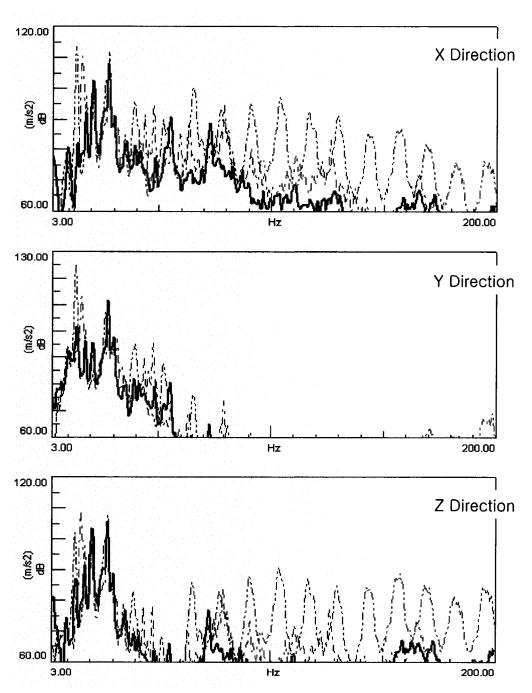
Intact
Intact
I Blade Separation
I Blades Separation

- Steering Wheel Vibration (unit: dB)

ldle	2000 rpm	3000 rpm	
Intact	113.0	119.6	122.2	
1 Blade Separation	115.0	124.9	124.2	
2 Blade Separation	125.5	125.2	136.7

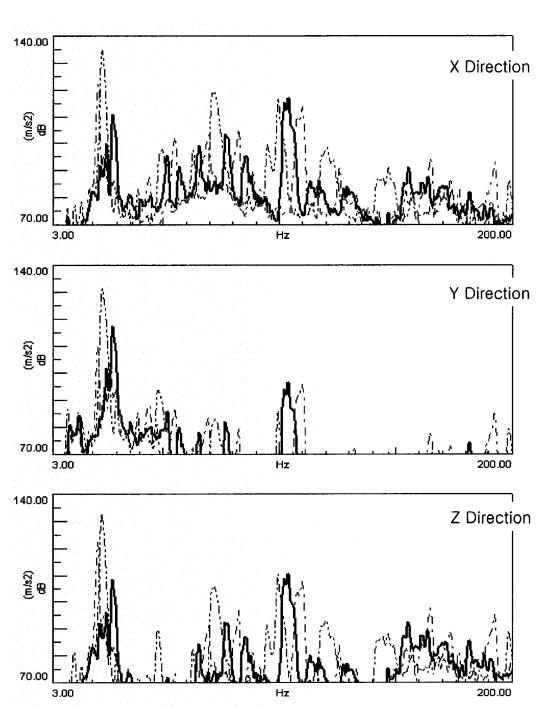
■ 3000 rpm

Intact
Intact
Intact
I Blade Separation
I Blade Separation
