PE06-048

MAZDA

APPENDIX 4

LAWSUITE 1

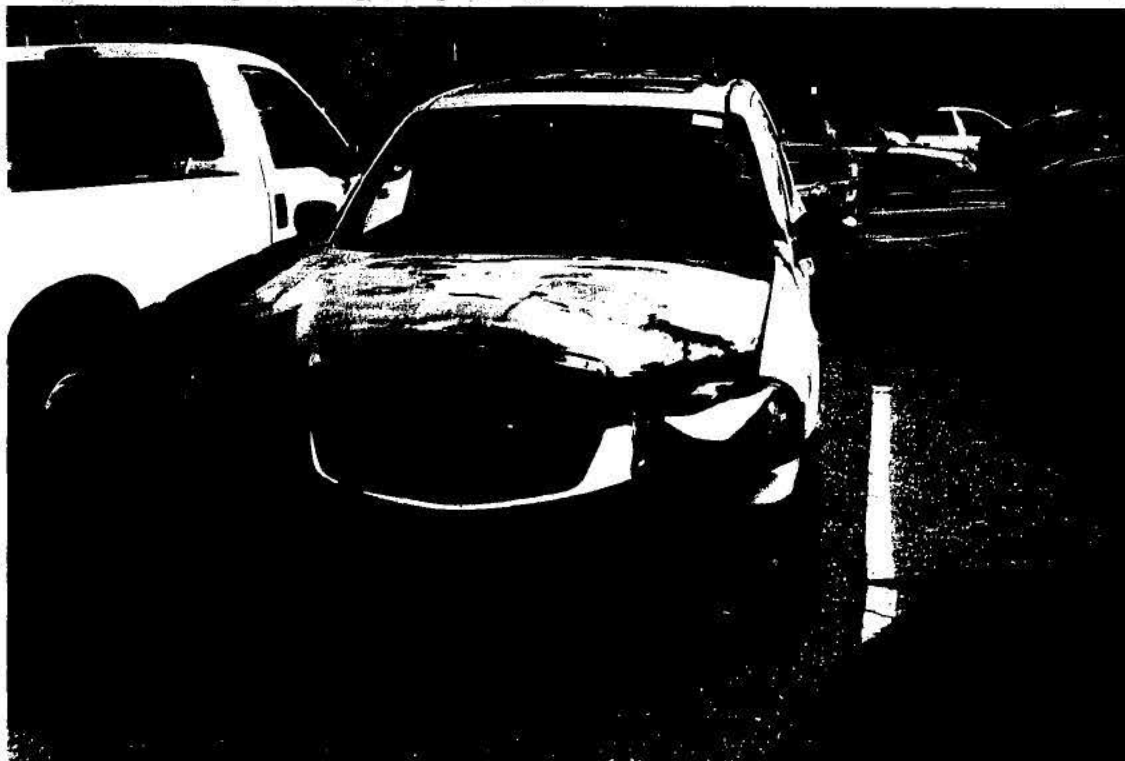
Initial observations reveal evidence of a fire to have originated within the engine compartment, with the most severe damage present to the painted surface of the hood on the left or driver's side. The fire extends, lessening in degree toward the right or passenger's side.

- 
8. A view of the front of the vehicle with the burn pattern present on the left or driver's side extending to the right or passenger's side.

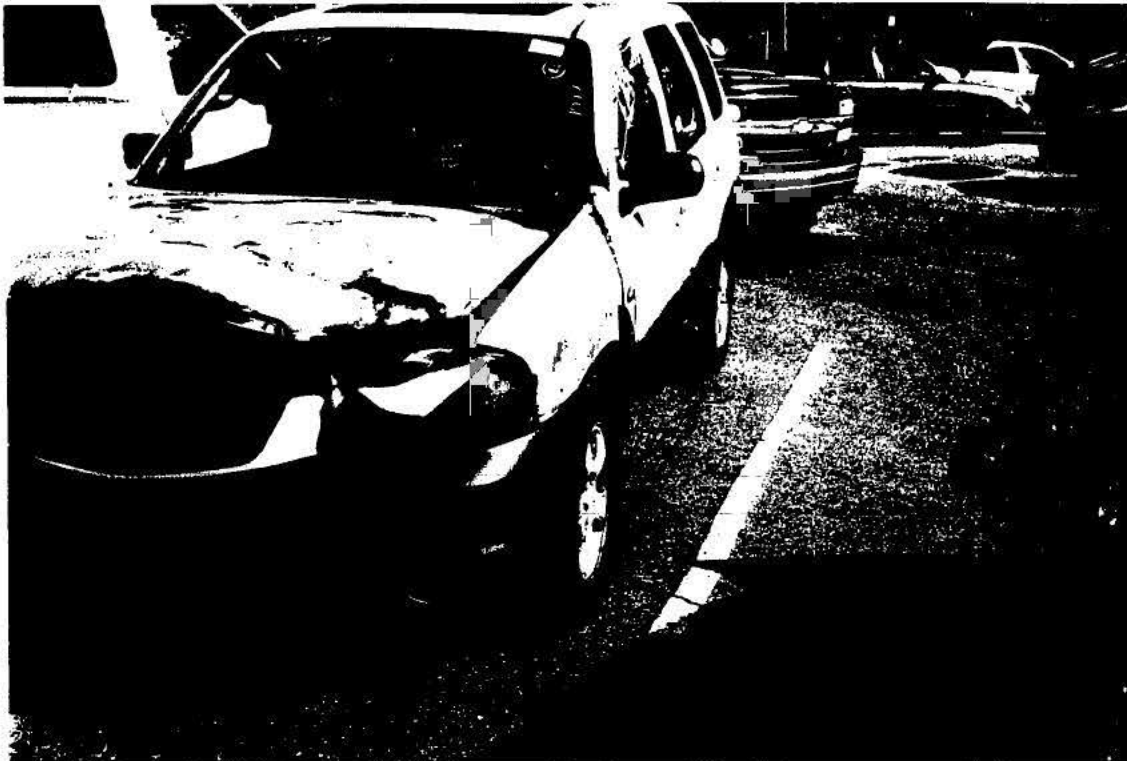
9. A view of the left front showing fire damage present to the painted surface of the left fender extending out the headlight assembly.

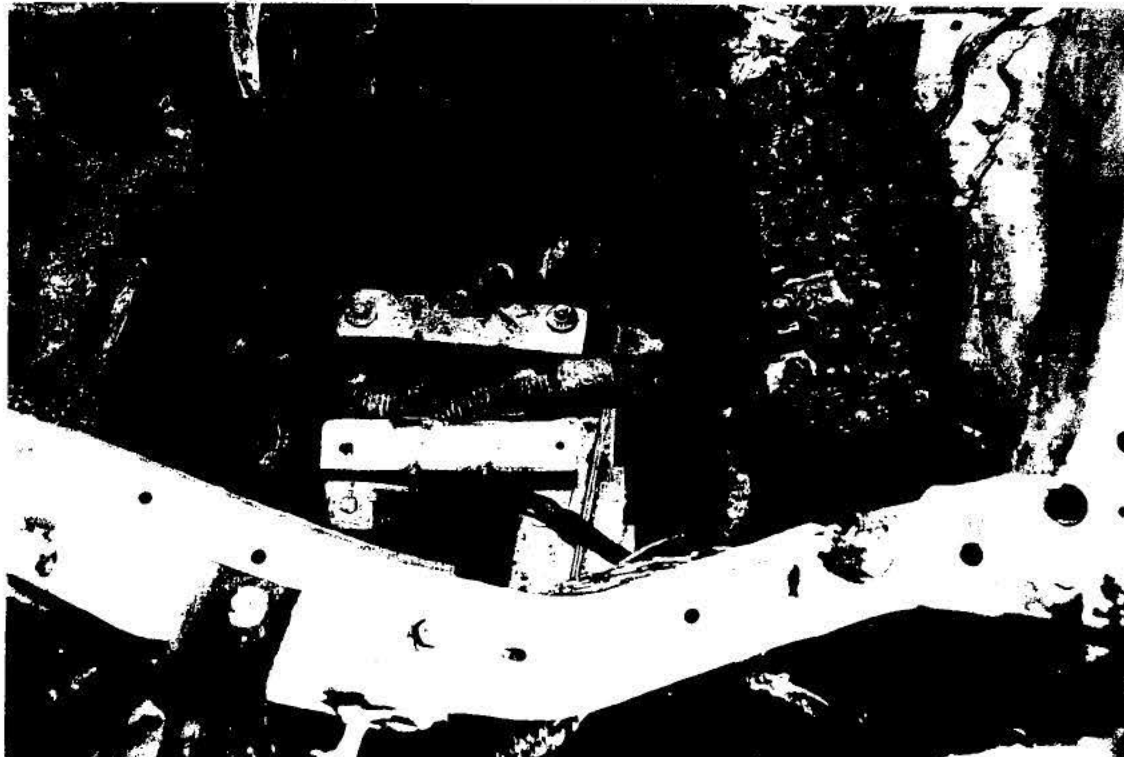
29. A view of wiring found in the underside of the power distribution center with evidence of electrical faulting.
