PE06-048

MAZDA

APPENDIX 4

**SOUTHERN FARM BUREAU CASUALTY INSURANCE COMPANY  
MISSISSIPPI FARM BUREAU MUTUAL INSURANCE COMPANY  
MISSISSIPPI FARM BUREAU CASUALTY INSURANCE COMPANY  
P. O. BOX 780 . BATESVILLE, MISSISSIPPI 38606-0780 . (601) 561-0116**

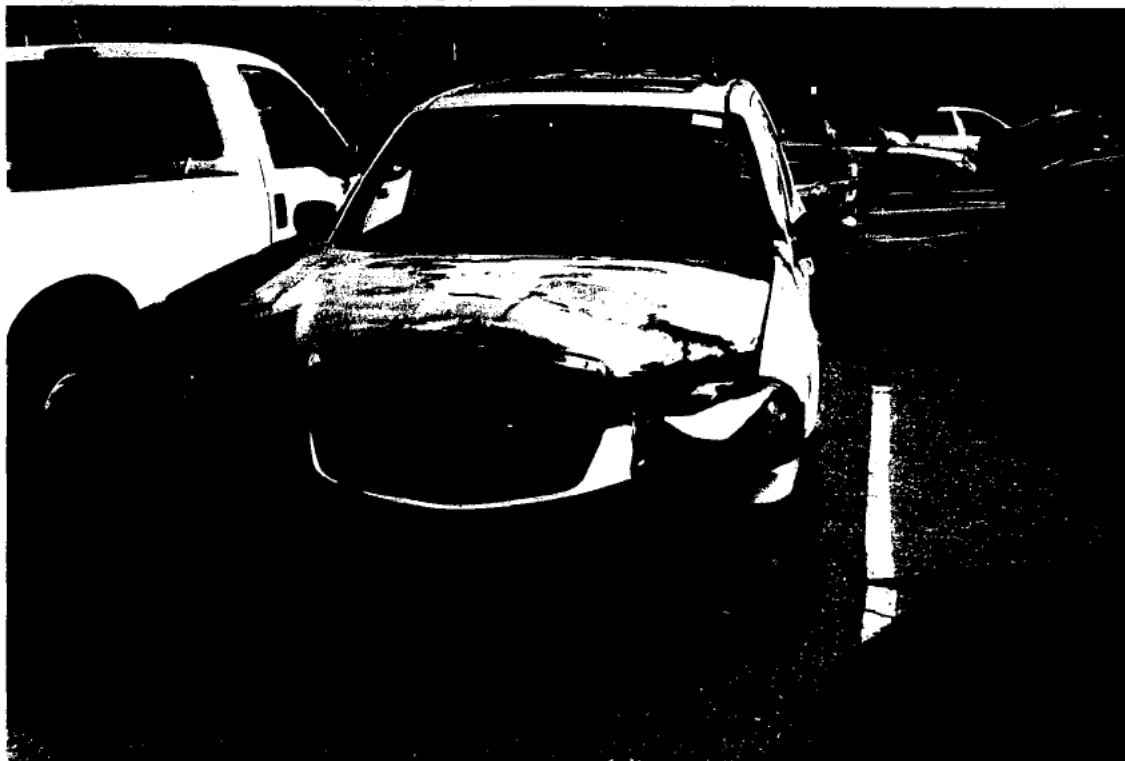
Initial observations reveal evidence of a fire to have originated within the engine compartment, with the most severe damage present to the painted surface of the hood on the left or driver's side. The fire extends, lessening in degree toward the right or passenger's side.

- 
8. A view of the front of the vehicle with the burn pattern present on the left or driver's side extending to the right or passenger's side.

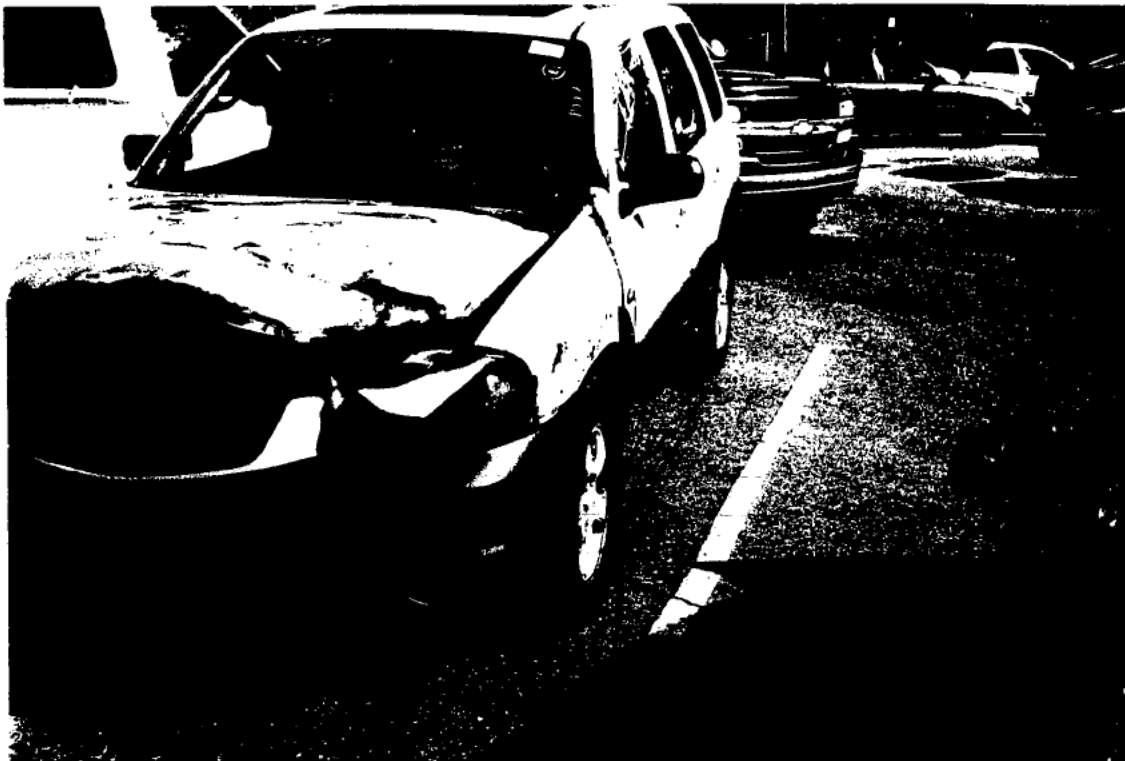
9. A view of the left front showing fire damage present to the painted surface of the left fender extending out the headlight assembly.

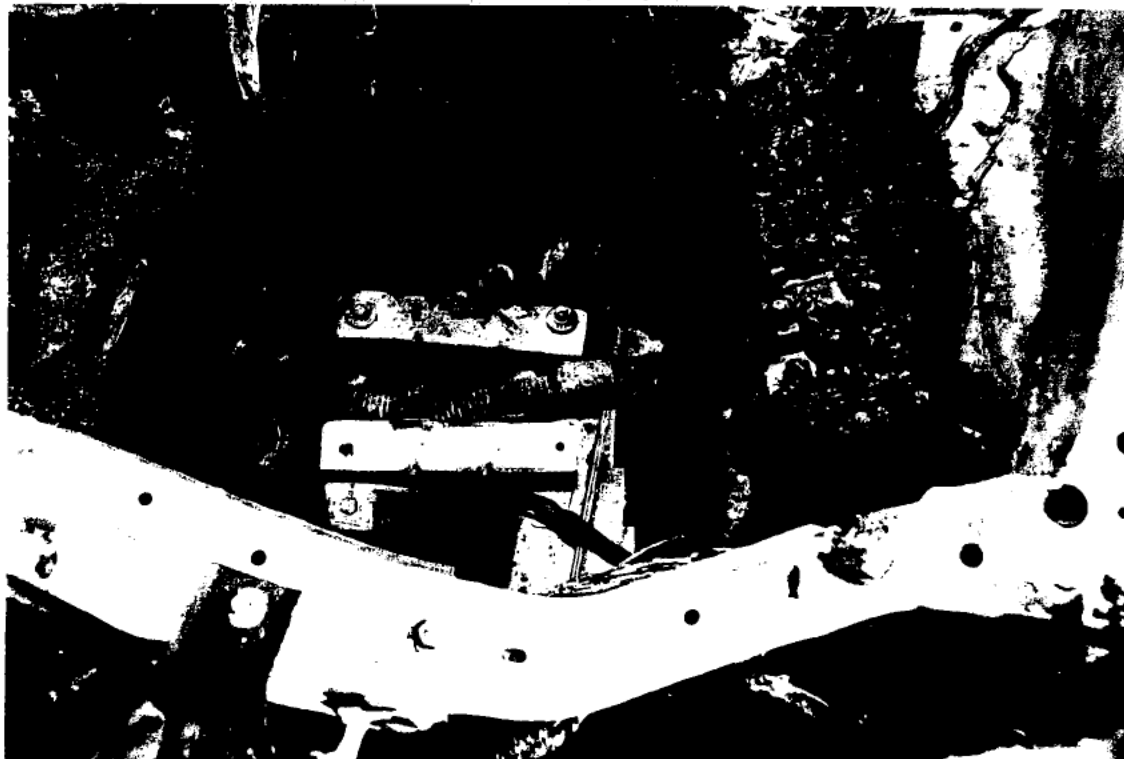
29. A view of wiring found in the underside of the power distribution center with evidence of electrical faulting.

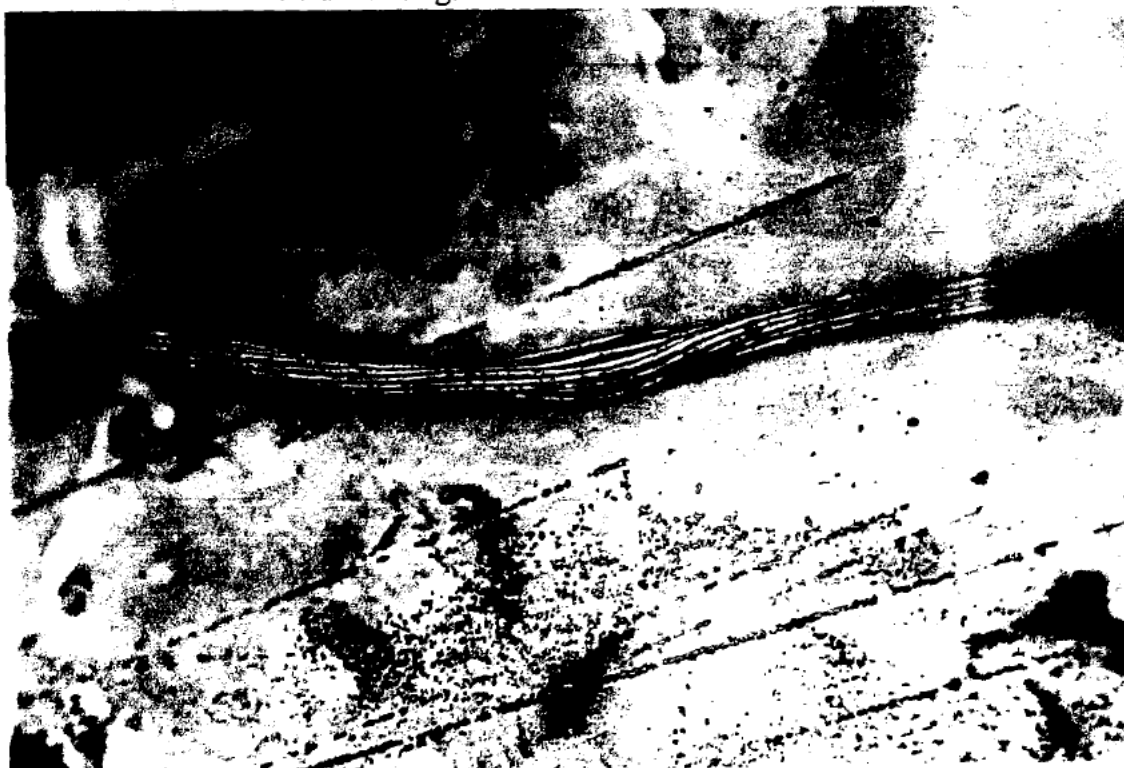
31. A close-up view of overheating of the wiring insulation on the harness that travels along the inner left fender.
- 
32. Another view of the wiring with evidence of overheating of the wiring insulation that travels along the inner fender.
