# Service Bulletin

**FLUID LEAKAGE FROM BRAKE RESERVOIR CAP**

2001-2002 Tributes

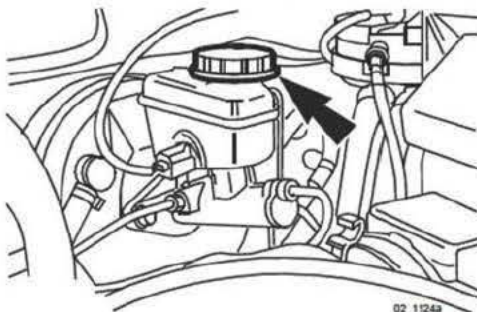
Some vehicles may exhibit fluid leakage from the brake reservoir cap. This may be caused by the insufficient sealing of the cap.

To improve the sealing, a new brake reservoir cap is available to prevent this condition.

1. Verify concern.
2. Remove the brake reservoir cap by turning counterclockwise.
3. Install a new cap and turn it clockwise to secure.

**NOTE:** Turn the cap until it completely stops.
