**TOYOTA**  
**TOYOTA MOTOR NORTH AMERICA, INC.**

February 16, 2007

Re: NVS-213aan; PE06-055

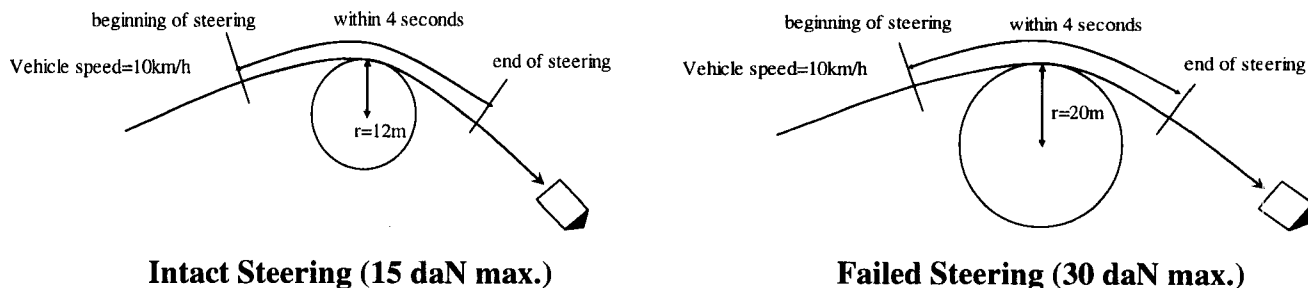
### ECE 79 Steering Effort Test

While steering effort is not regulated in the United States, the European Union (through the United Nations) has ECE 79 for vehicles sold in those countries. As prescribed in ECE 79, a vehicle of the Highlander Hybrid class (M1) would need to maneuver into a 12 m turning circle by steering the vehicle within 4 seconds with a steering input force of less than 15 daN with a normally functioning power steering system and into a 20 m turning circle within 4 seconds with a steering input of less than 30 daN when the system has failed. The Highlander Hybrid fully complies with ECE 79 with ample margin (50%) in effort, and, therefore, meets an accepted requirement for steering effort in the event of

a loss of power steering assist.

For the test, the vehicle is loaded to the Gross Vehicle Weight Rating (GVWR) with the front axle is loaded to its rated capacity. Force measurements are calculated at the steering wheel rim. The vehicle speed is very low, 10 km/hr, as a loss of power steering assist is most affecting during low speed operation. At high speed, since boost is already reduced, and inputs are small, a complete loss of power assist does not affect driver effort significantly. At low speeds, driver effort will increase, but well within the limits prescribed by ECE 79. While not required, Toyota also evaluated the Highlander Hybrid without power steering assist through the 12 m maneuver. The resulting steering effort was measured at slightly over 15 daN, which is the compliance limit of the regulation for a normally functioning steering system.
