Subject: FINAL REPORT: VRTC-DCD7106 "Investigation of
Instrument Panel Warpage That May Affect Passenger Airbag
Deployment"

Investigation of Instrument Panel Warpage That May Affect Passenger Airbag Deployment

FINAL REPORT
November 2007

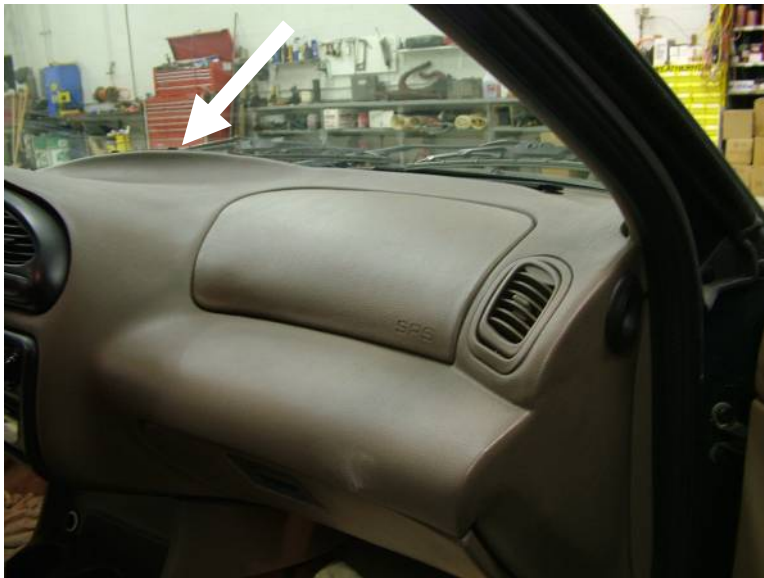
Figure 7 – 2000 Ford Contour with Warped Instrument Panel, Close-up (Hillsdale MI)

Arrow shows warpage on instrument panel on driver's side of vehicle.

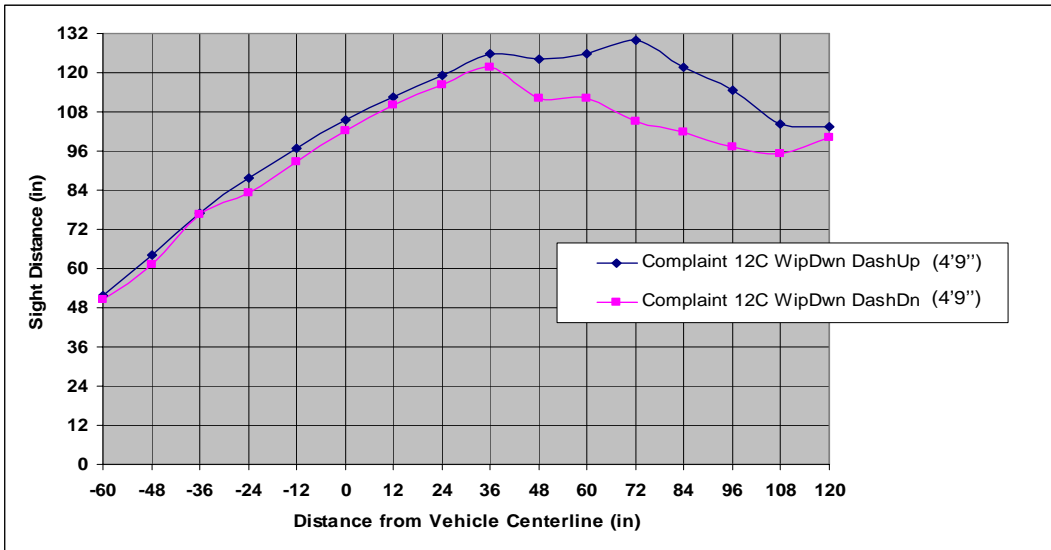
Figure 16 – Complaint Vehicle without Effects of Instrument Panel Warpage¹¹

Complaint vehicle with 4'9" height test subject with and without a warped instrument panel (warped instrument panel held down). Locations on the left side of the vehicle and any location directly in front of the vehicle show little difference in viewing distance.

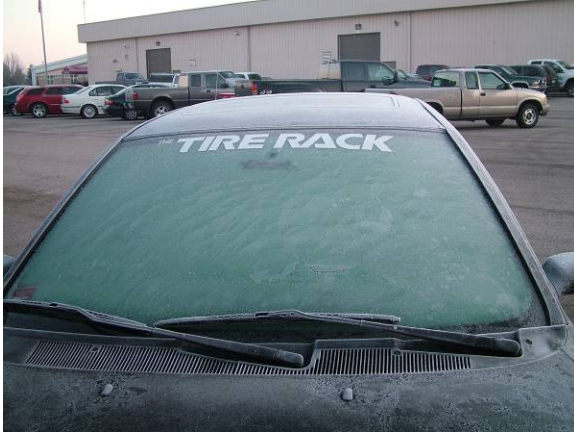
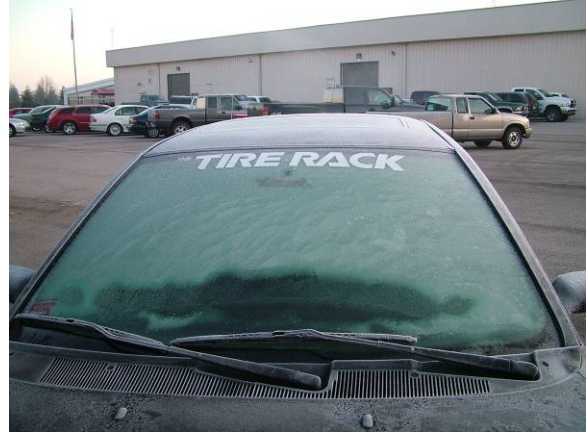
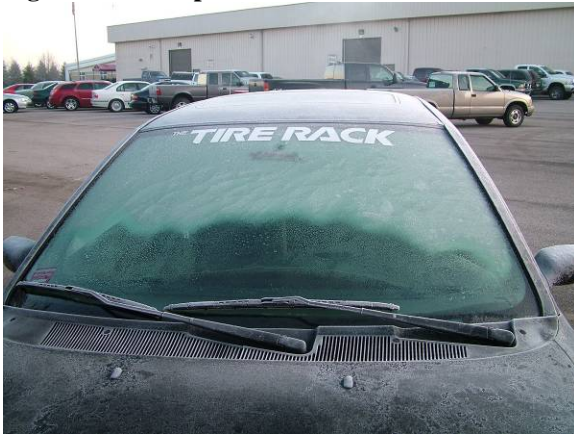
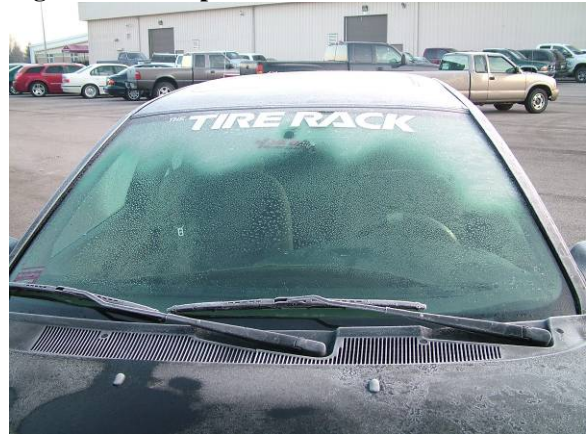
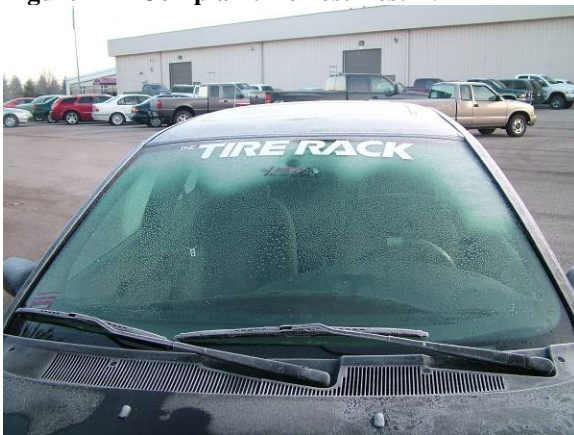
Figures 22-26. Ford Contour Complaint Vehicle Defroster Test Results.

VEHICLE	TYPE	TIME	TIME TO DEFROST	REMARKS
2000 Contour	Complaint	7:56-8:11 am	15+ min	Clearance with ~15% frost remaining
1999 Volvo S80	Peer	7:56-8:11 am	11 min	Fast front and rear defrost. Good defrost rate.
2005 Saturn Ion	Peer	8:19-8:33 am	12 min	Slow defrost start; with good side defrost with ~10% frost remaining.
