**MEMORANDUM REPORT VRTC-DCD-6099**  
**EA06-002**  
**Investigation of Rear Tire Puncture Due to Coil Spring Fracture**  
**on 2000 – 2001 Ford Taurus Vehicles**

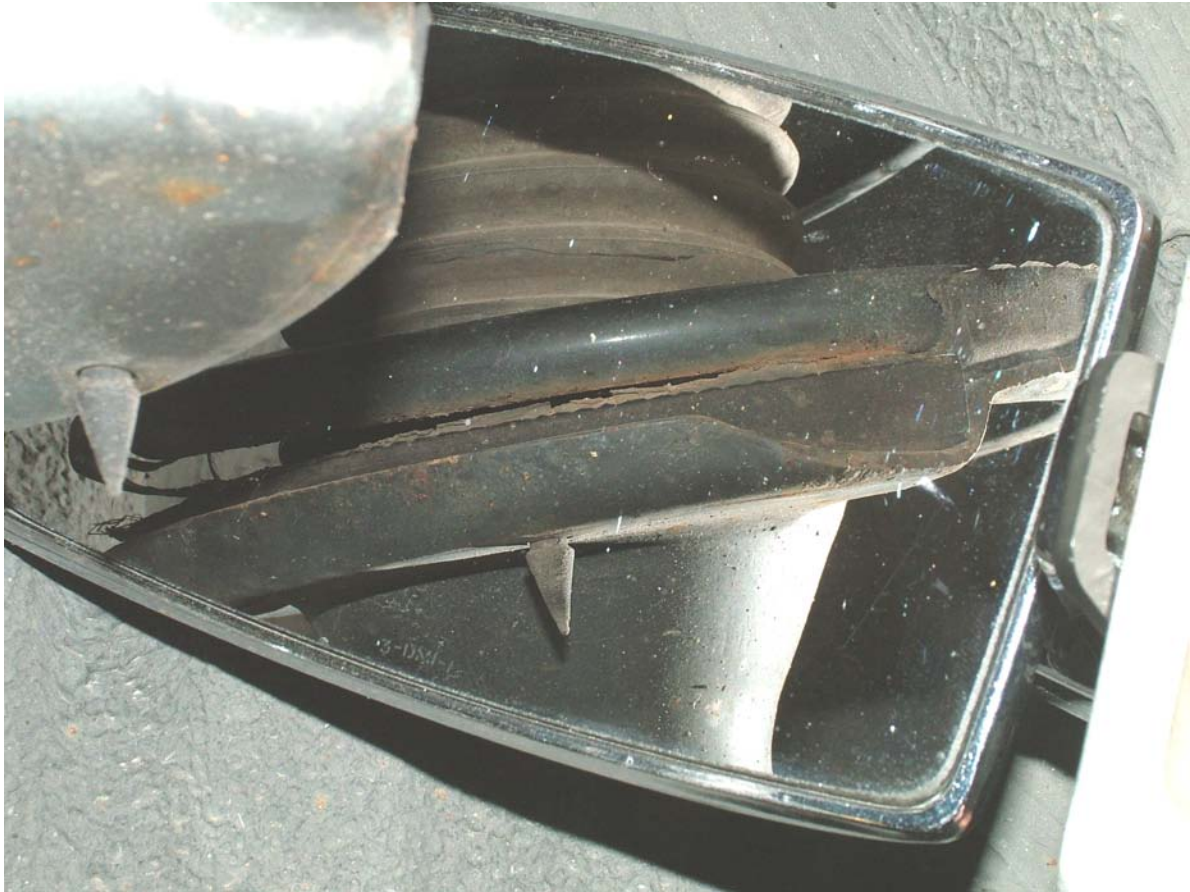
When mounted in the vehicle, the subject spring compressed and the fracture area bore directly on the coil below it. Figure 1 (taken through a mirror) shows a non-fractured subject spring mounted in a subject vehicle at curb weight. Contact exists between the bottom coil and second coil. The contact area became greater as the load in the vehicle was increased.

**Figure 1**  
**Coil Contact at Curb Weight**

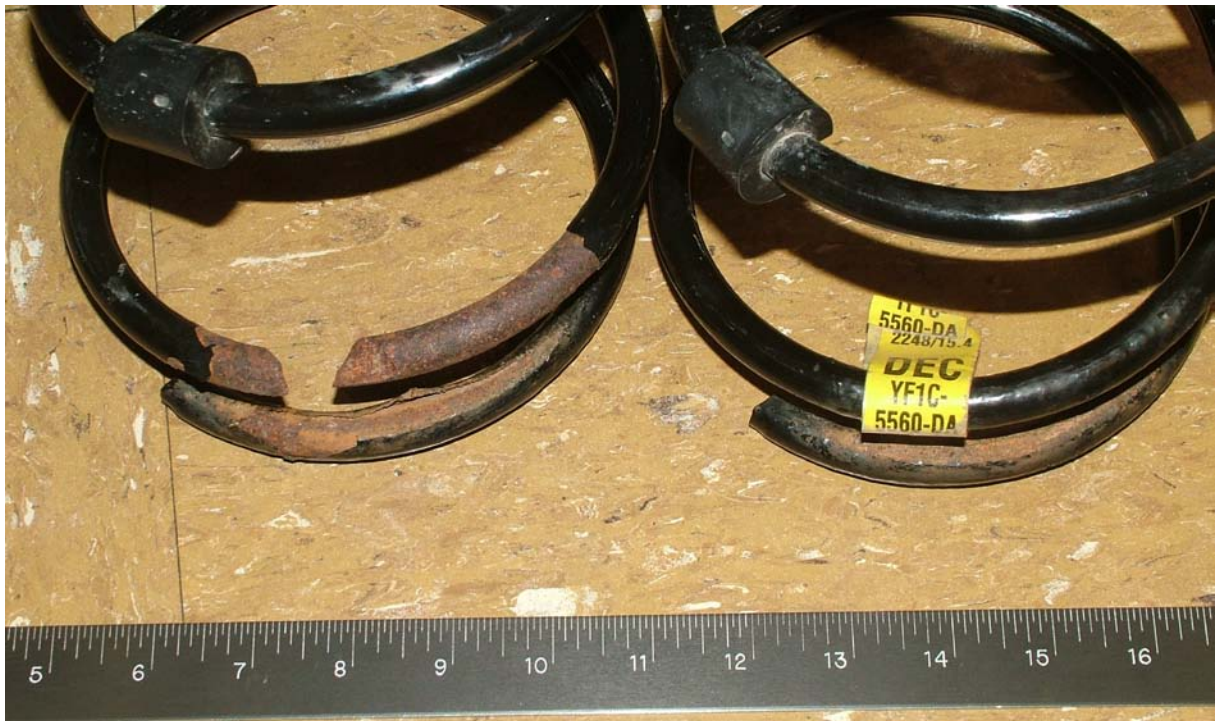
Figure 2 shows the lower end of the two complaint springs that were received. It is evident that the first ~90 degrees of both springs have been in contact with the coil immediately above it. This contact has caused the protective coating to wear away and corrosion to begin on the first two coils of the fractured spring but only on the first coil of the non-fractured spring.

**Figure 2**  
**Lower End of Complaint Springs**

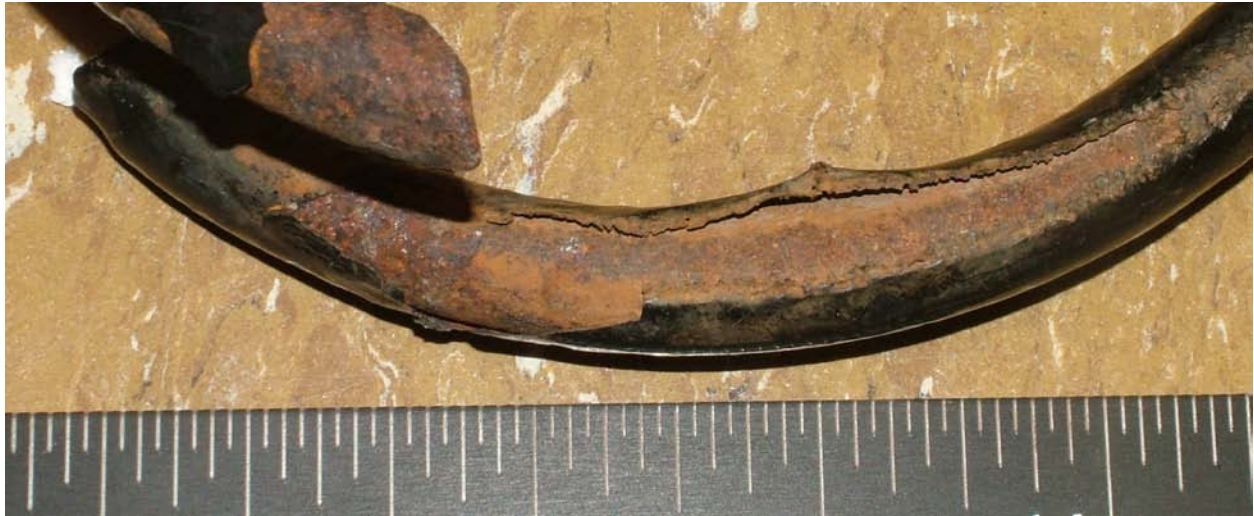
Figure 3 shows that not only did the protective coating wear away, but the remaining coating acted as a pocket to gather debris and moisture. This condition was evident on both springs.

**Figure 3**  
**Cupping and Corrosion of Lower Coil**

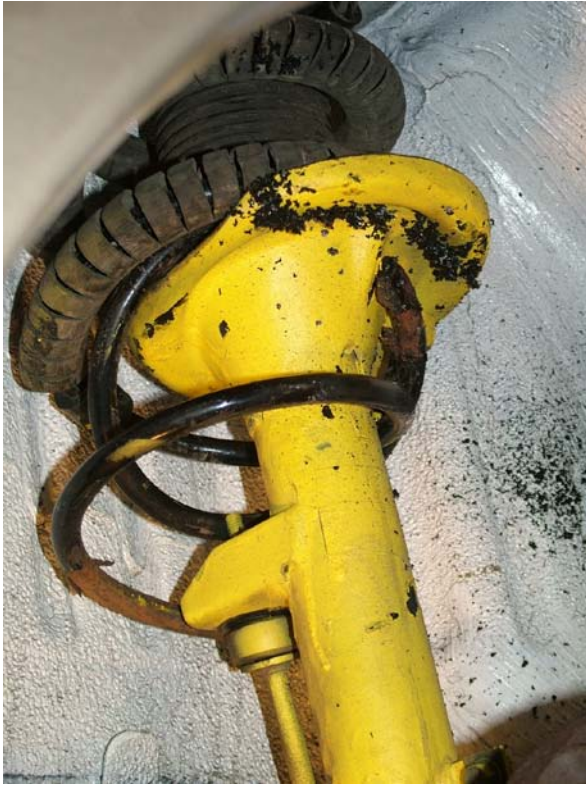
A fractured spring was installed on a subject vehicle. The vehicle was then driven with the spring rubbing against the inner sidewall of the tire. A small hole was created in the sidewall, which resulted in air loss, after driving 3.8 miles. No loss of vehicle control was experienced. After installing the space-saver spare tire, there was no contact between the broken spring and the tire. Driving the vehicle in this manner would only be limited to the capability and limitations of the spare tire. Figure 4 shows the orientation of the spring at the conclusion of the test. Figure 5 shows rubber that was abraded from the tire and deposited on the front of the wheel well.

**Figure 4**  
**Spring at End of Test**

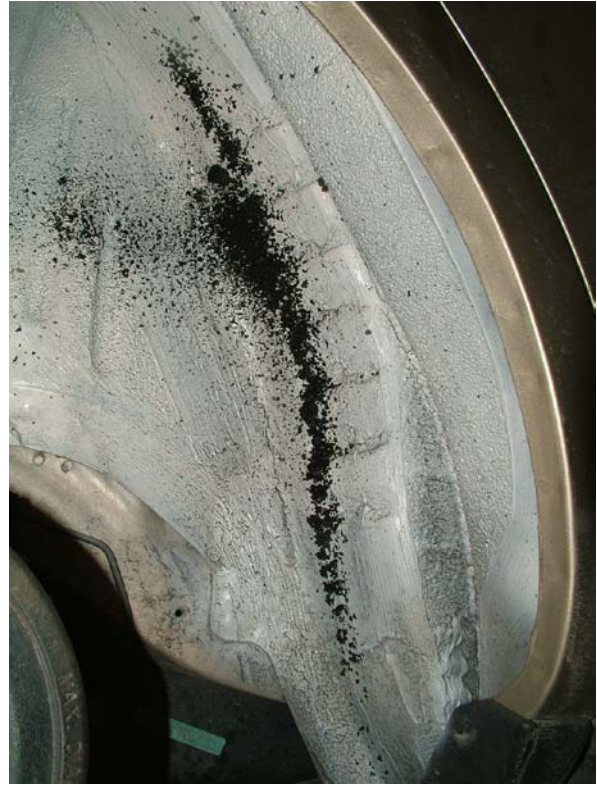
**Figure 5**  
**Rubber on Wheel Well**

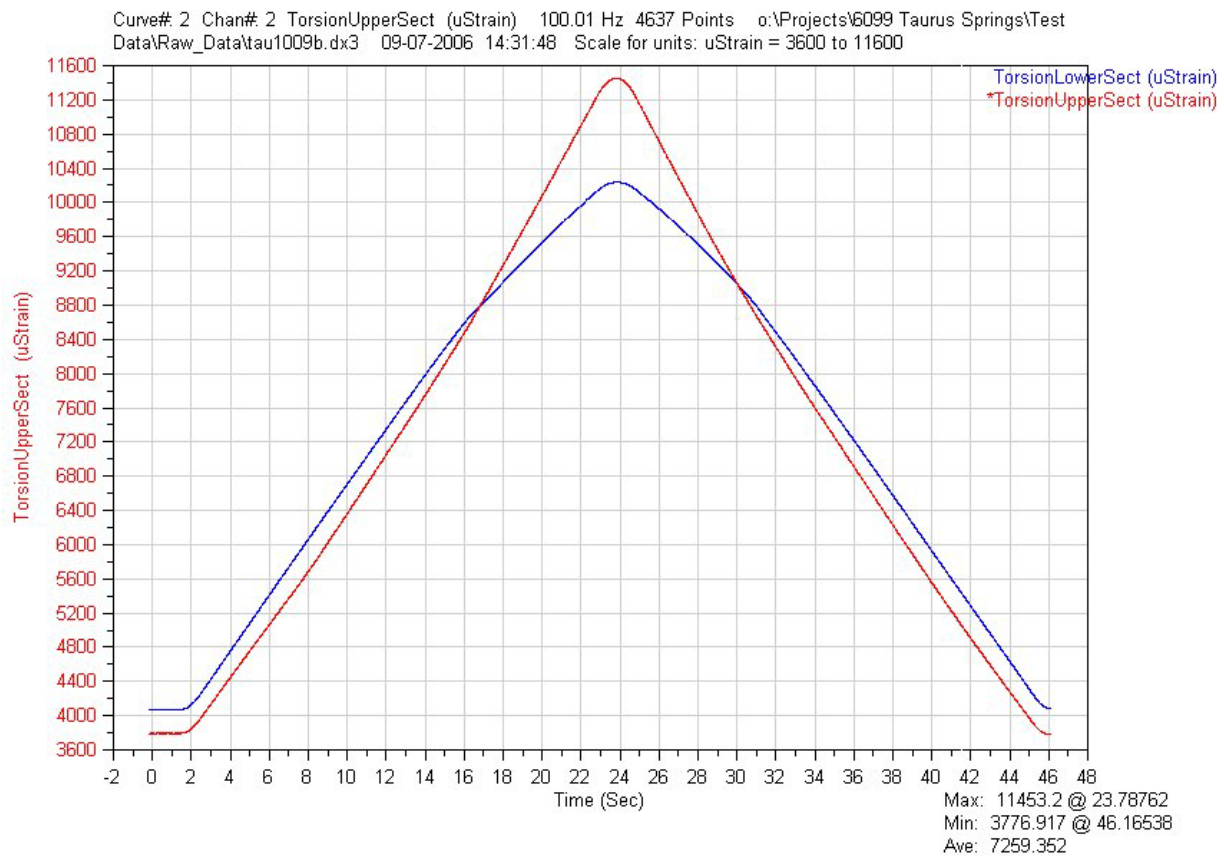
Shown below are several data plots that illustrate the strains recorded during testing. Because of the constant application rate, the strain data are plotted vs. time<sup>3</sup> rather than load. The peak strain in the center of the plots represents the 1,200 lb load where the UTS machine automatically stopped and then unloaded. Figure 8 shows that the torsional strains for both the upper and lower strain gages are similar.

**Figure 8**  
**Upper and Lower Torsional Strain**

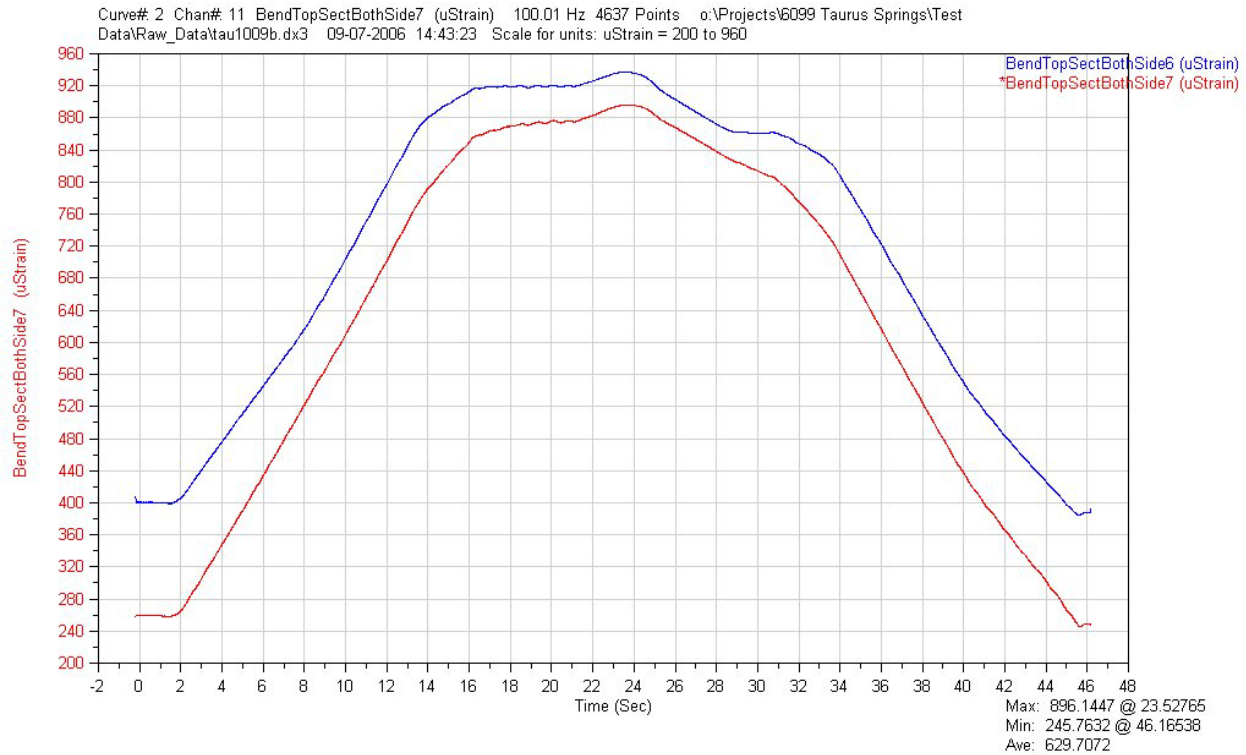
Figure 9 shows the straight strain for both upper gages measuring straight strain. Like the torque values, they are similar, rise more or less gently to a peak, and then decrease as the load is reduced.

**Figure 9**  
**Straight Strain in Middle of Spring**

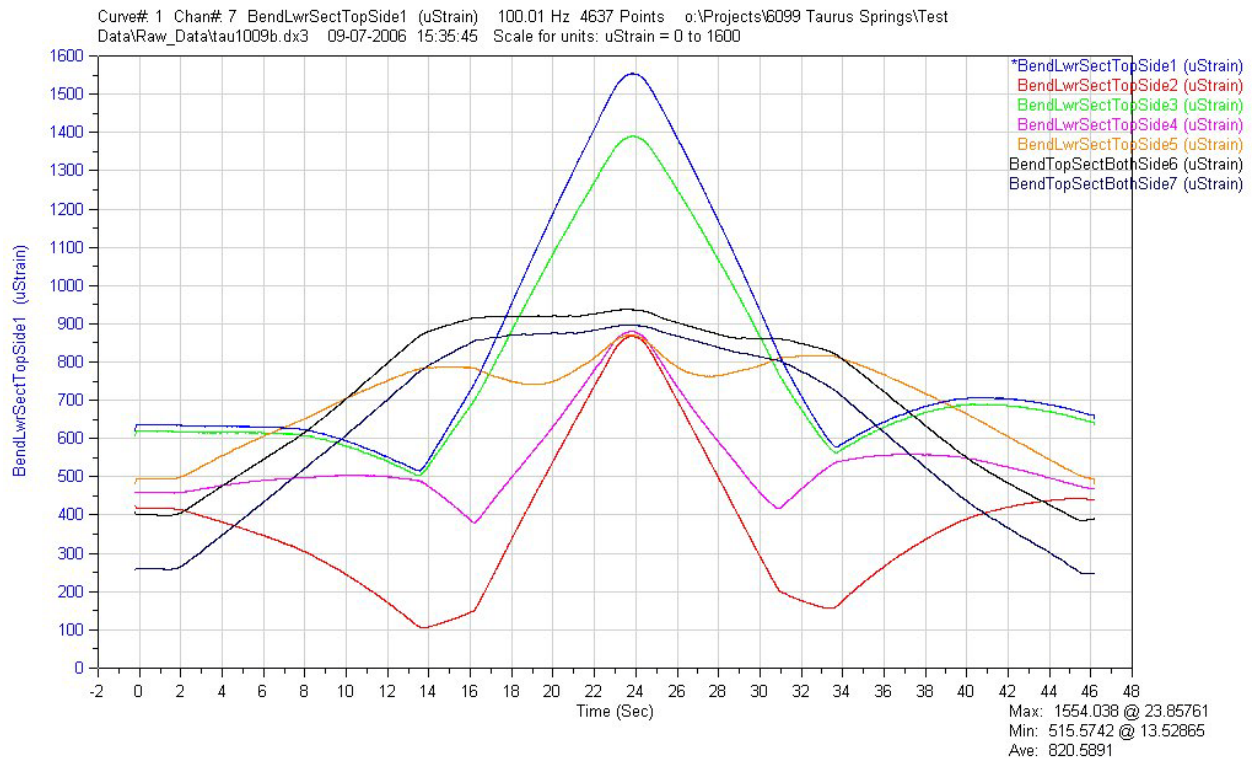
Figure 10 shows the straight strain measured on gages 1 – 5, located on the coil directly above the end of the spring, and gages 6 and 7, (same data but different scale as Fig. 4) located in the middle of the spring. Gages 1 – 4 initially measured a reduction in strain, then an increase. Gage 5, the furthest up the spring, measured strain that approximated that of gages 6 and 7, which were located in the middle of the spring. The strain measured at gages 1 and 3 reversed sharply and then increased to almost double that measured on the other gages. The strain measured on gages 2 and 4 reversed sharply a little later than gages 1 and 3 and then increased to a level similar to gages 5 – 7. The reversal of strain at 14 seconds coincides with the point at which coil contact begins. While each of these gages starts at a different value, the differences are due to the preloading of the spring that is created when it is installed in the strut. Before mounting the spring in the strut, the output from all seven strain gages read zero.

**Figure 10**  
**Straight Strain for All Seven Measured Locations**

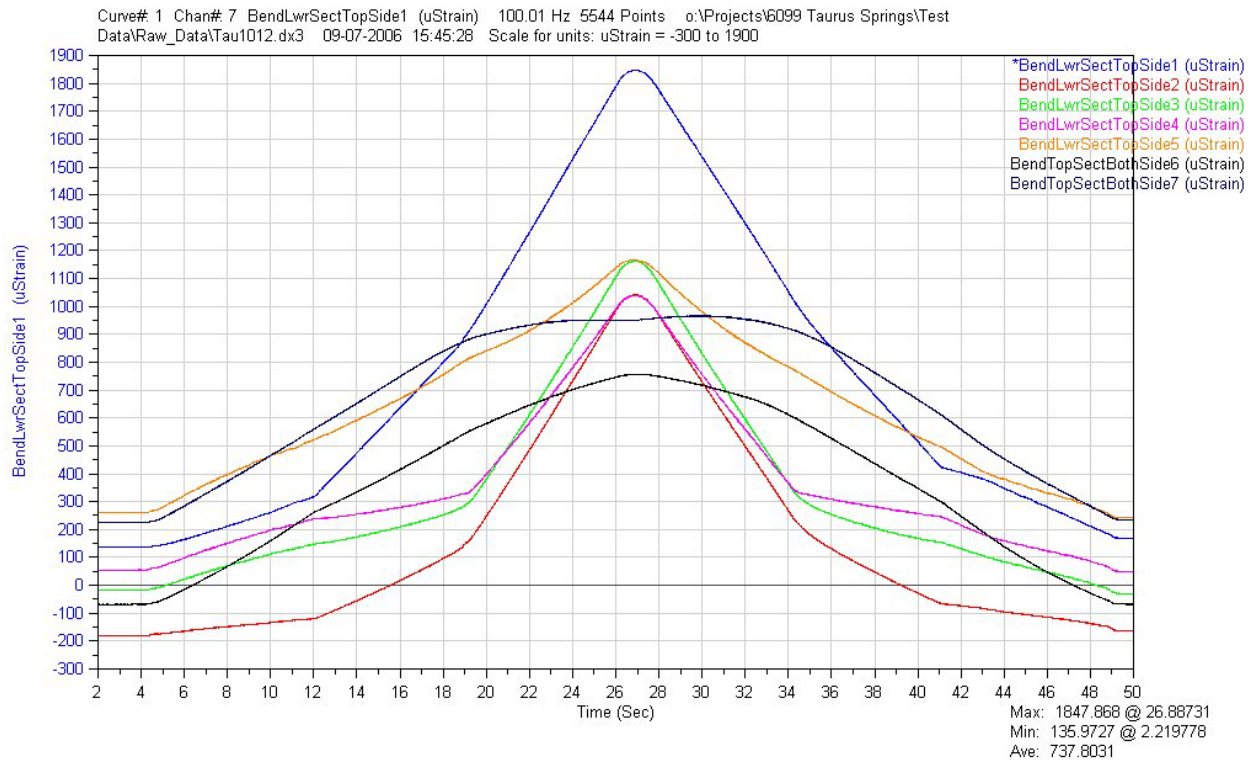
It was hypothesized that the coil-to-coil contact was causing the strain reversal that was being measured. In order to test this hypothesis, the spring was removed and inverted in the strut. This orientation placed the instrumented end at the flat upper spring mount and eliminated the coil bind at the instrumented end of the spring that was experienced in the standard mounting method. Figure 11 shows that while gage 1 still demonstrates almost double the strain of the other gages, the reversal of strain was eliminated with the spring in the inverted orientation.

**Figure 11**  
**Strain with Spring Inverted**
