Re: Toyota Siennas with Power Liftgates; EA06-020
Response to Recall Request Letter

Sienna Door Energy

**2004 through 2006 Model Year Sienna Back Door Stays (Rear Liftgate Struts)
Warranty Enhancement Notification**

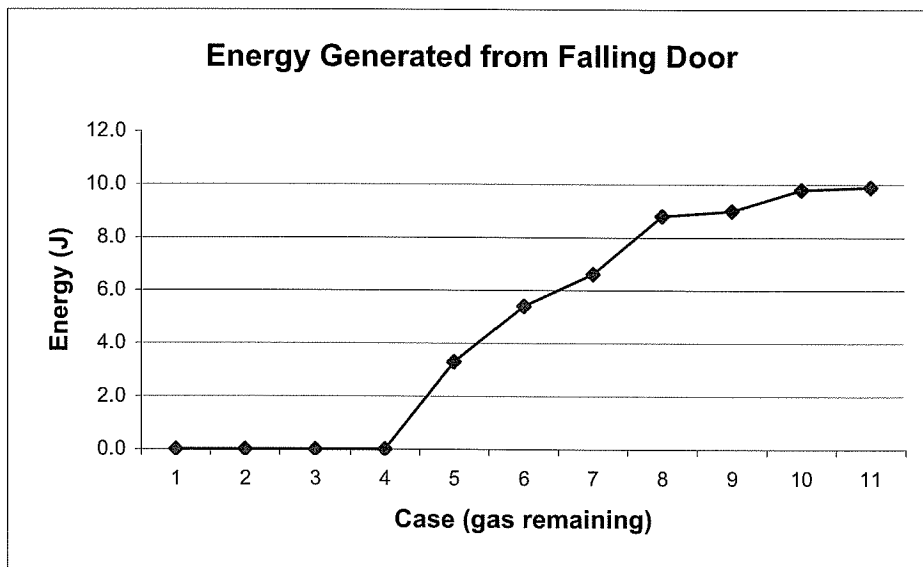
To assess the possibility of serious injury from a falling liftgate during the 10-inch drop before the motor engages, Toyota measured the maximum speed at which the liftgate will fall, given various levels of gas loss from the struts, and then calculated the energy that would be generated by the falling liftgate in each case. As shown in the enclosed table, the peak speed of 37.8°/second occurred with one strut removed, simulating a case in which one strut has lost all of its gas and the other remains in good condition.⁶ This converts to a maximum speed of 0.75 meters/second at the end of the liftgate, which will generate 9.9 Joules of energy. As would be expected, when there has been less gas loss from the struts, the speed of the falling liftgate – and the resultant energy level – will be lower. Toyota has reviewed the available literature with respect to the amount of energy needed to cause a serious head injury in the unlikely event that an individual is struck in the head by a liftgate during the initial drop.⁷ For example, in an article in the *Journal of Sports Medicine* that addressed the subject of head injuries to soccer players due to impacts, the authors noted that “the mean impact energy ranged between 45 J [Joules] for non-loss of consciousness concussion and 75 J when loss of consciousness for longer than one minute was observed.”⁸ Thus, the 10 J or less that can be generated by a falling Sienna liftgate is far less than the energy needed to cause a “non-loss of consciousness concussion,” and in any event, such a concussion is classified as a minor AIS-1 injury under the AIS scale.

Case	Vehicle Condition: Gas remaining in Damper Stays (total both sides)	Peak Angular Velocity (deg/sec)	Linear Velocity (m/s)	Energy (J)
1	100.0%	0.0	0.00	0.0
2	92.5%	0.0	0.00	0.0
3	85.0%	0.0	0.00	0.0
4	75.0%	0.0	0.00	0.0
5	67.5% (85% & 50%)	21.7	0.43	3.3
6	62.5% (75% & 50%)	27.8	0.55	5.4
7	55.0% (85% & 25%)	30.9	0.62	6.6
8	50.0% (50% & 50%)	35.6	0.71	8.8
9	50.0% (100% & 0%)	36.0	0.72	9.0
10	50.0% (0% & 100%)	37.7	0.75	9.8
11	50.0% (LH strut removed)	37.8	0.75	9.9

door does not fall
