Service Bulletin

File In Section: Special Coverage
Bulletin No.: 06186
Date: October 2007

SUBJECT: SPECIAL COVERAGE ADJUSTMENT – FRONT SUSPENSION CROSSMEMBER CORROSION

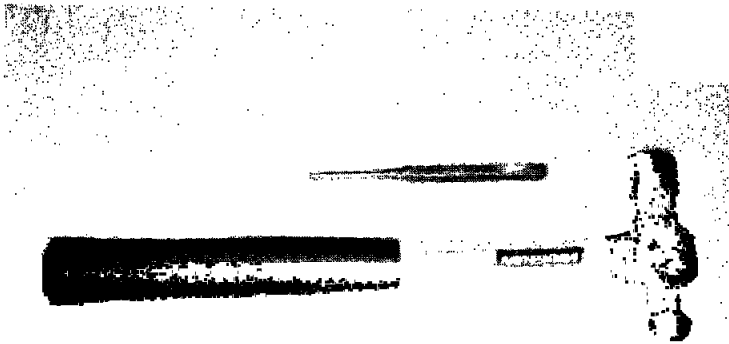
2010237

1. Conduct the steel integrity inspection using a 4.8 mm (3/16 in) flat-tip punch and a 340-454 gram (12-16 ounce) hammer.
