**National Highway
Traffic Safety
Administration**

ODI RESUME

Investigation: EA07-009

Subject: Fuel Pump Module Leaks Gasoline

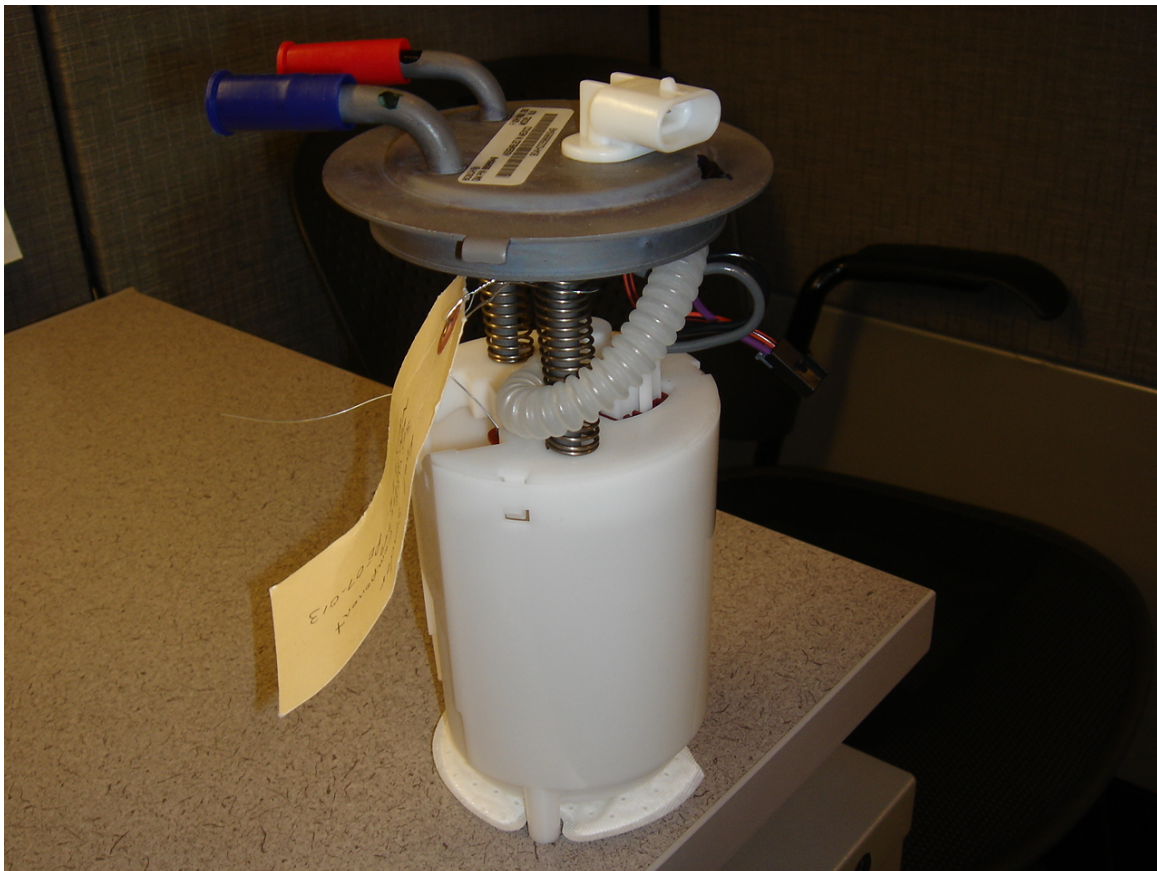
The subject component is the fuel pump module, also called the modular reservoir assembly (MRA) (Figure 1). The MRA is installed into the top of the fuel tank. The top

Figure 1: MRA Module

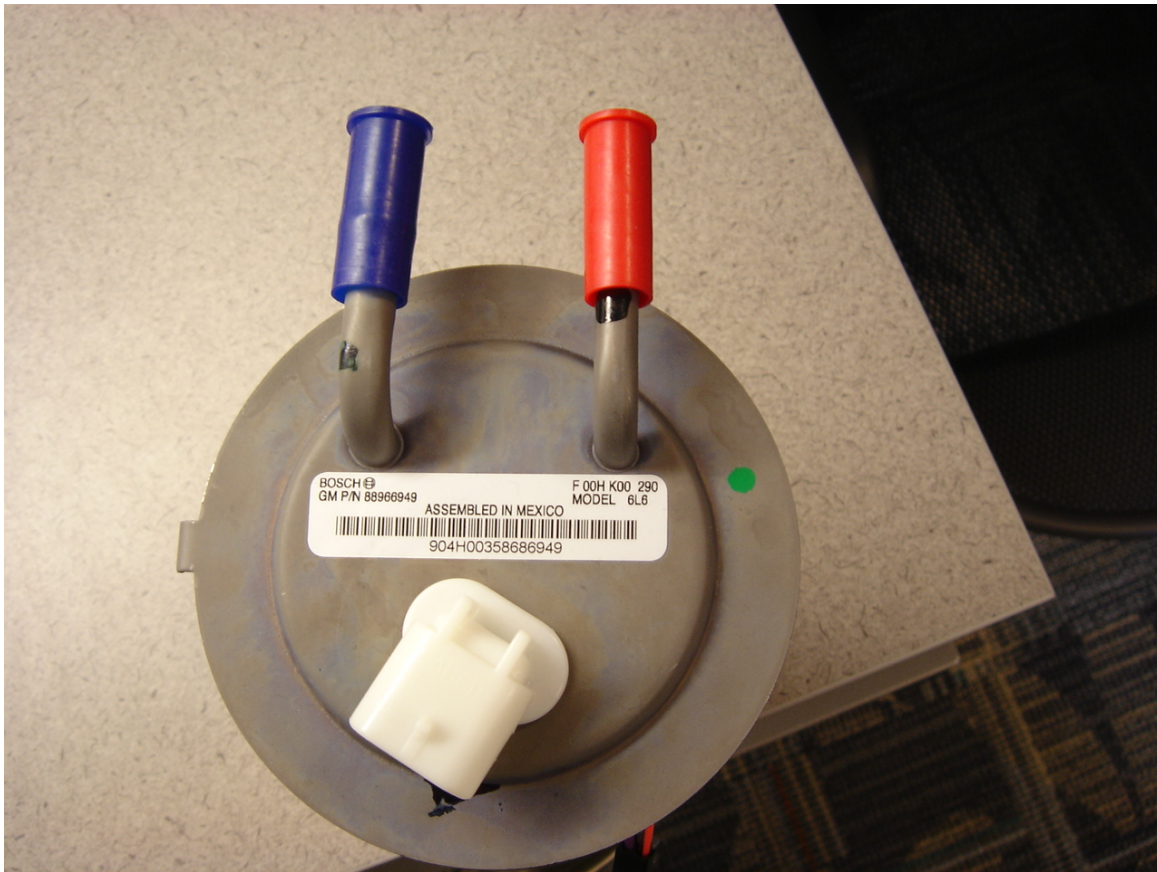
of the MRA is exposed at the top of the tank and a ring gasket provides a seal between the top of the MRA and the top of the fuel tank. Two metal fuel lines (supply and return) emerge from the top of the MRA and are bent 90 degrees to the horizontal to connect to plastic fuel lines that supply fuel to the engine and return unused fuel (see Figure 2).

Figure 2: Metal Supply and Return Lines from top of MRA Flange

The alleged defect is gasoline leaking from either or both of the MRA's metal supply and return lines.

The primary cause of the MRA leaking gasoline is corrosion of the metal gasoline supply and return lines. The top of the MRA and metal fuel lines are exposed to outside elements, including water and, where applied, road salt. Also, the top of the MRA is slightly recessed into the vehicle's fuel tank shell and thus can hold standing water and salt. When the vehicle's engine is running, the fuel in the metal supply and return lines is

under pressure (the metal supply line fuel pressure can be as high as 68 pounds per square inch (psi) while the return line fuel pressure is generally under 5 psi). As corrosion progresses, the pressurized fuel can leak from the metal supply and return fuel lines, and puddles of fuel can form on the recessed top of the MRA and drip down the side of the fuel tank.

- Redesigned MRA
- Changed MRA original equipment supplier
- Modified corrosion protection coating requirements
- Redesigned the fuel tank shell to allow water drainage away from the MRA
- Improved corrosion protection validation and testing

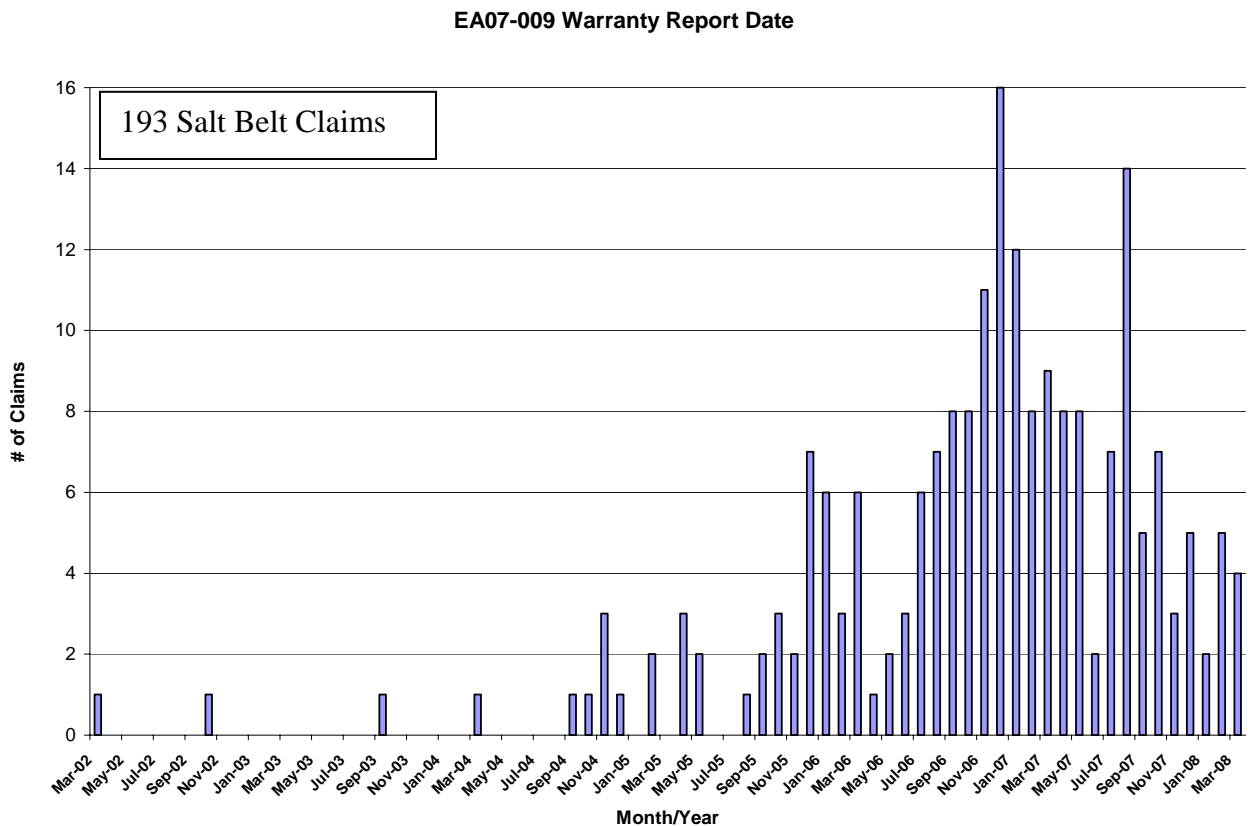
GM received 206 claims relating to the alleged defect in the subject component between March 2002 and March 2008 out of a population of 1,244,889 vehicles. Of these 206 claims, 193 came from owners of vehicles in salt belt states, while only 13 claims came from owners of vehicles outside of this area. Figure 4 shows the number of warranty claims from owners in salt belt states by report date. The chart also appears to show an overall continuity of repairs over time. The chart appears to show an increasing repair trend during the winter months, when most of the road salt is applied to roads. By contrast, Figure 5, which shows the number of claims from owners outside of the salt belt region from June 2003 to February 2008, appears to show no upward trend, seasonally or over time.

Figure 4: Warranty Claims Salt Belt by Report Date

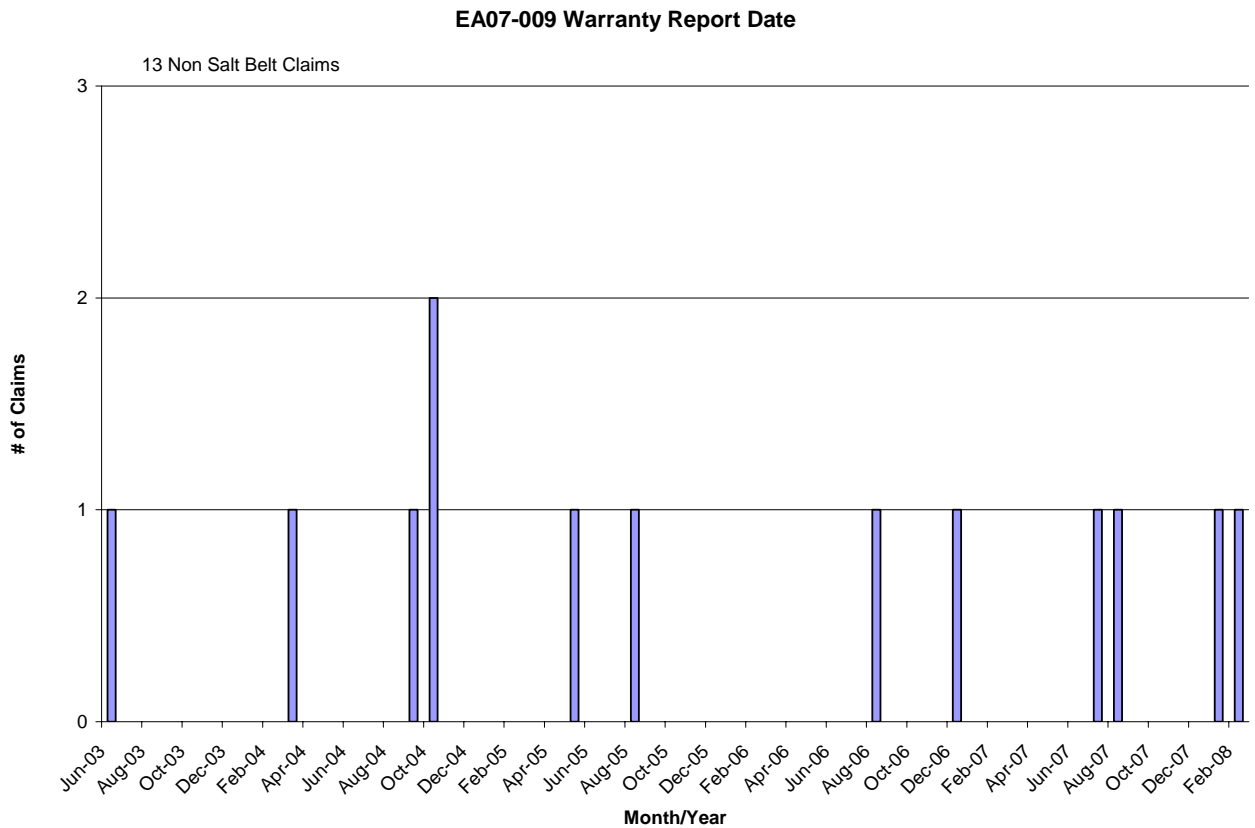
Figure 5: Warranty Claims Non Salt Belt by Report Date

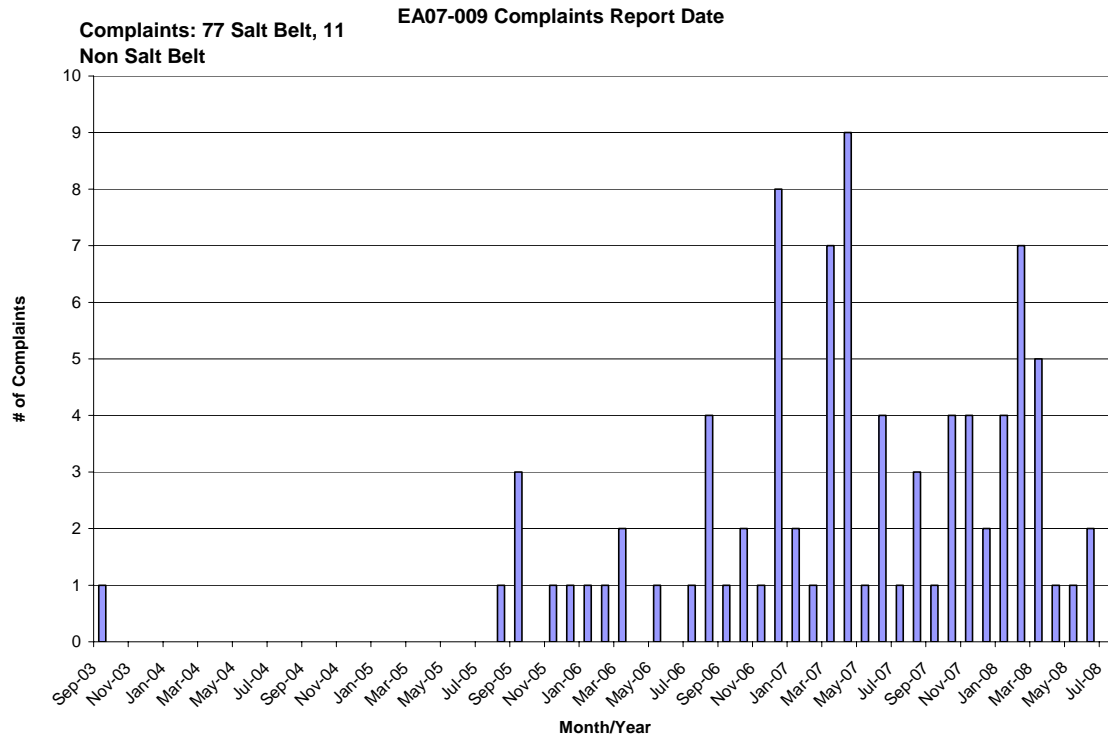
As shown in Figure 6, the majority of the complaints were reported between September 2006 and July 2008, the last month of data used in this report. The trend in complaints appears to be increasing. There are no indications from the data given to ODI that the increasing complaint trend is likely to reverse, especially since the underlying mechanism, corrosion, is a time dependent condition.

Figure 6: Reports by Month
