## ODI RESUME

Investigation: EA07-016

Subject: Overheating Disc Brake Caliper

## ENGINEERING ANALYSIS CLOSING REPORT

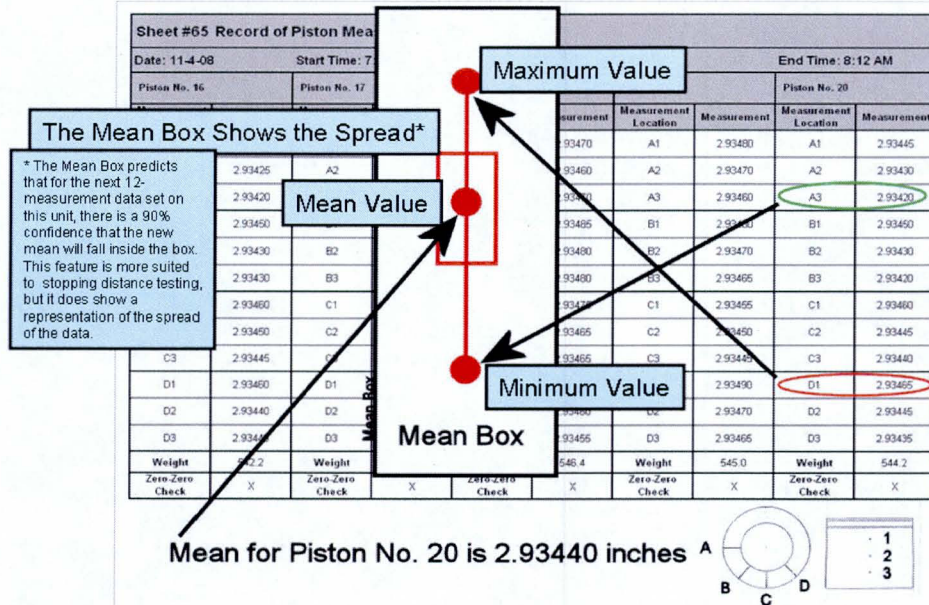
**Figure 5 – The Mean-Box Plot Icon Shows the Max, Min, and Mean of the 12 Diameters Measured on Each Piston**

**VRTC-TESTING:** Phenolic pistons in calipers returned from the field were found to be oversized. Factory records indicated the pistons had originally been manufactured within the required specifications. One theory for the identified out-of-spec condition was water absorption by the phenolic piston on these lightly used RVs. VRTC focused their testing efforts to determine the extent of piston diameter increase due to “water swell.” A test was designed to attempt to accelerate the phenolic piston swell observed to occur over a two or three year period of “low usage.” A steadily increasing diameter during bench testing would confirm the water swell theory and allow appropriate remedies to be evaluated by the manufacturers. Each piston was measured at 12 different diameter positions. The data sheet, with 12 measurements, was assembled into a mean-box-plot icon, as shown in Figure 5. This testing was designed to accelerate water absorption in the phenolic matrix by exposing the pistons to a pressure range of +/-7 psig, a temperature range of 40 to 170°F, and a humidity of between 50 and 100%. The ZOHT pistons were compared to peer phenolic and steel pistons. All of the phenolic pistons, including the ZOHT pistons, continued to grow at a steady rate throughout the entire test period, as shown in Figure 6. If these pistons (now oversized due to test induced “water swell”) were installed in a caliper on a vehicle that was driven in “heavy traffic” stop-and-go driving, the pistons likely would not retract after the driver released the brake pedal due to inadequate clearance between the (oversized) piston and the caliper bore. The steel pistons varied little, as shown in Figure 7. The piston weights showed the same trend, as can be seen in more detail in the PowerPoint<sup>5</sup> summary of this testing located at the ODI website.

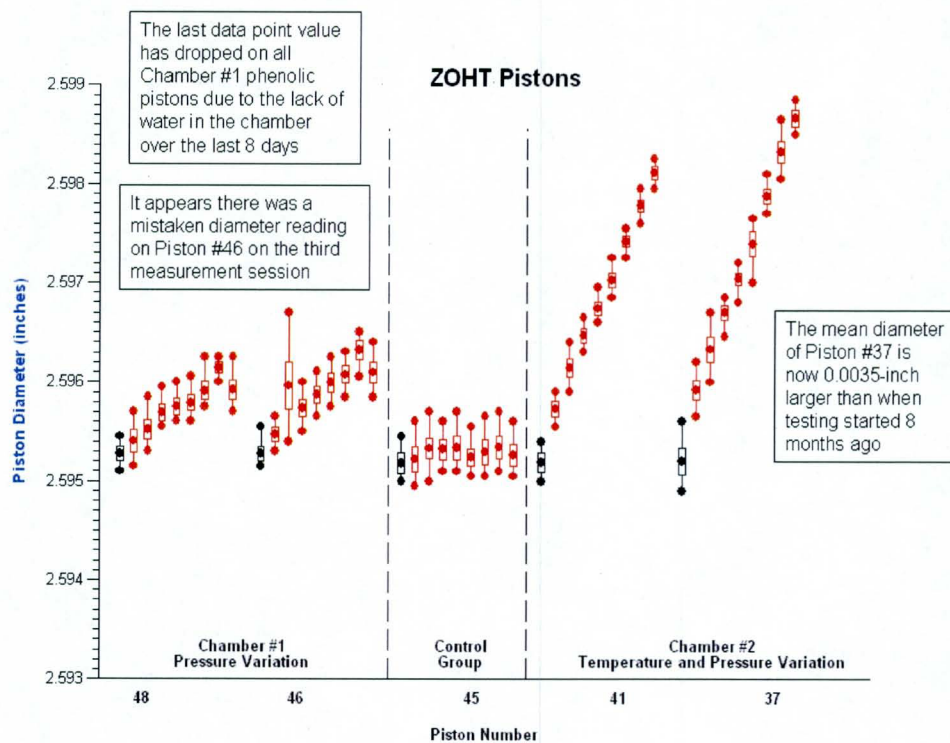
**Figure 6 – The ZOHT Pistons Increased in Diameter, Especially in Chamber #2 with the Temperature Cycles**

Bench testing at VRTC verified that the phenolic pistons could absorb moisture, swell in diameter and create an interference fit in the caliper bore during the heat shock of stop-and-go driving. The ZOHT pistons grew up to 0.0035-in in diameter during the eight month accelerated testing, similar to pistons that had been sitting unused for three years. According to relevant WCC warranty and complaint data and ODI's VOQ data, this interference can result in fire, burn, smoke, brake drag and boiling brake fluid. The first three conditions can result in decreased braking performance and the last condition (boiling brake fluid), a total loss of braking on a subject vehicle.

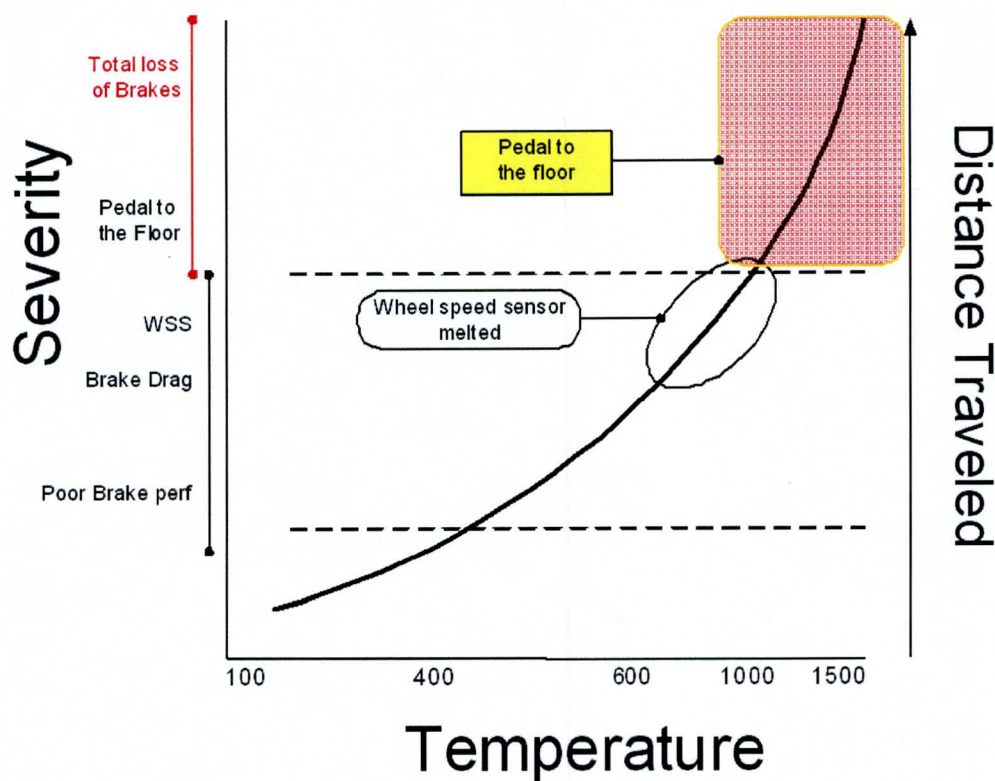
**Figure 8 - Failure Mode Progression**

**FAILURE MODE:** The water swell of the phenolic piston occurs when a vehicle is operated only occasionally and driven in a “stop-and-go” environment, such as heavy traffic in a city. In these conditions, the phenolic pistons absorb water and their diameter increases and creates an inadequate clearance between the phenolic piston and caliper bore only during stop-and-go driving, preventing the piston from retracting after a brake application until the brakes cool. Typically, the heat of routine driving removes moisture that may have been absorbed by the phenolic piston (other medium duty trucks equipped with this brake system typically are driven daily). However the RV vehicles typically sit for months at a time between uses. As a result, the pistons on the subject vehicles retain moisture and eventually grow large enough to interfere with the bore. Generally, the wheel end equipped with a caliper piston experiencing sufficient water swell will experience brake drag, smoking, melting of the ABS sensor, a possible wheel end fire and potential brake fluid boil (Figure 8). The final and most severe failure mode is when the brake fluid boils and the brake pedal goes “to the floor.” ODI has conducted owner interviews during which the consumers stated that when the brake pedal went to the floor they could not stop the vehicle. Some reported that they ran through stop signs and red lights. In some cases, consumers stated that they had to make aggressive steering maneuvers to avoid pedestrians and other vehicles while trying to stop their vehicle.
