# ODI RESUME

Investigation: EA07-019  
 Prompted by: PE07-044  
 Date Opened: 12/11/2007  
 Principal Investigator: John Abbott  
 Subject: Power Sliding Door  
 Date Closed: 02/23/2009

Manufacturer: General Motors Corporation  
 Products: Model Year 2005-2007 General Motors Mini Vans  
 Population: 187,937

Problem Description: Power sliding door opening while vehicle is in motion

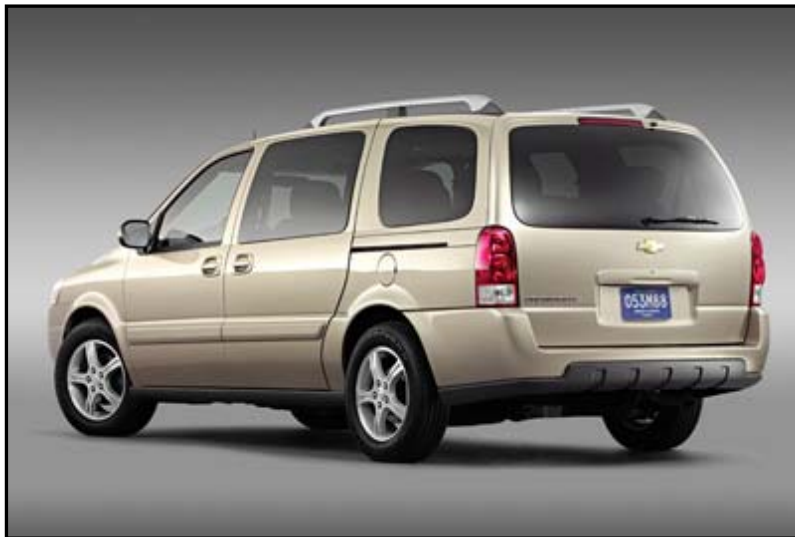
Photo 1 MY 2006 Chevrolet Uplander

**SUBJECT VEHICLES:** The subject vehicles included in this investigation are GM minivans produced for model years (MY) 2005 through 2007. The vehicles are equipped with a PSD on the driver's side, or the passenger's side, or both. Table 1 identifies the subject vehicles by make/model, model year, and vehicle production. For reference, Photo 1 is a MY 2006 Uplander.

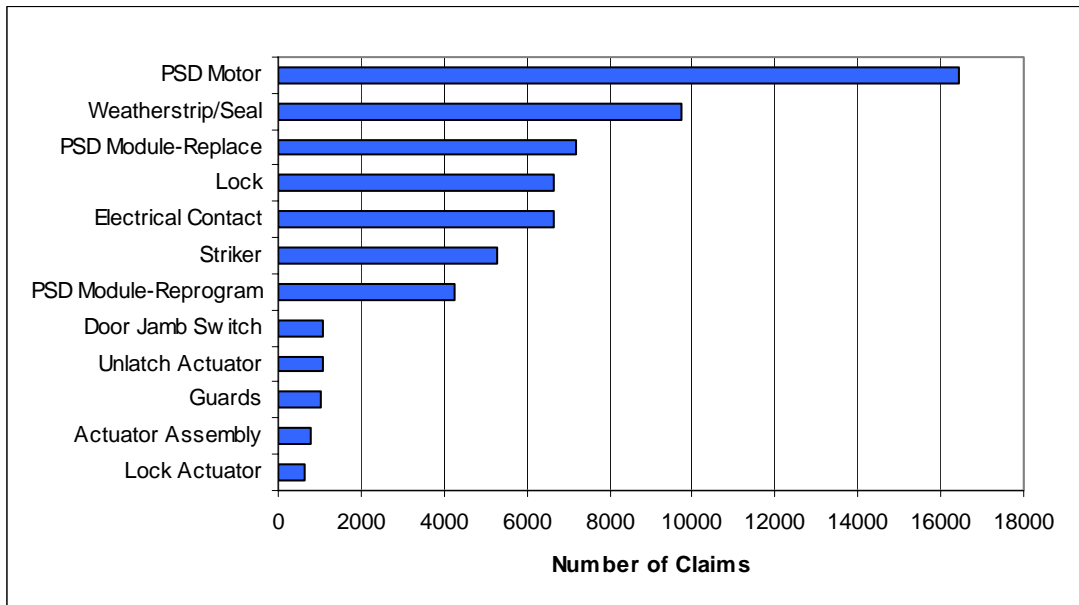
**Figure 1. Repaired Component Using Warranty Labor Codes**

GM's warranty submissions provided labor codes which identify the component replaced or repaired. By using the labor codes listed for the 60,799 warranty claims, ODI determined the number of PSD related components replaced or repaired (see Figure 1). The data show that the PSD motor was replaced most often. However, ODI does not believe that a failure or malfunction of the motor would cause or contribute to the alleged defect condition. Various other components were also replaced.

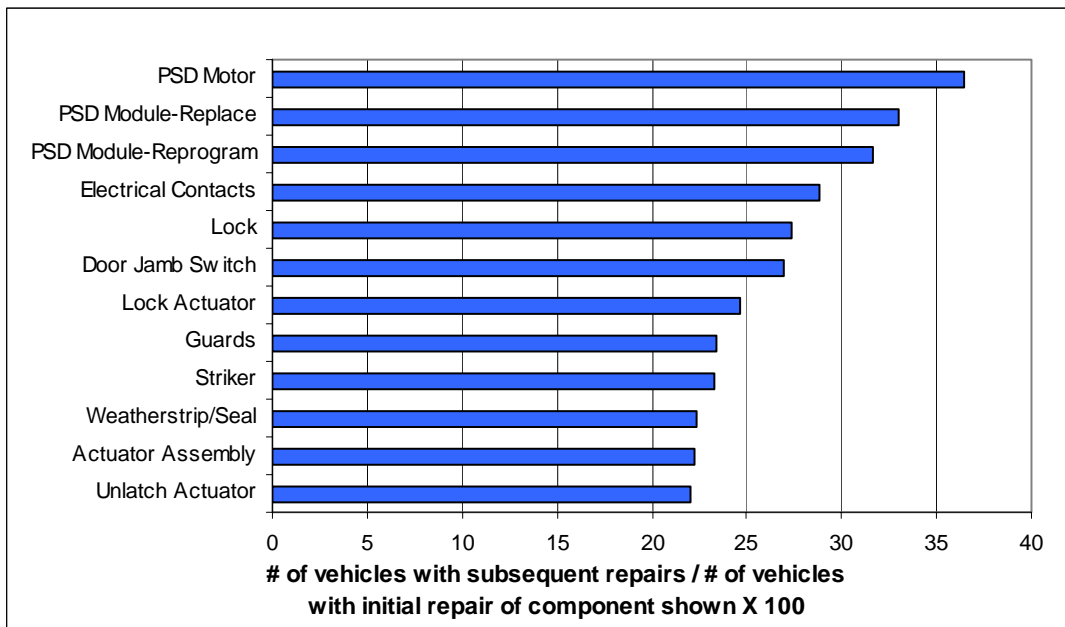
**Figure 2. Subsequent Repair Rate**

Approximately 38,000 warranty repaired vehicles had a single component replaced or repaired on the initial visit and approximately 11,000 of these vehicles had subsequent repairs. Using this data, ODI determined the rate of subsequent repairs by component (see Figure 2, on page 7). This means, for example, 36 percent of vehicles with an initial PSD motor replacement had subsequent repairs.

The subsequent repair rates range from 22 to 36 percent with the PSD motor and module repairs having the highest rates (32-36 percent). The repairs of the unlatch actuator, actuator assembly and weather-strip/seal have the lowest rates (all at 22 percent) and may be more effective remedies than other repairs.
