ENGINEERING ANALYSIS CLOSING REPORT

SUBJECT: Alleged non-crash fire originating in the engine compartment that may be related to oil leakage from the front valve cover gasket.

INVESTIGATION: EA07-008

SUBJECT VEHICLES: Model year (MY) 1999 through 2002 Buick Park Avenue, Regal, and Riviera; Oldsmobile LSS; and Pontiac Bonneville and Grand Prix vehicles that use the same or substantially similar transverse mounted “L67” supercharged version of the General Motors Corp. (GM) 3800 Series II V6 engine.

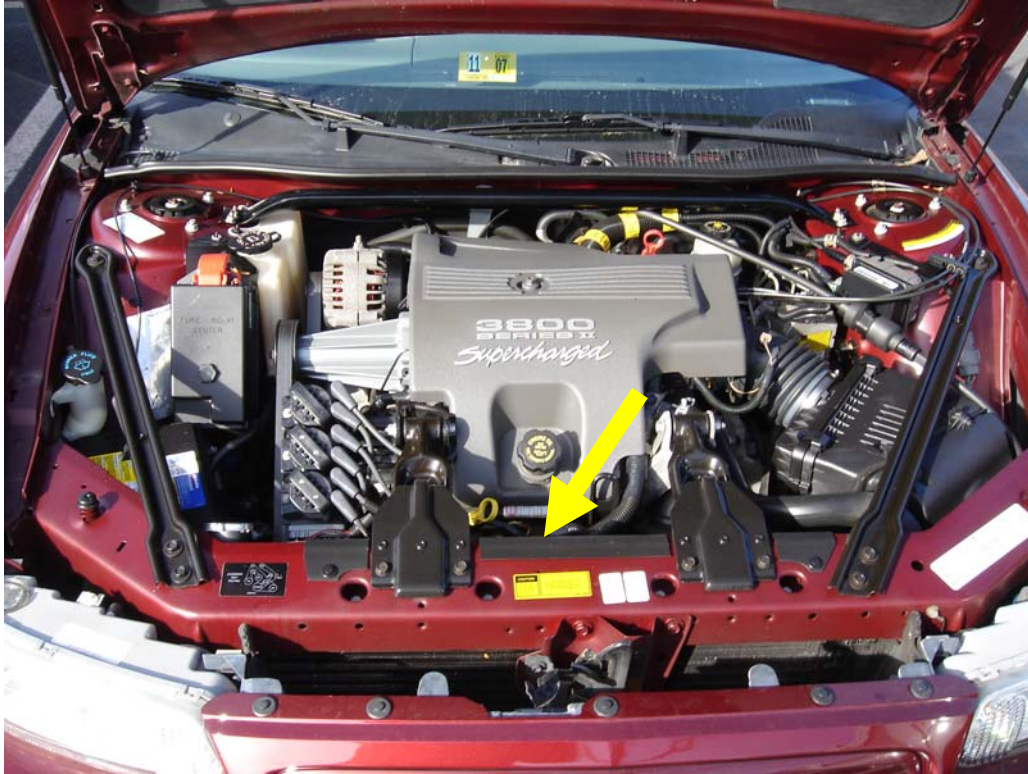
DESCRIPTION OF COMPONENT OR VEHICLE SYSTEM: The subject vehicles are equipped with a gasoline-fueled internal combustion V6 engine mounted transversely in the front of the vehicle ahead of the passenger compartment. The “L67” engine is equipped with a belt-driven supercharger that is capable of forcing air into the engine intake manifold at above atmospheric pressures. The supercharger is largely responsible for the increased power output of the “L67” engine over the naturally aspirated “L36” engine that it’s based on. The “L67” engine in the subject vehicles is mated to an automatic, planetary type gearbox that transmits power to the front wheels. See Figure 1 (below) for a pictorial description of an exemplar subject vehicle engine compartment.

Figure 1: Exemplar Vehicle (yellow arrow shows subject fire area of origin)

THE ALLEGED DEFECT: The alleged defect is any non-crash fire originating in the engine compartment that may be related to oil leakage from the front valve cover gasket. Initially, ODI considered all non-crash related engine compartment fires to determine what defect trend(s), if any, might exist. After gathering and analyzing additional information, it became apparent that the strongest fire trend was ignition key-off events first discovered approximately 5 to 15 minutes after the vehicle had been driven and then parked. A pattern began to emerge that indicated many fires originated in the center portion of the engine compartment near the exhaust manifold for the front cylinder bank (cylinders 1-3-5).

FAILURE MECHANISM: Engine oil may escape past the valve cover gasket on the front cylinder bank (cylinders 1-3-5) and deposit onto hot exhaust system components. Under certain conditions, it is possible for this oil to ignite a small pilot flame, which may spread to the adjacent plastic spark plug wire channel, the spark plug wires themselves, the plastic engine cover, and other under hood components. Reports indicate this most often occurs on higher-mileage vehicles shortly after the vehicle has been driven and then parked. Typically, the fire was discovered within 5 to 15 minutes after the vehicle was parked. During this time window, under hood temperatures may become elevated. Such elevated temperatures combined with a lack of airflow through the engine compartment may permit a small pilot flame to propagate and ignite other fuel sources.

To correct the safety defect, GM will install an improved design front valve cover gasket and spark plug wire retainer. The new front valve cover gasket has a higher initial sealing pressure and improved compression set characteristics for greater longevity. This remedy is available free of charge for all recalled vehicles. Until sufficient parts become available to repair all of the affected vehicles, GM strongly recommends that owners observe the following important precautions: (1) they strongly recommend that owners do not park their vehicle in a garage, carport, or other structure; (2) if owners notice a burning odor, they should have their dealer inspect the vehicle - the dealer will inspect the vehicle without charge; and (3) use premium fuel (91 octane or higher) in the vehicle as recommended in the vehicle's owner manual.
