# ODI RESUME

Investigation: EA07-011  
 Prompted By: PE07-022  
 Date Opened: 08/14/2007  
 Principal Investigator: Derek Rinehardt  
 Subject: Engine Compartment Fire  
 Date Closed: 08/13/08

Manufacturer: BMW of North America, LLC. Bayerische Motoren Werke  
 Products: MY 2002 – 2003 Mini Cooper  
 Population: 50,000

**ENGINEERING ANALYSIS CLOSING REPORT**

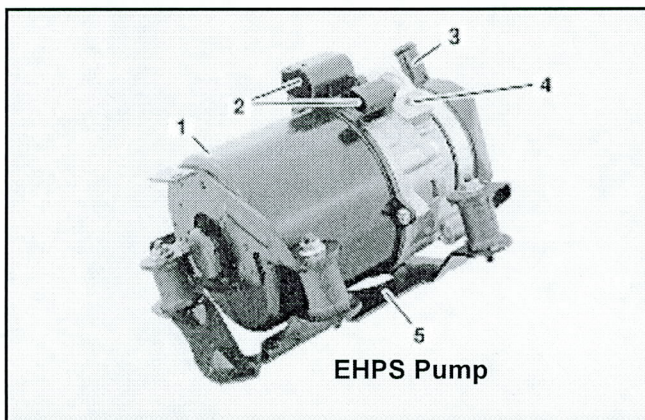
FIGURE 1

The EHPS provides a means to supply the driver with power assisted steering. The EHPS in the subject vehicles is primarily composed of an electro-hydraulic pump (see Figure 1), an auxiliary cooling electric fan (see Figure 2) and the associated wiring. The electric motor replaces the customary design whereby the hydraulic pump is driven by the engine via an ancillary belt. The EHPS is designed to save engine power, provide a reduction in fuel consumption, and requires less maintenance than customary belt driven systems.

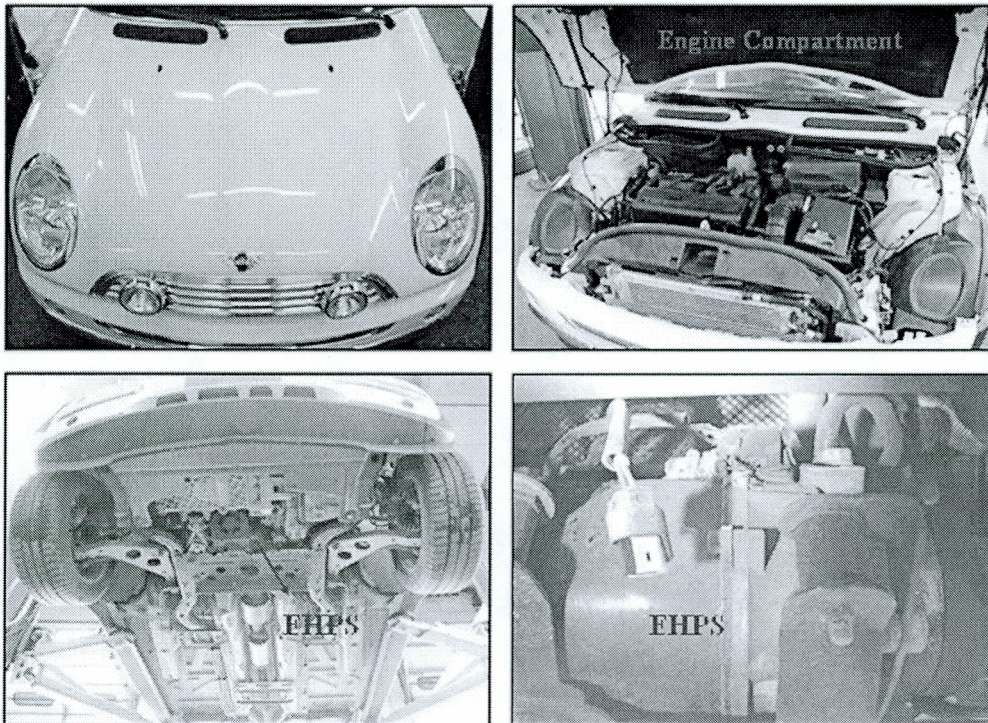
FIGURE 3

Figures 3 through 5 below represent a sample of the pictures provided to ODI by BMW during the PE and the EA. All of the pictures were taken after the vehicles were alleged to have been involved in a fire due to EHPS failure. The pictures below show overheating of the wiring and the wiring connection to the EHPS. The pictures show minimal damage to components surrounding the EHPS and minimal damage to the vehicles as a whole.

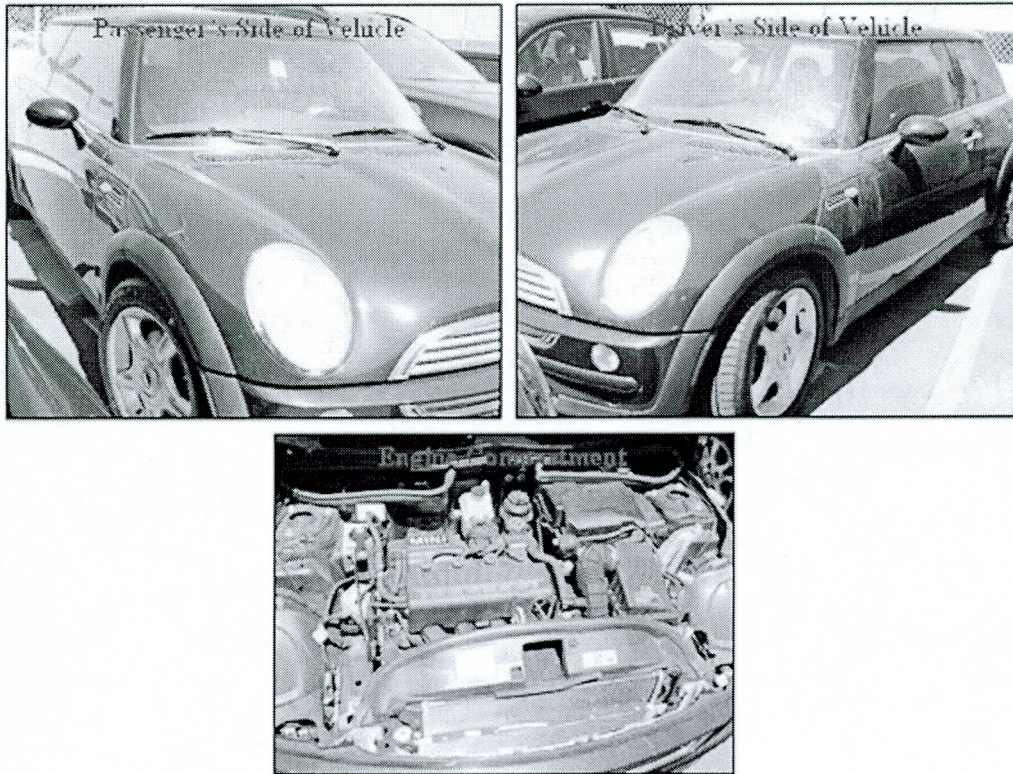
FIGURE 6

During the PE and the EA, 9 consumers submitted complaints to ODI alleging a fire due to failure of the EHPS system. Five of these complainants alleged they witnessed small flames originating in the engine compartment. Two of these of complainants provided pictures of the vehicles after the alleged fires occurred (see Figure 6 and Figure 7). In both cases, there was minimal damage to the vehicles beyond the EHPS system. Four of the 5 vehicles where the complainants allege witnessing flames in the engine compartment, were repaired by replacing the EHPS system and the associated wiring. In addition to damage to the EHPS system and wiring, the fifth vehicle was alleged to have experience damage to the battery as a result of the EHPS failure. None of the complainants allege vehicle damage beyond these components.

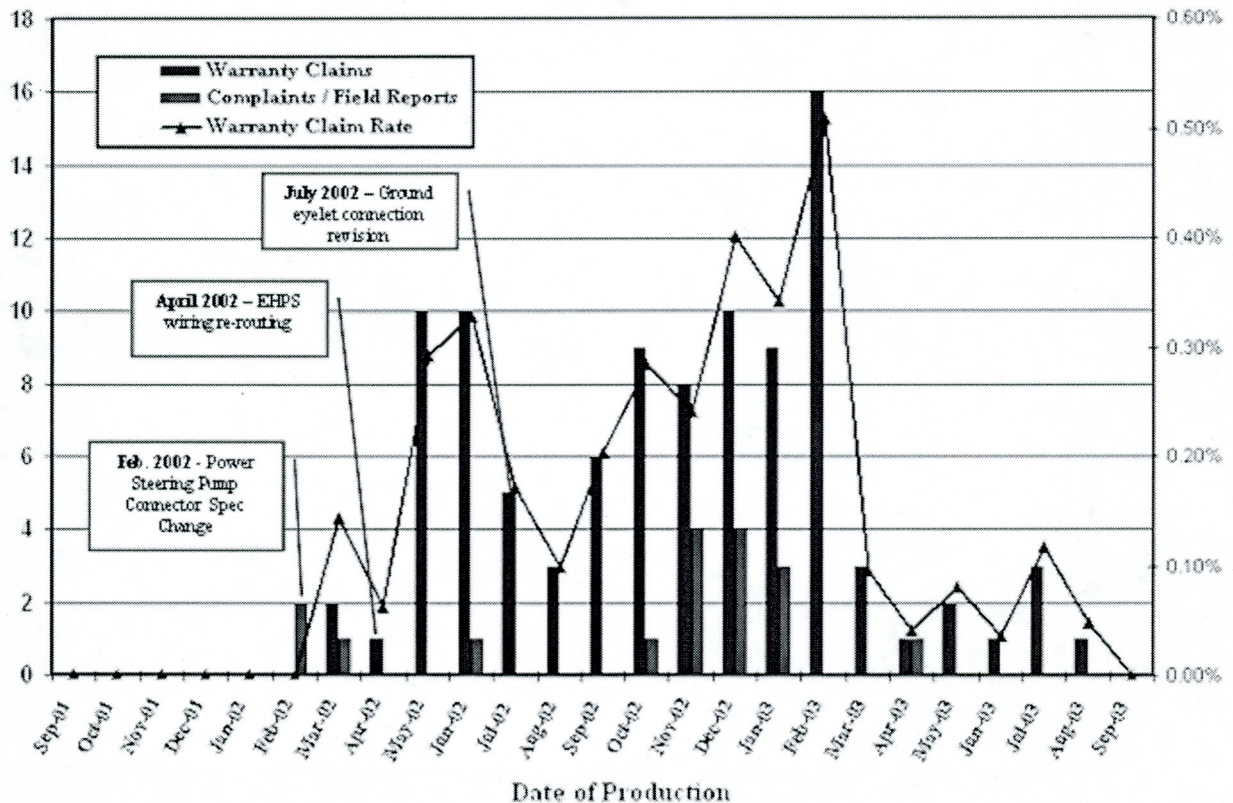
ODI's analysis of warranty and complaint data provided by BMW indicates that approximately 74% of the vehicles warranty claim and 75% of the consumer complaints had manufacture dates after all the design changes that are potentially related to the alleged defect were incorporated in vehicle production. Based on field experience data and production data provided to ODI, there is an increasing warranty claim rate trend after the final design revision (July 2002) was incorporated into production until March of 2003 as represented in Chart 1 below. BMW stated that its wiring supplier's ground eyelet revision process (introduced in July of 2002) was unstable until February of 2003. Between February of 2003 and March of 2003 (and in subsequent production months) there is a drastic decline in the warranty claim rate and number of consumer complaints. Although based on the data, the design / process revisions initially appear to be largely effective in reducing consumer complaints and warranty claims; ODI has not been unable to determine that the failures have presented an unreasonable risk to motor vehicle safety. As shown in Figures 3 through 7 above, the vehicles exhibited minimal.
