Subject: FINAL REPORT: "2007 Lexus ES-350 Unintended  
Acceleration"

**VRTC MEMORANDUM REPORT EA07-010**  
**VRTC-DCD-7113**

**2007 Lexus ES-350 Unintended Acceleration**

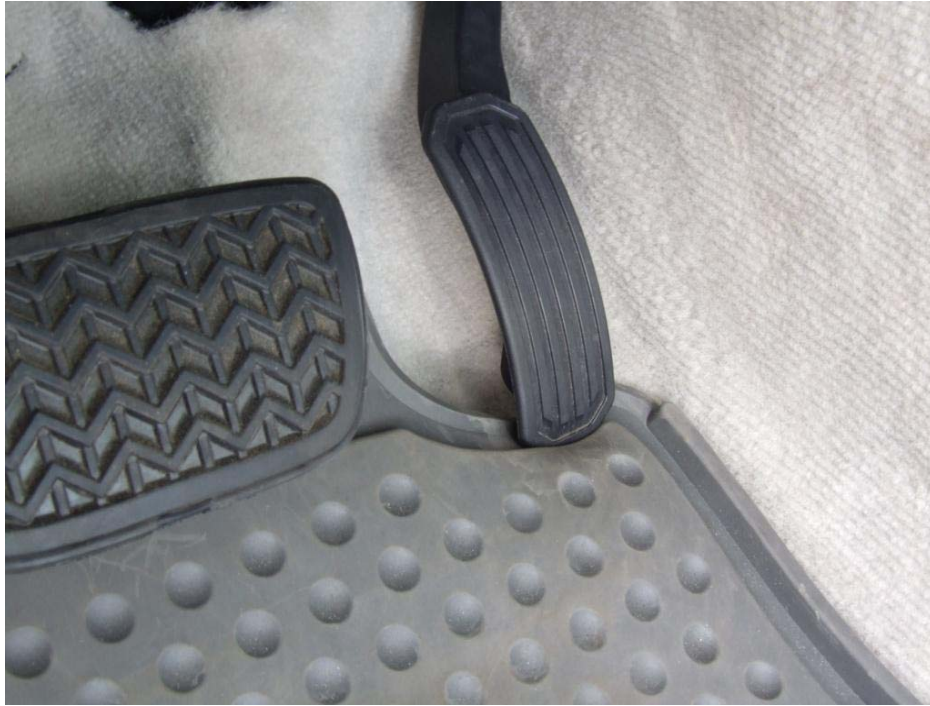
pedal revealed that the one-piece, non-articulating accelerator pedal assembly was easily entrapped in the groove of the rubber all-weather floor mat (Figures 2 and 3) if the rubber mat was not properly secured with at least one of the two retaining hooks (Figure 4). In many observed ES-350's, the rubber mats were stacked on top of the existing carpeted floor mats, which prevented attachment of the rubber mats and facilitated the interference failure mode. A warning is embossed on the front of the floor mat that reads "Do not place on top of existing floor mats". Very few owners interviewed were able to find or read this warning (see Figure 5).

- Mechanical interferences at the accelerator pedal revealed that the accelerator pedal assembly was easily entrapped in the groove of the rubber all-weather floor mat if the rubber mat was not properly secured with at least one of the two retaining hooks.

**Figure 3 – Accelerator Pedal Trapped at Full Throttle by Unsecured Rubber Floor Mat**
