**National Highway
Traffic Safety
Administration**

Memorandum

Subject: Consumer Interview and Vehicle Inspection **Date:** 8/30/2007
Vehicle Owner Questionnaire (VOQ) ODI 10189655

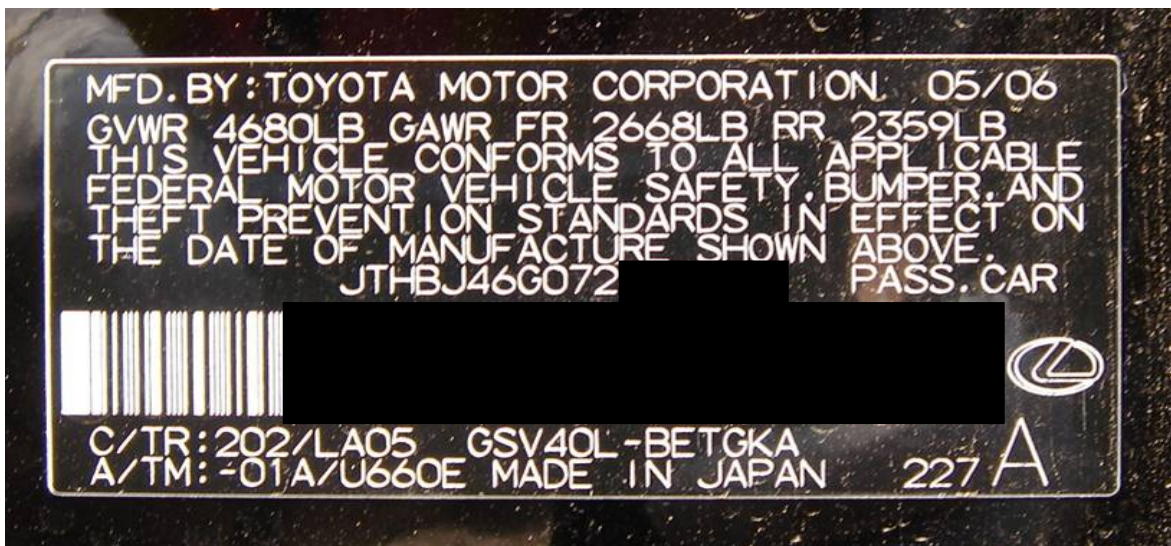
The VIN was recorded as JTHBJ46G072[REDACTED], the date of manufacture as 05/06, and the point of manufacture as Japan (photo 1). The vehicle has been located at the current facility for an unknown length of time; it is fully disabled, has significant collision damage to the front end, and has suffered an engine compartment fire; the fire breached the windshield. The insurance agent who filed the VOQ report advised that the vehicle is a total loss.

Photo 1: Certification label, driver side door jam (redacted)

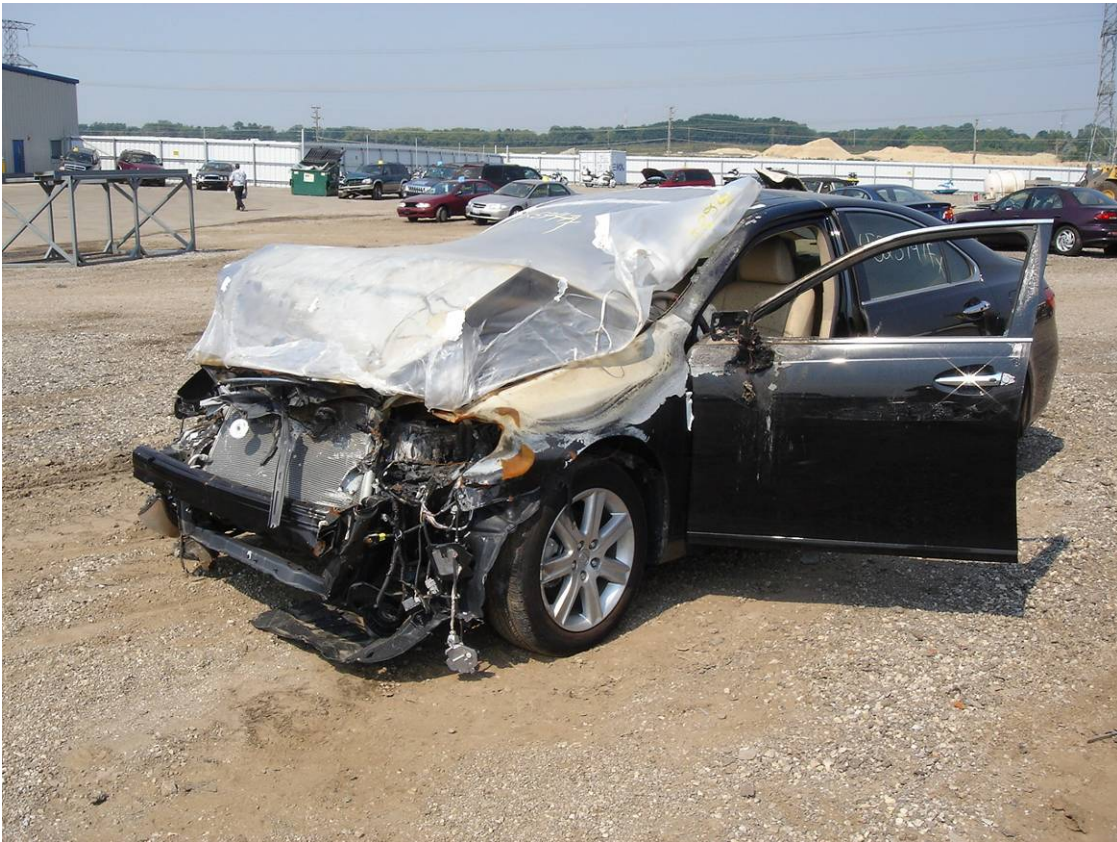
With the exception of the damage related to the collision, fire, and the subsequent storage and protection, the vehicle's condition is consistent with the estimated vehicle mileage indicated on the VOQ. The fire origination appears to be in the engine compartment; causation was not evident however portions of the fuel system were damaged. The fire consumed most of the

engine compartment combustibles and damaged the windshield, driver glass, and other interior and exterior components. See photos 2 to 5.

Photo 2: Front oblique view of vehicle showing collision and fire damage

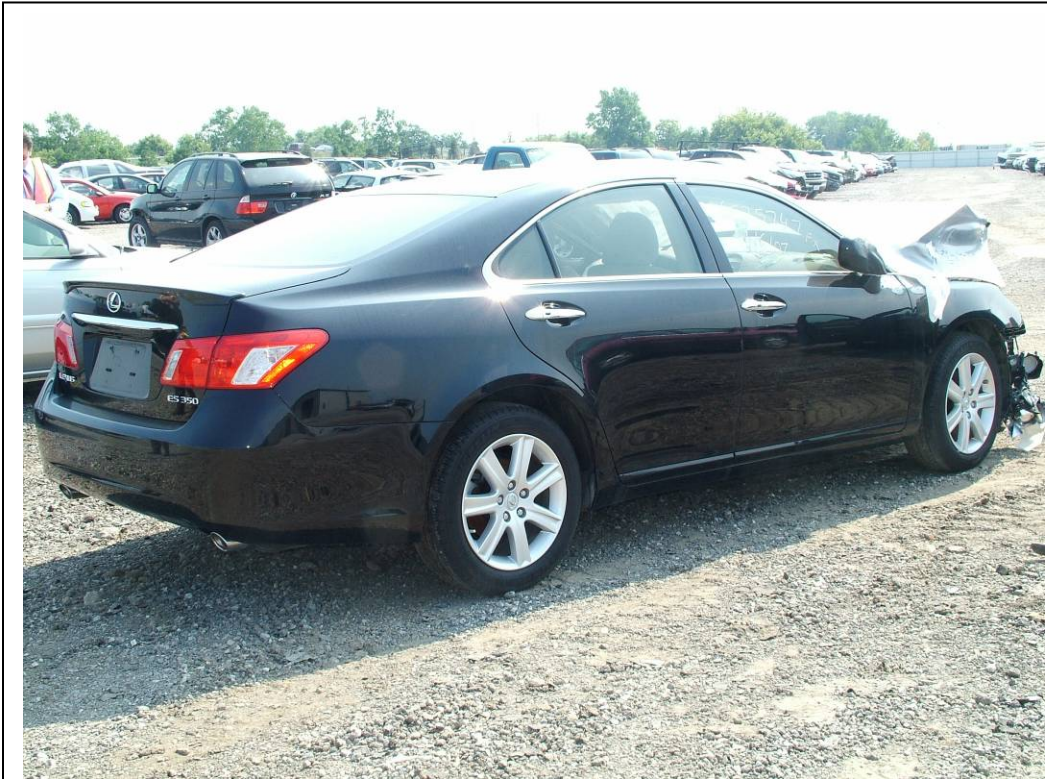
Photo 3: Rear oblique view of vehicle.

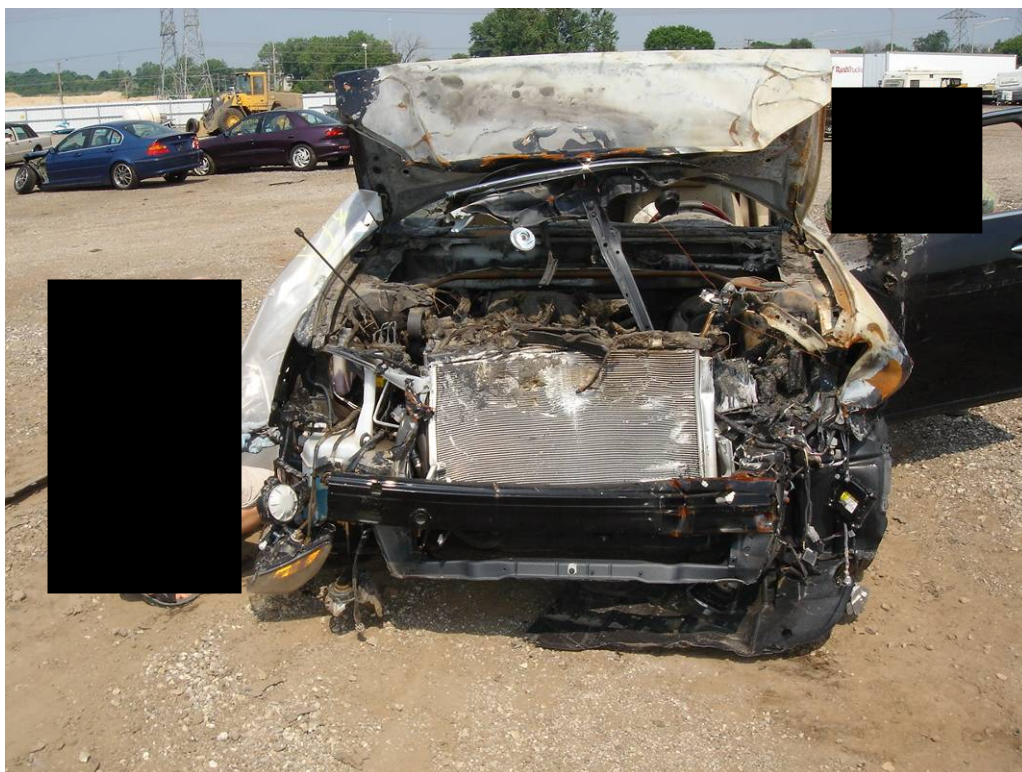
Photo 4: Front view, hood open, fire damage in engine compartment (redacted)

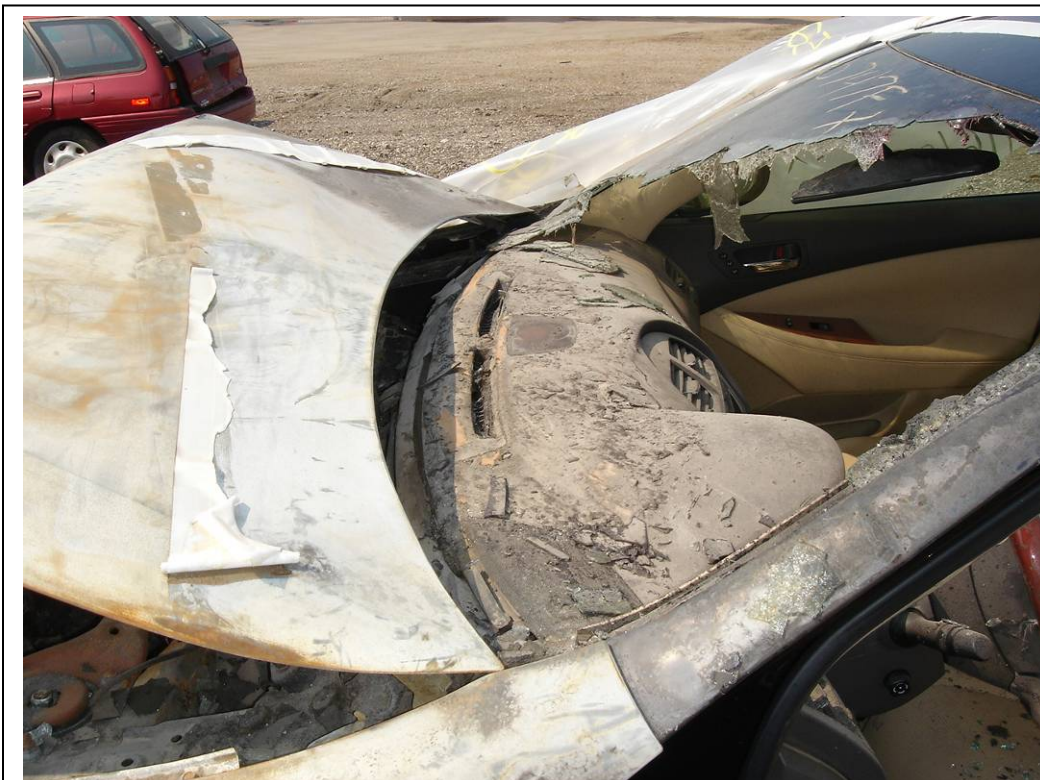
Photo 5: Fire damage to front windshield and dash panel

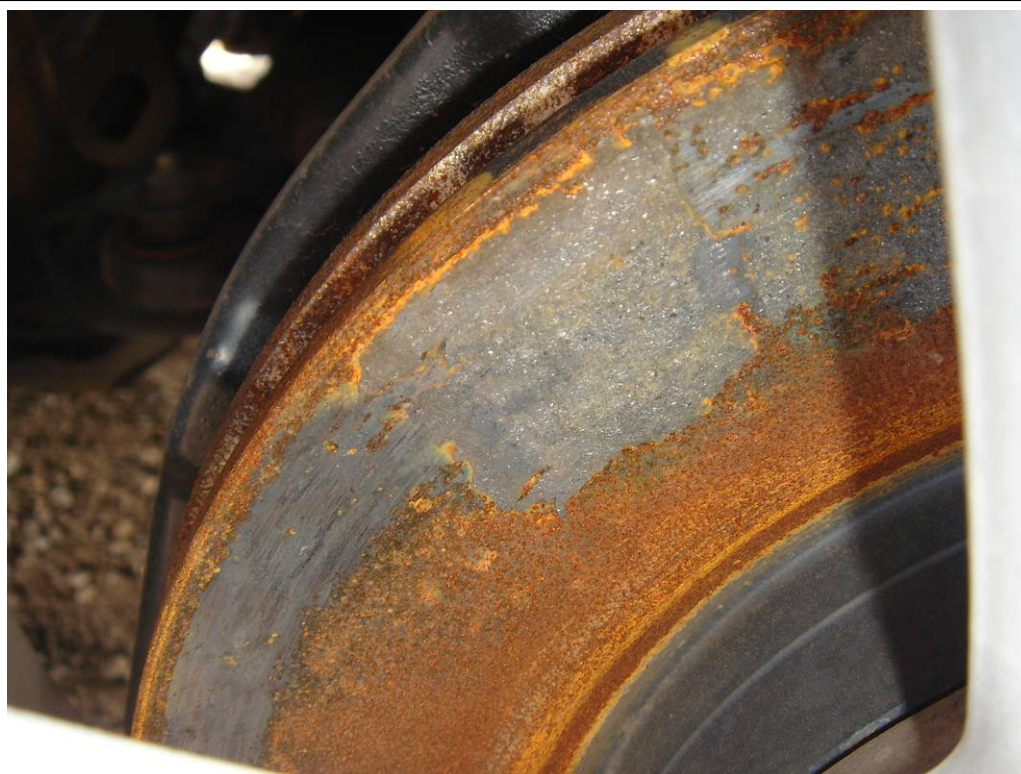
Discoloration, rust and surface damage to the brake rotors is visible through all four wheel apertures. The LHF and LHR brake calipers were removed and the brake components inspected. The components displayed significant damage due to overheating. The damage is consistent with the driver's statement that she was attempting to stop the vehicle while it was moving at high speed for a significant distance. See photos 6 to 10.

Photo 6: RHF rotor surface as viewed through the wheel aperture

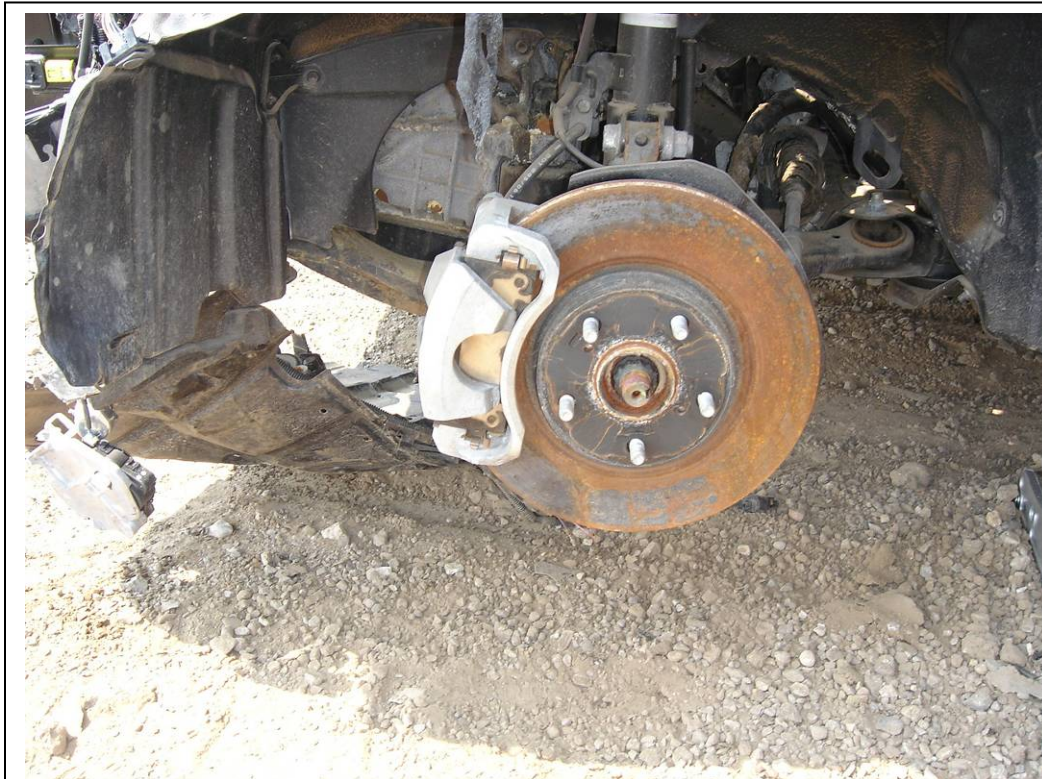
Photo 7: LHF brake assembly, wheel removed

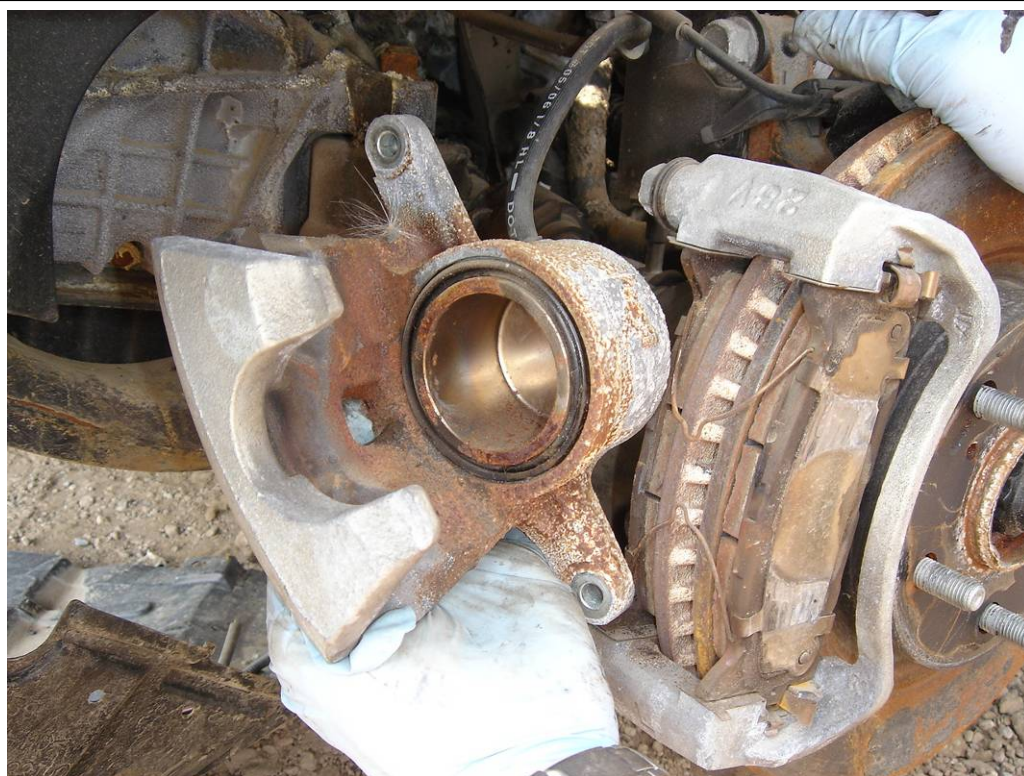
Photo 8: LHF brake hardware, caliper removed

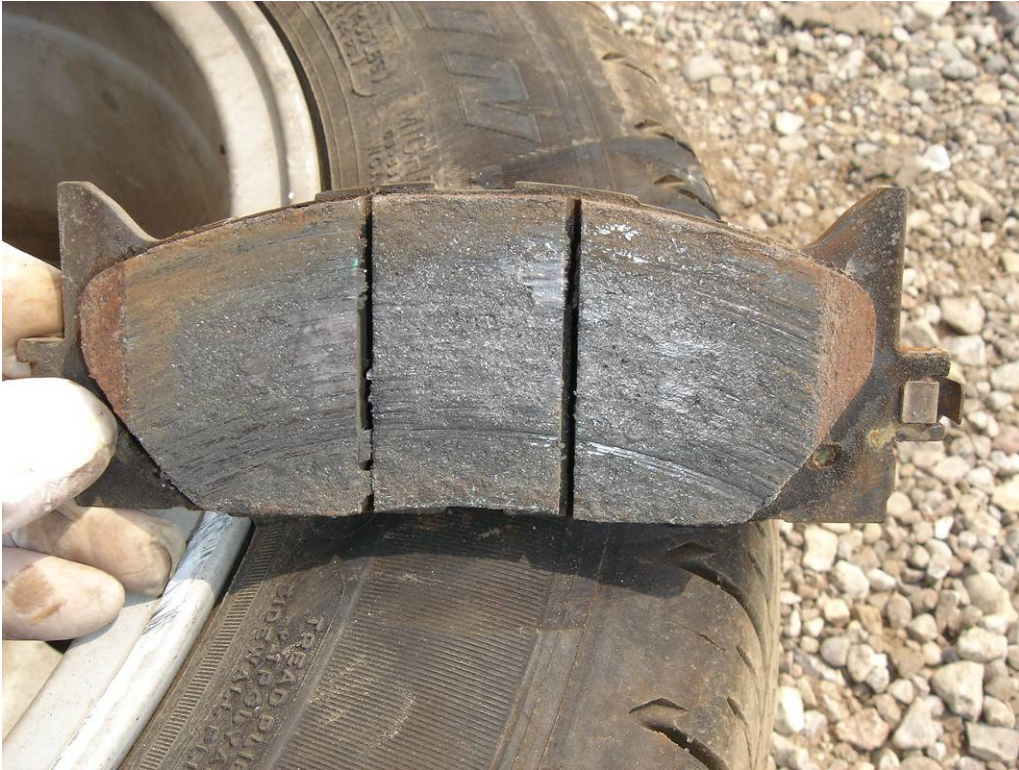
Photo 9: LHF disc brake pad, friction surface/rotor side

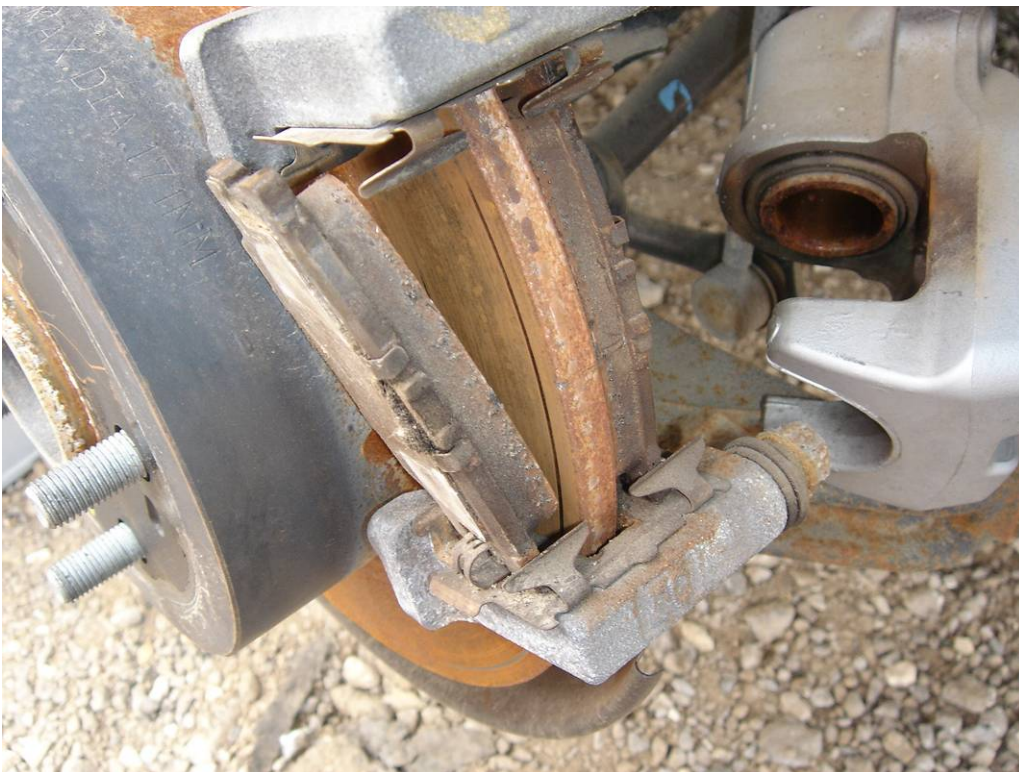
Photo 10: LHR disc brake hardware, caliper removed

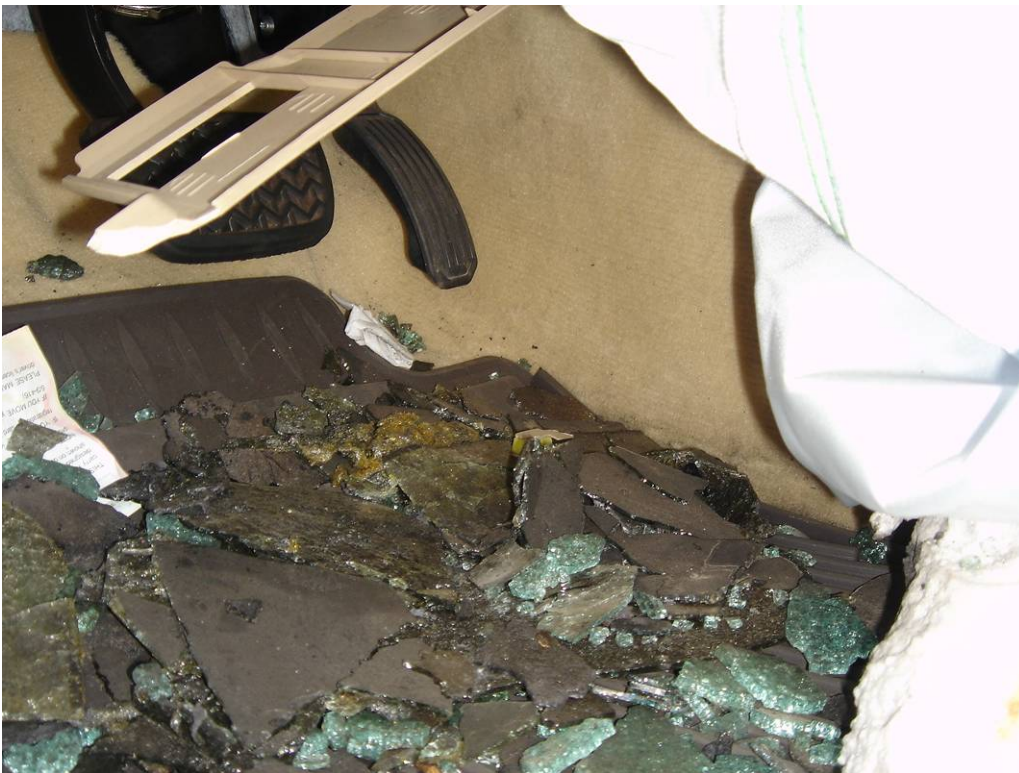
The vehicle interior condition is consistent with the estimated vehicle mileage. All weather mats are installed at all four seating positions. The driver side all weather mat was found to be installed by itself; it was not on top of another floor mat. The installed mat was found to be unsecured by the retention hooks; the mat did not interfere with the accelerator pedal in the position it was originally inspected. The mat was removed from the vehicle. The two retention hooks were found engaged in the flooring material after the mat was removed⁵. The hooks were intact and did not appear to be damaged from the collision. See photos 11 to 16.

Photo 11: Driver side floor board as inspected, all weather mat installed

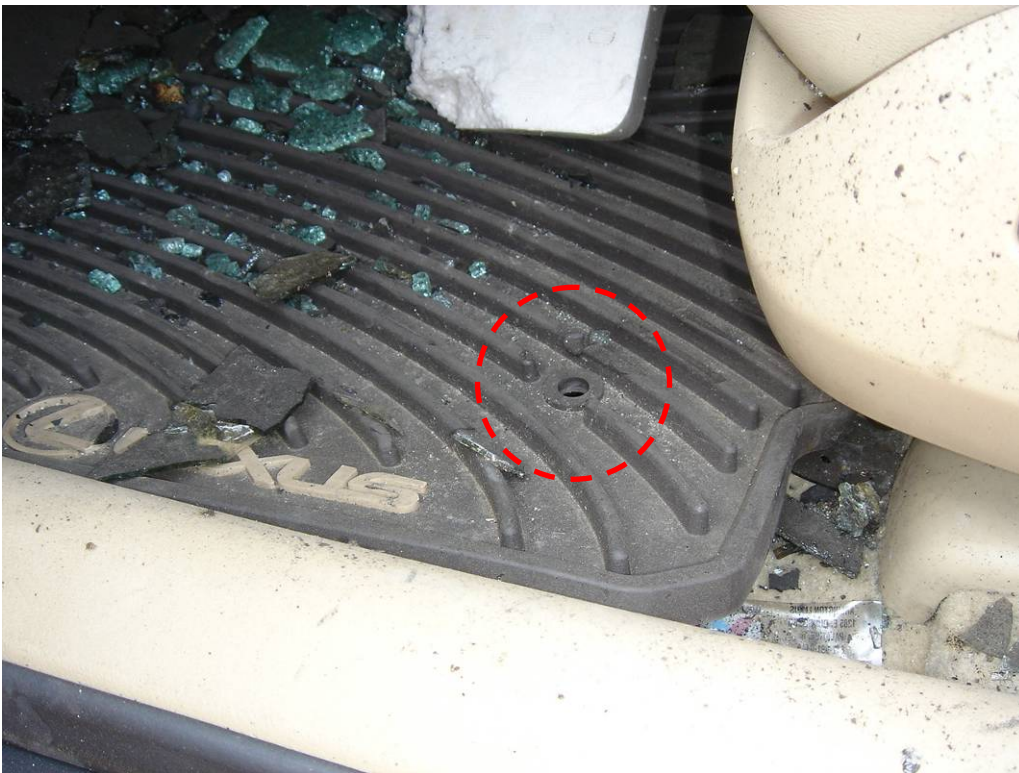
Photo 12: Drivers outboard mat retention hole without retaining hook engaged

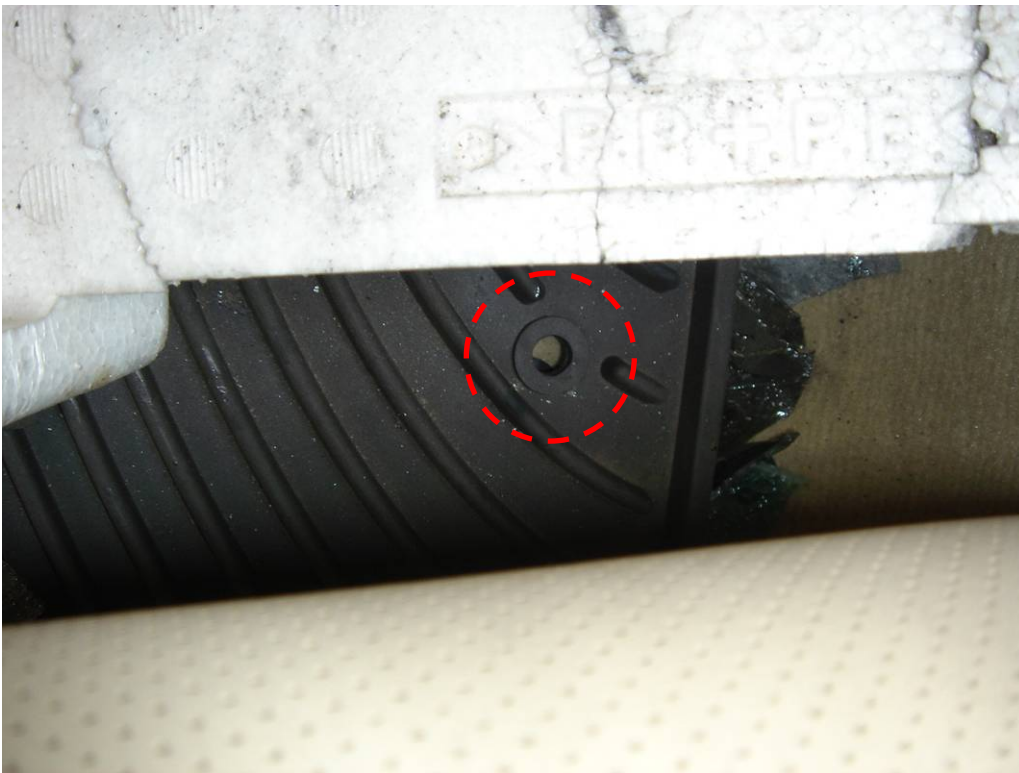
Photo 13: Driver inboard mat retention hole without retaining hook engaged

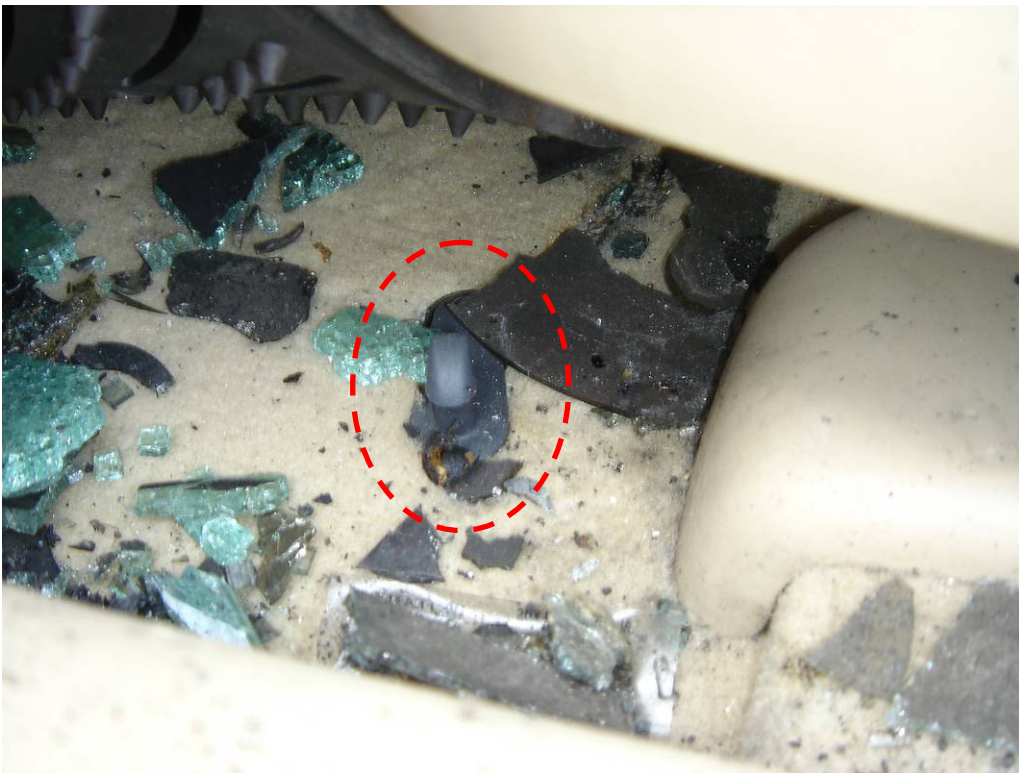
Photo 14: Driver outboard hook engaged in flooring, carpet mat not installed

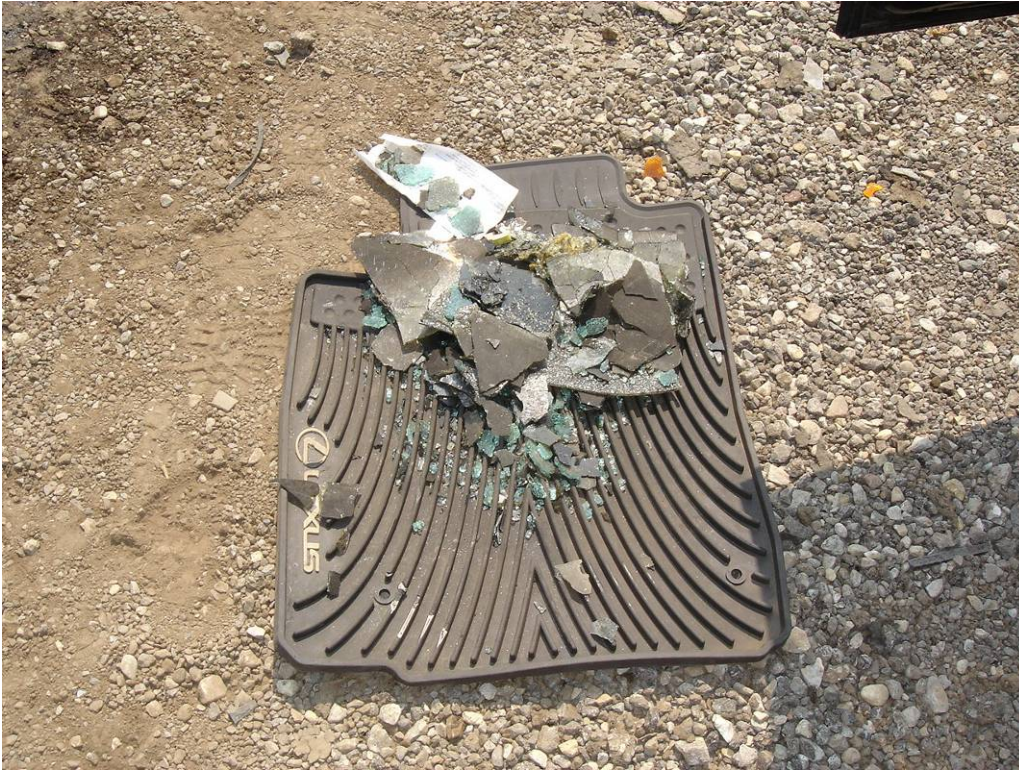
Photo 15: Driver all weather mat removed from vehicle

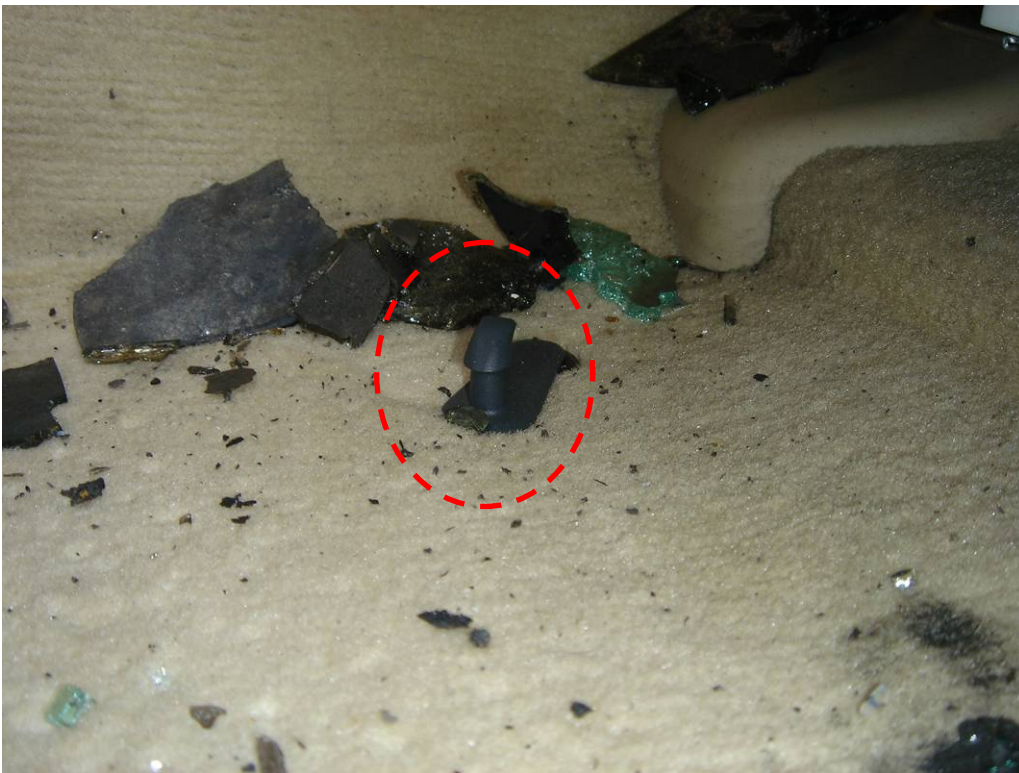
Photo 16: Driver inboard mat retention hook engaged in floor material
