**National Highway  
Traffic Safety  
Administration**

# Memorandum

Subject: Complainant Interview, Vehicle and Site Inspection      Date: 10/10/2007  
Vehicle Owner Questionnaires (VOQs) ODI 10174732 and 10176450

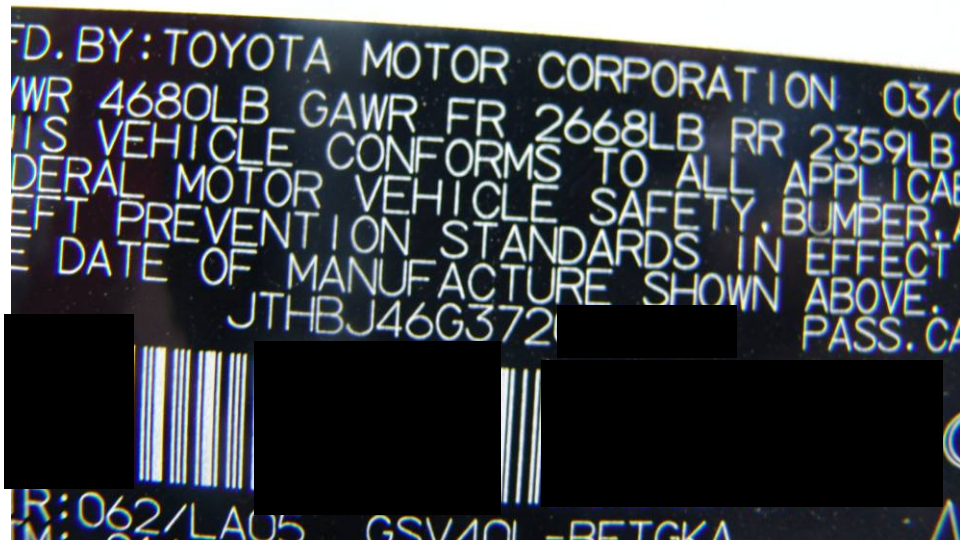
Photo 1: Certification label, driver side door jam

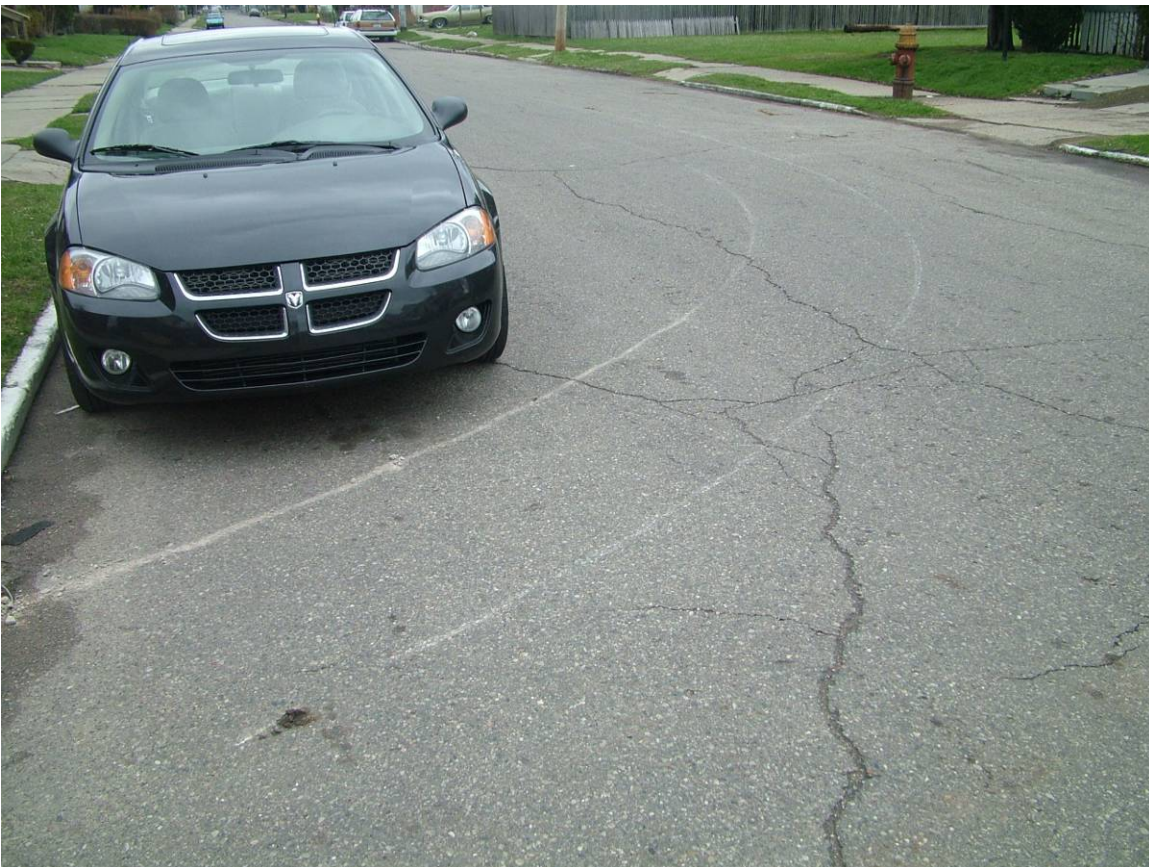
Photo 2: Drag marks on pavement from location where SV was stored and removed from.

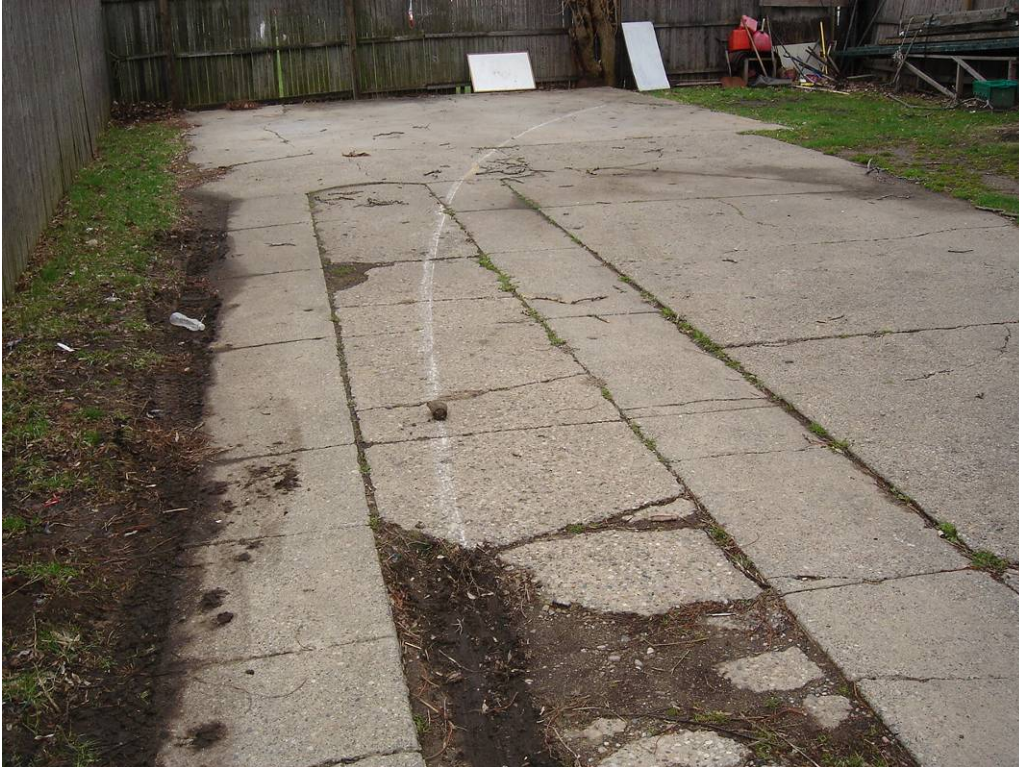
**Photo 3: Location where SV was stored showing drag marks from removal.**

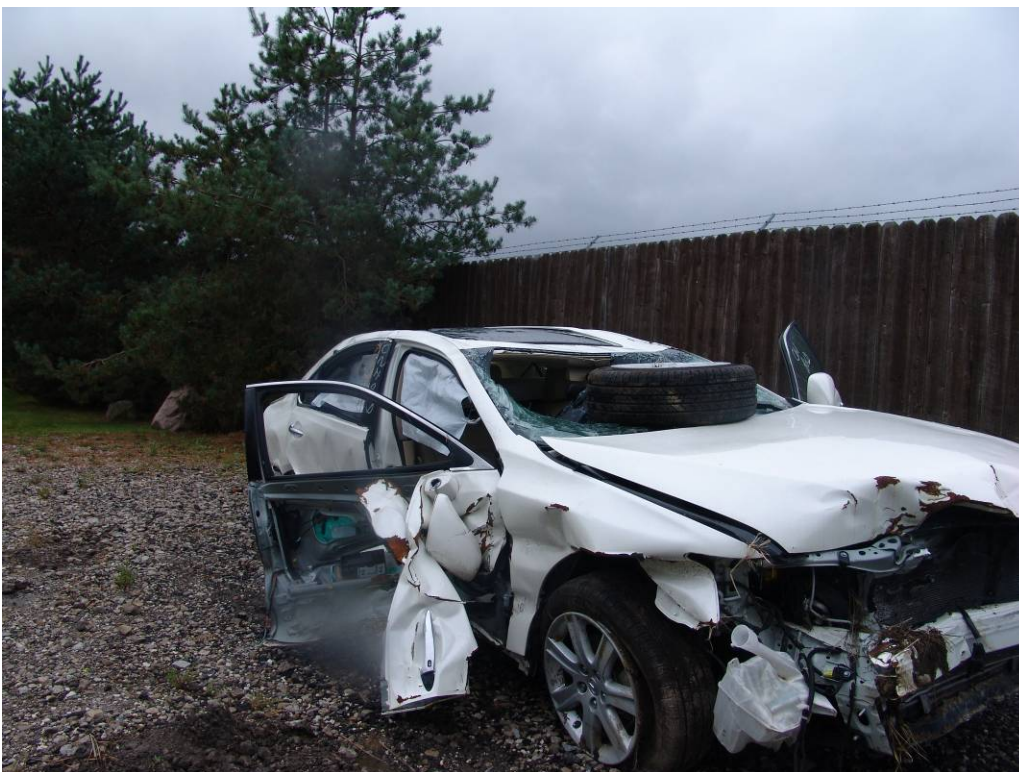
**Photo 4: Vehicle damage, right front and side**

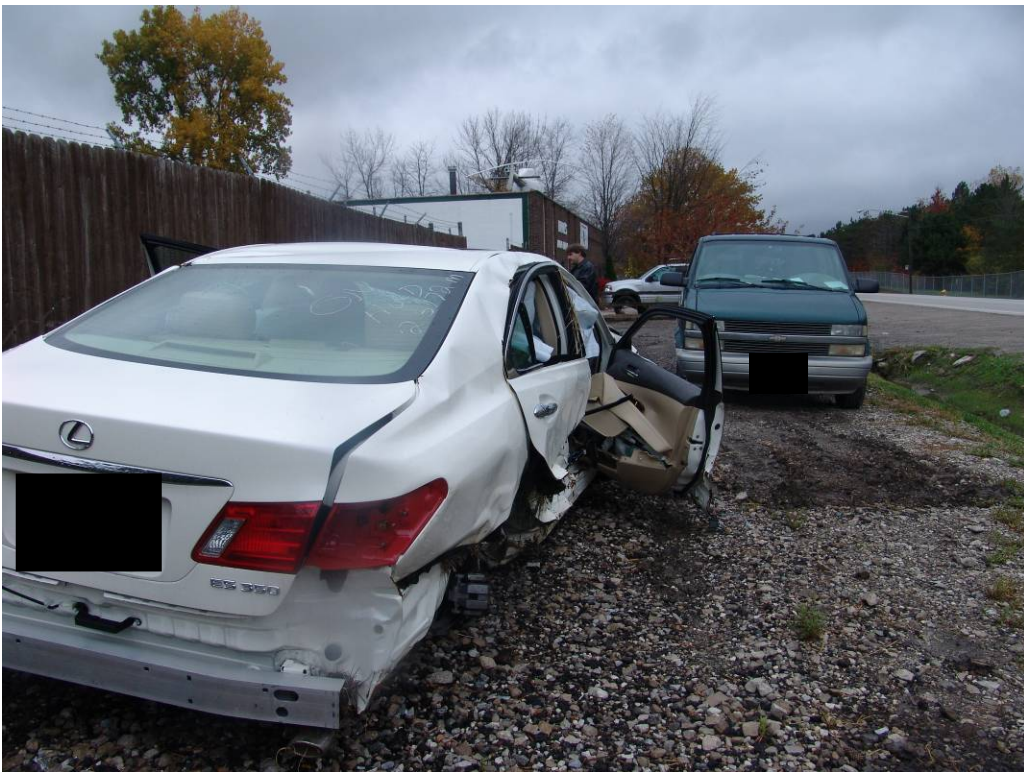
Photo 5: Vehicle damage, right rear and side, note side airbag deployment

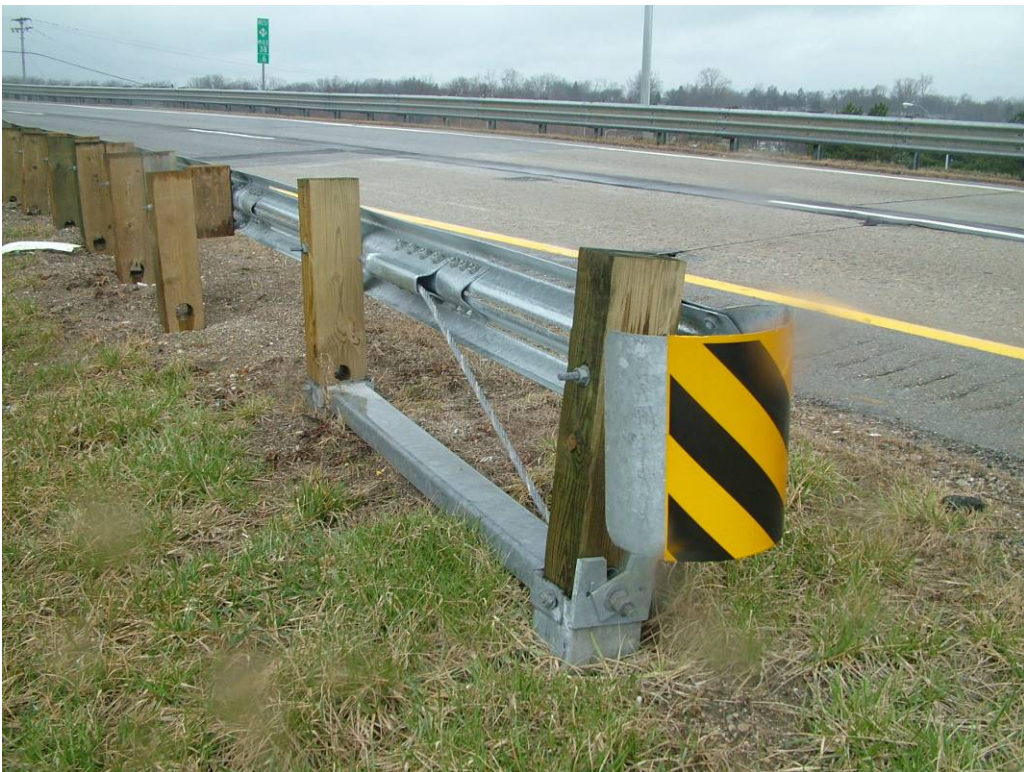
Photo 6: Repaired guardrail at incident site, note SV debris in left background

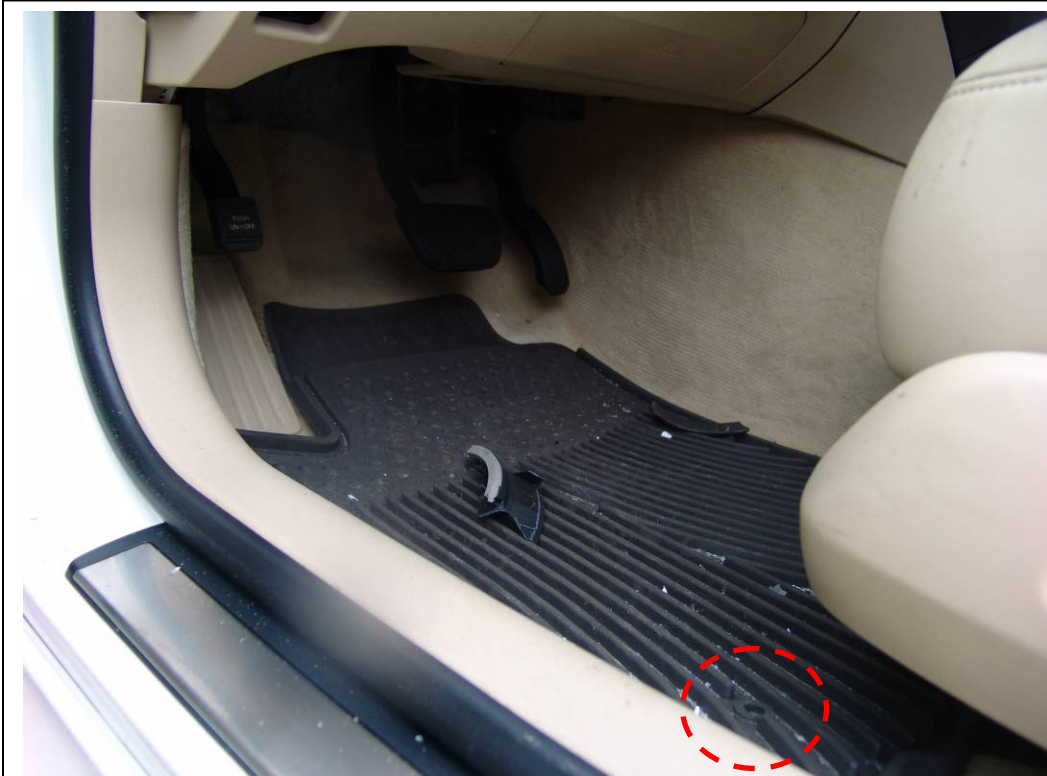
Throttle entrapment due to an unsecured all weather floor mat was studied in defect investigations Preliminary Evaluation (PE) 07-016 and Engineering Analysis (EA) 07-010, and was the subject of Toyota Safety Recall 07E-082<sup>6</sup>. The photographs supplied by the investigator show the all weather floor mat in an unsecured state on the driver's floor, a condition where it could entrap the throttle when depressed (see photo log); we believe this a plausible explanation for the unwanted acceleration alleged by the complainant. Additionally, her description of the onset of the incident, that it occurred after she had applied the throttle pedal (to pass another vehicle), is consistent with other reports of unwanted acceleration ODI concluded were caused by unsecured all weather floor mats.

**Photo 7: Unsecured all weather floor mat photo from investigator, note missing retainer**

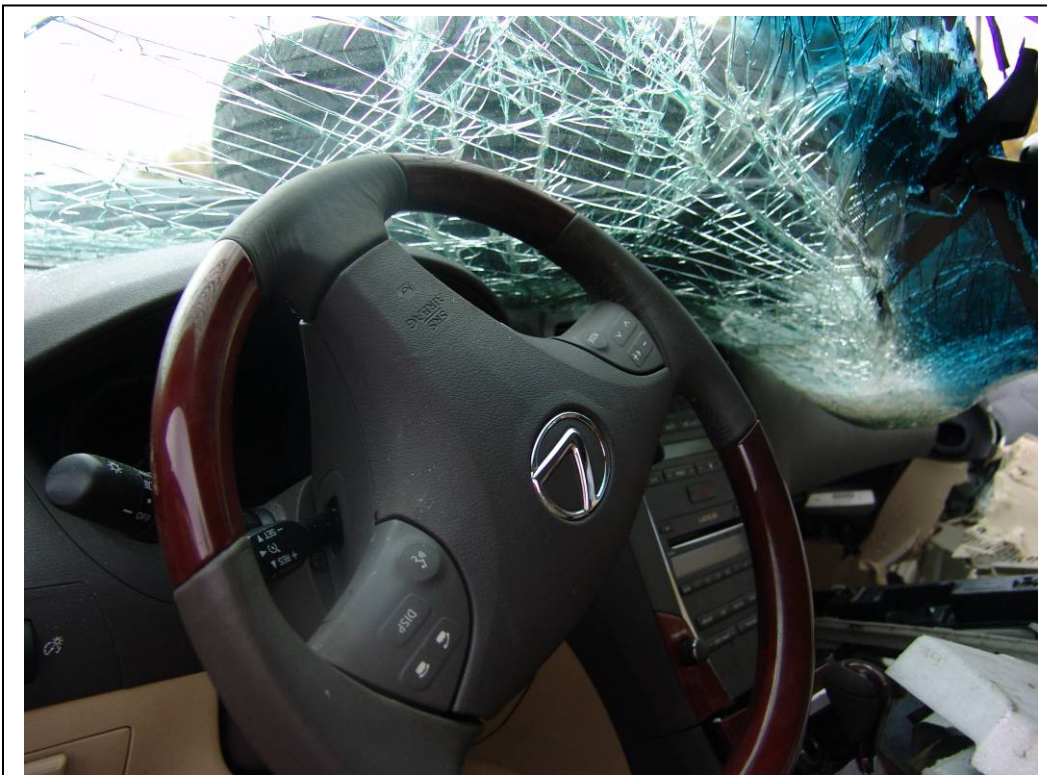
**Photo 8: View of interior damage**

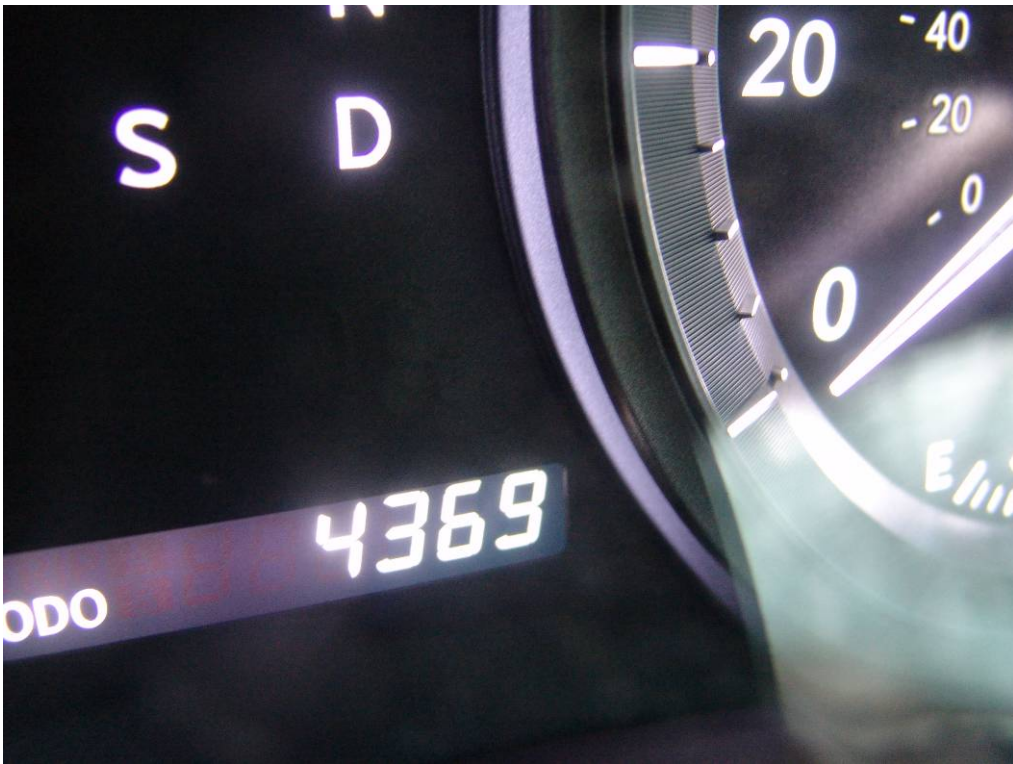
Photo 11: Investigator's photo of odometer

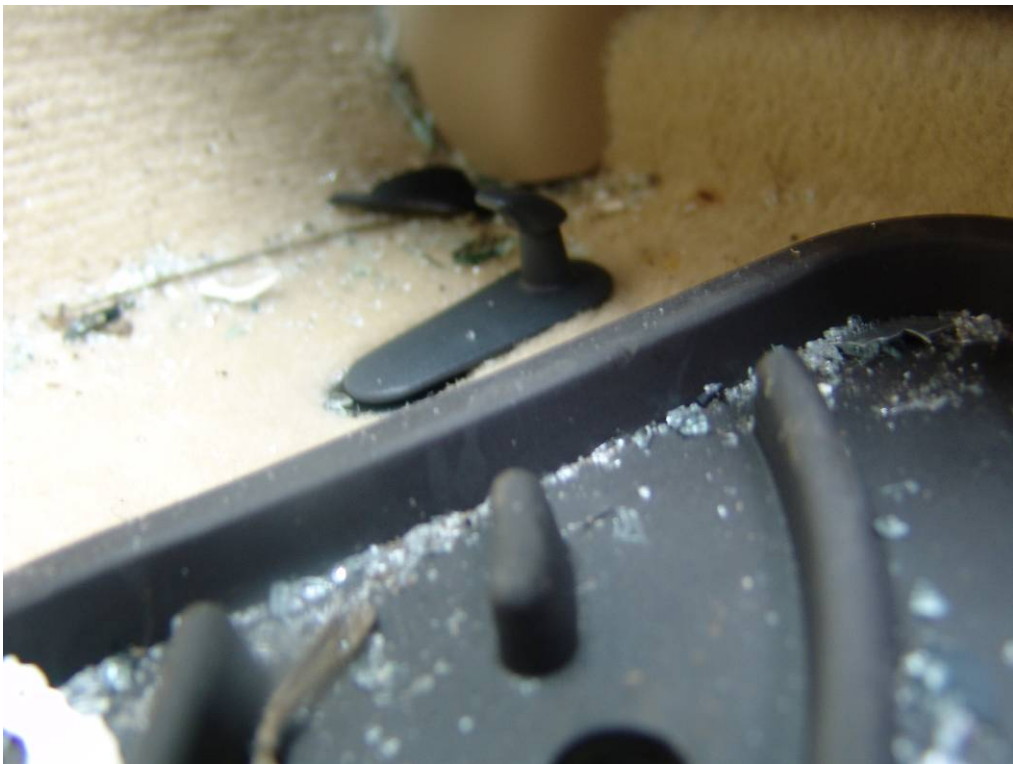
We noted from the pictures taken by the investigator that the retaining hooks for the driver's floor mat, while not engaged in the all weather mat, were properly engaged in the flooring material and that one of them was oriented 180 degrees from the proper position (see photo log). We asked the complainant about the driver floor mat and her recollection of how it had been installed in the vehicle. She advised that on the morning of the incident she had taken the carpet mat out of the driver floor and replaced it with the all weather mat because it was raining and she didn't want to ruin her carpet mat. She had previously experienced difficulty engaging the mat on the retaining hooks and, given that it was raining at the time, she did not secure the mat<sup>5</sup>. She also advised she was unaware the all weather mat had the potential to interfere with, or entrap, the throttle pedal, or that it represented any hazard when unsecured.

Photo 12: Photo showing inboard retaining hook is oriented 180 degrees from normal

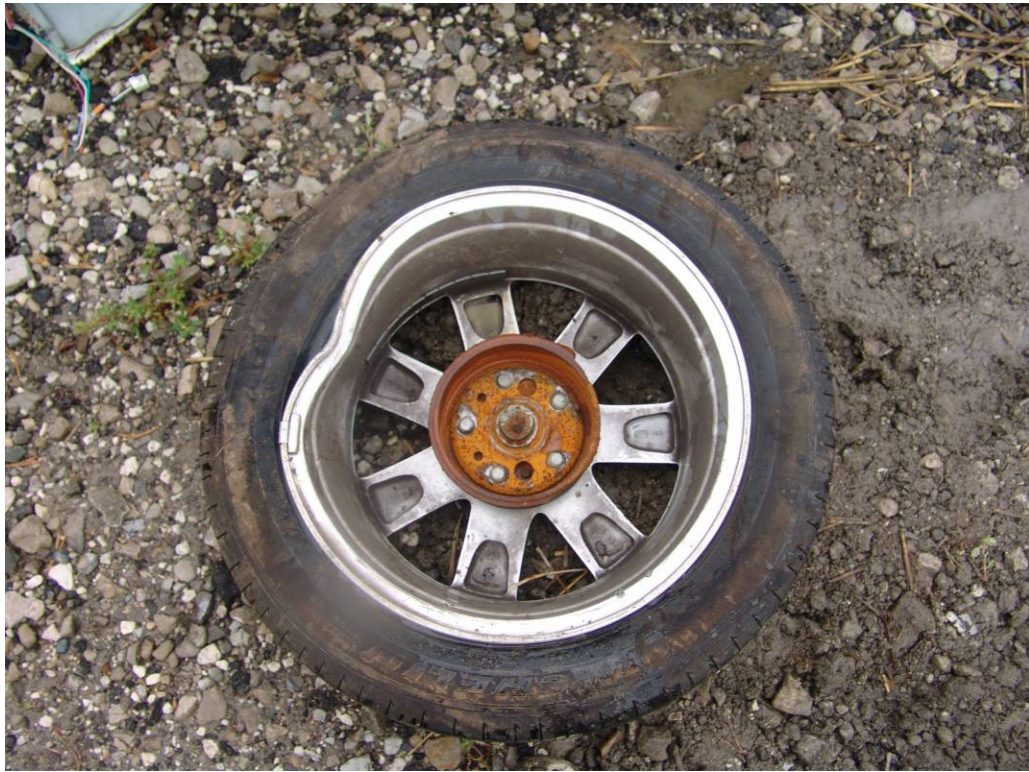
**Photo 9: View of the axle fracture of the right rear wheel assembly**

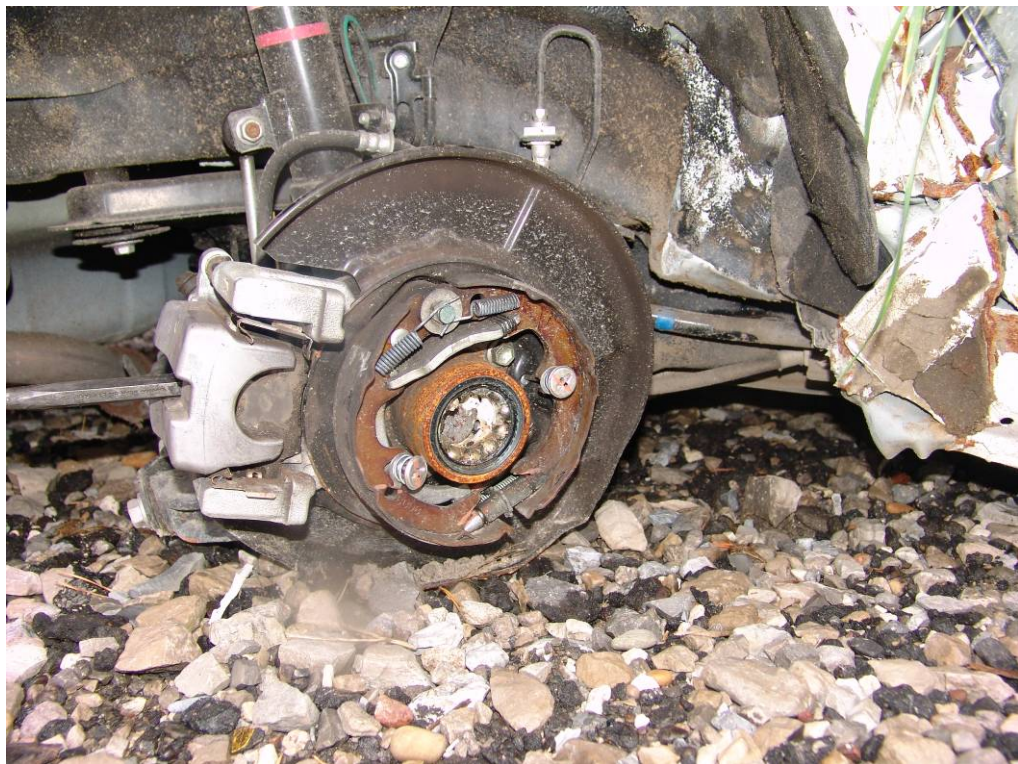
**Photo 10: Right rear brake components and broken axle shaft**

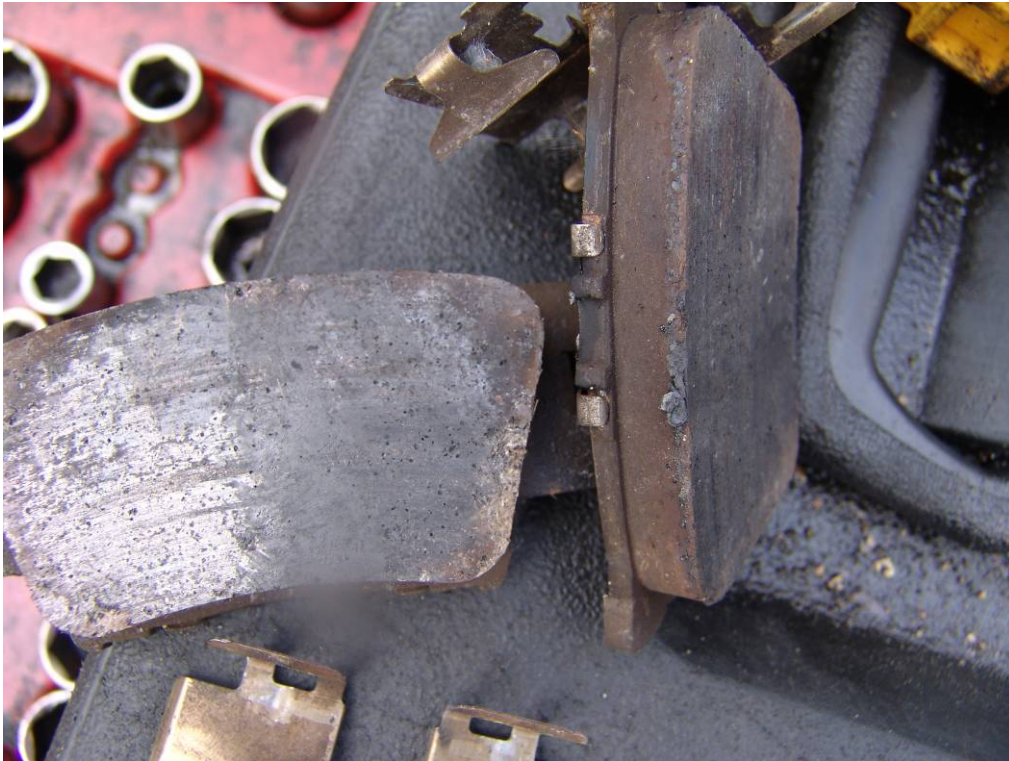
experienced unwanted acceleration due to floor mat entrapment of the accelerator<sup>8</sup> and has been duplicated in vehicle assessments VRTC conducted during PE07-016 and EA07-010. The investigator took photographs of the right rear brake assembly and hardware, including a photo of the brake pads (see photo log). The brake pads shown in the photo display the glazing and damage due to overheating that is consistent with the throttle being stuck open and the brakes being forcefully applied for the vehicle speeds and distances the complainant says occurred in her incident. This evidence supports the complainant's contention that she had her foot on the brake attempting to stop the vehicle during the incident, and that the throttle was open<sup>9</sup>. This also supports the investigator's conclusion that the brake system did not 'fail.'

**Photo 13: View of right rear brake pads, note glazing and heat damage (debris)**

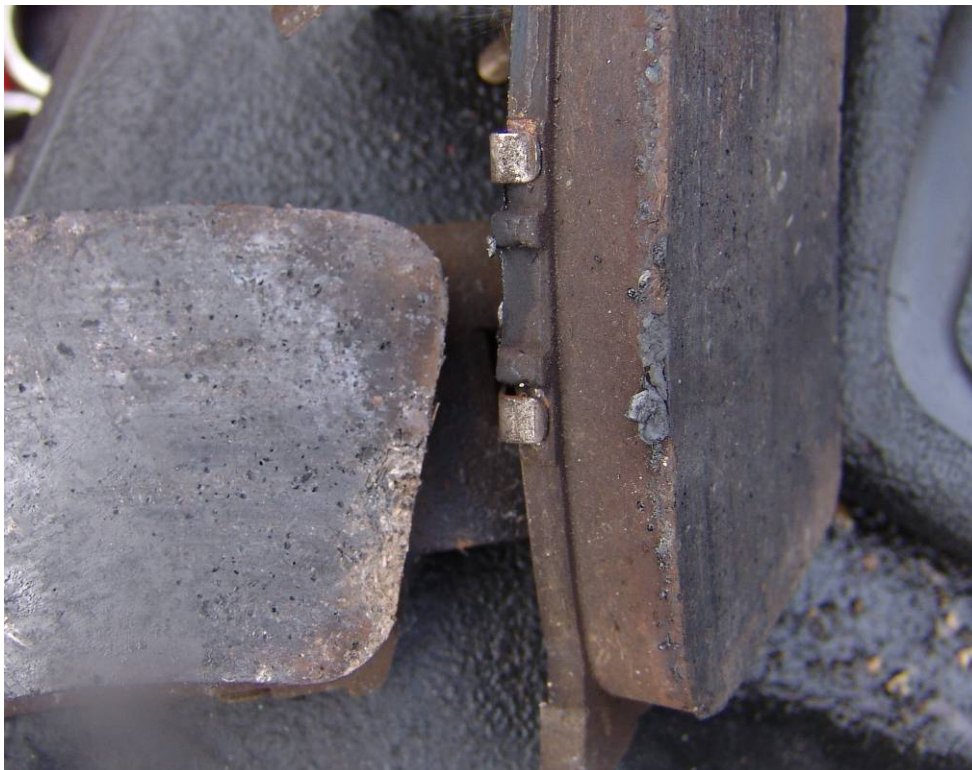
**Photo 14: Close up of right rear brake pad damage due to overheating**
