Monaco Motorhome Fire Trip Report

Date: November 29&30, 2007

Destination: Coparts Auto Auction
3300 Vandalia Road
Des Moines, IA

Purpose: Examine a vehicle that had experienced an engine compartment fire with representatives of the engine manufacturer, motorhome manufacturer, and vehicle owner's insurance company.

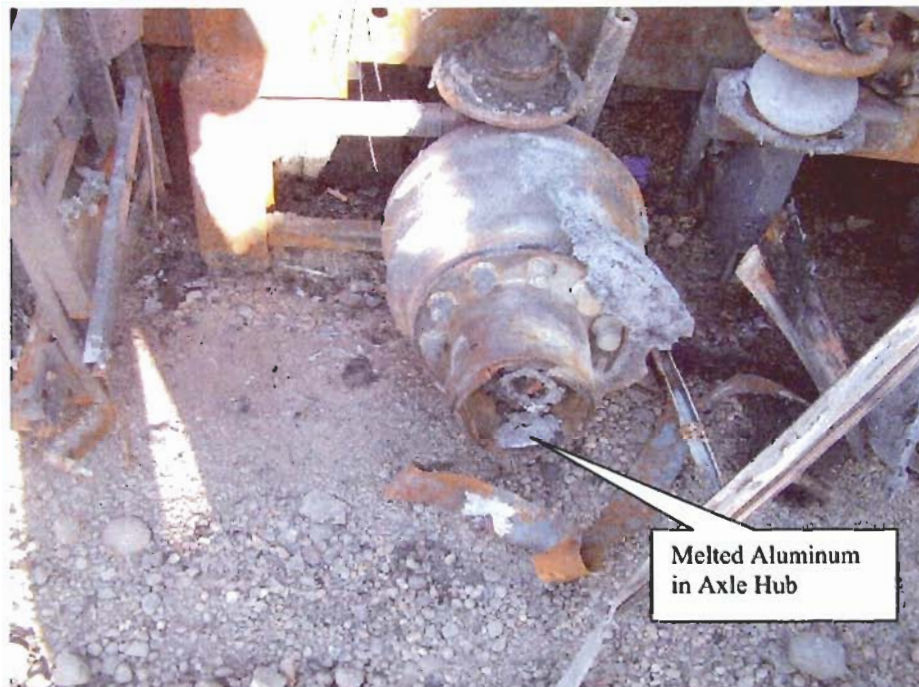
**Figure 6 – Melted Aluminum from the Wheel was Found in the
Right Rear Axle Hub of the Motorhome**

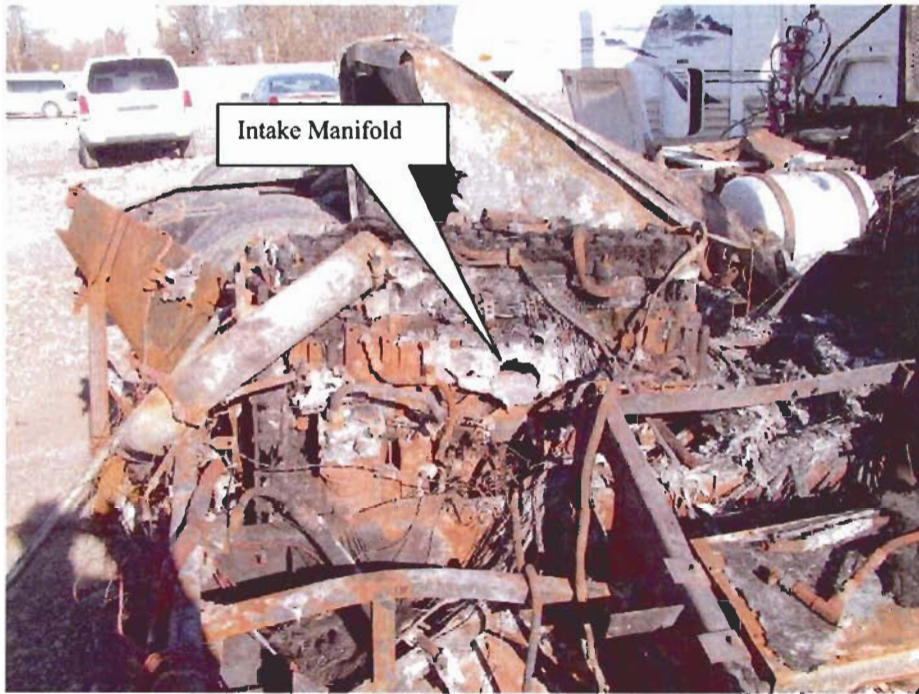
The General Casualty representative confided that the area that was most burnt was the origin, which he thought was the cold (right) side of the engine. He also said that he had not seen an alternator burnt down to the rotor. During his previous inspection of the vehicle, he had tried to follow the wiring from the battery compartment to "arc map" area, or find where a wire could have chafed and rubbed off the insulation and then arced to ground. He found the vehicle was consumed to the point that he could not perform that part of his investigation. He also pointed out that the straight plates of what was left of the batteries, as shown in Figure 12. He said that if the batteries had an internal problem and exploded, the plates would not be in that original parallel alignment.

Figure 7 – View of the Right (or Cold) Side of the Diesel “Pusher” Engine in the Motorhome

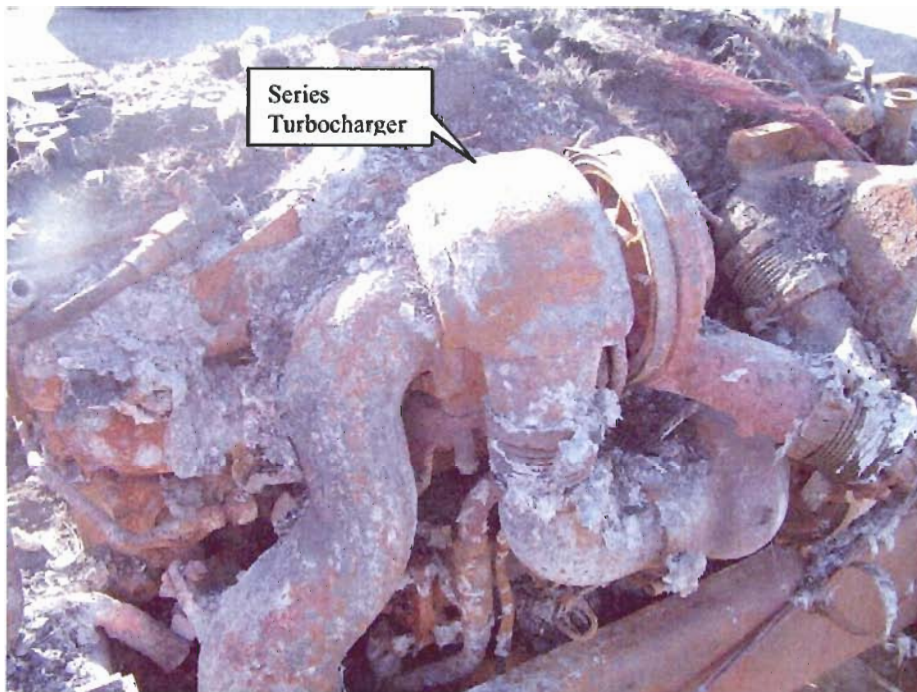
Figure 8 – View of the Left (or Hot) Side of the Diesel “Pusher” Engine in the Motorhome

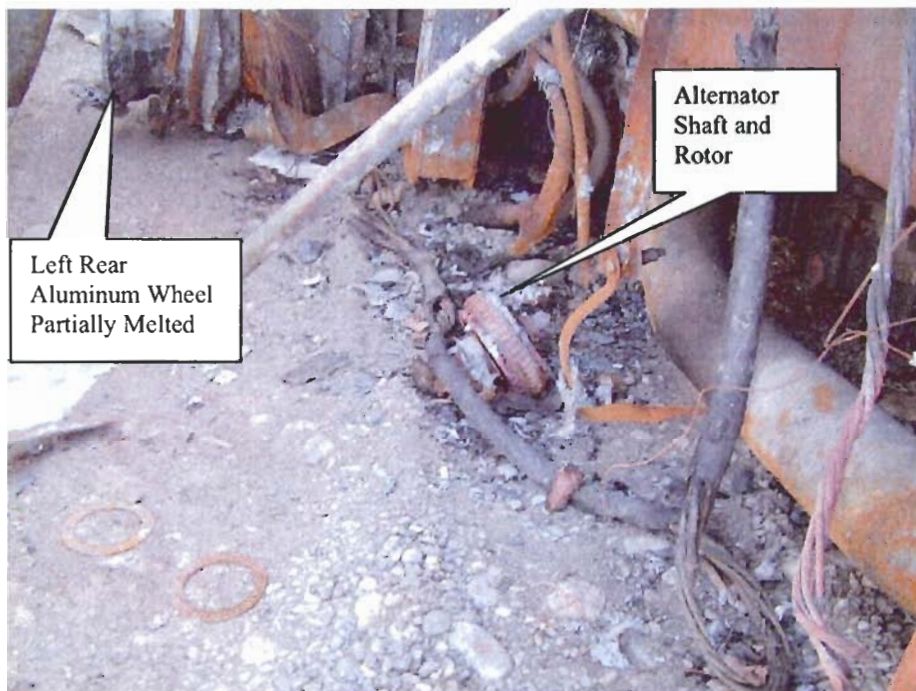
Figure 10 – The Alternator Housing had Melted Leaving only the Shaft and Rotor Below the Left Side of the Engine

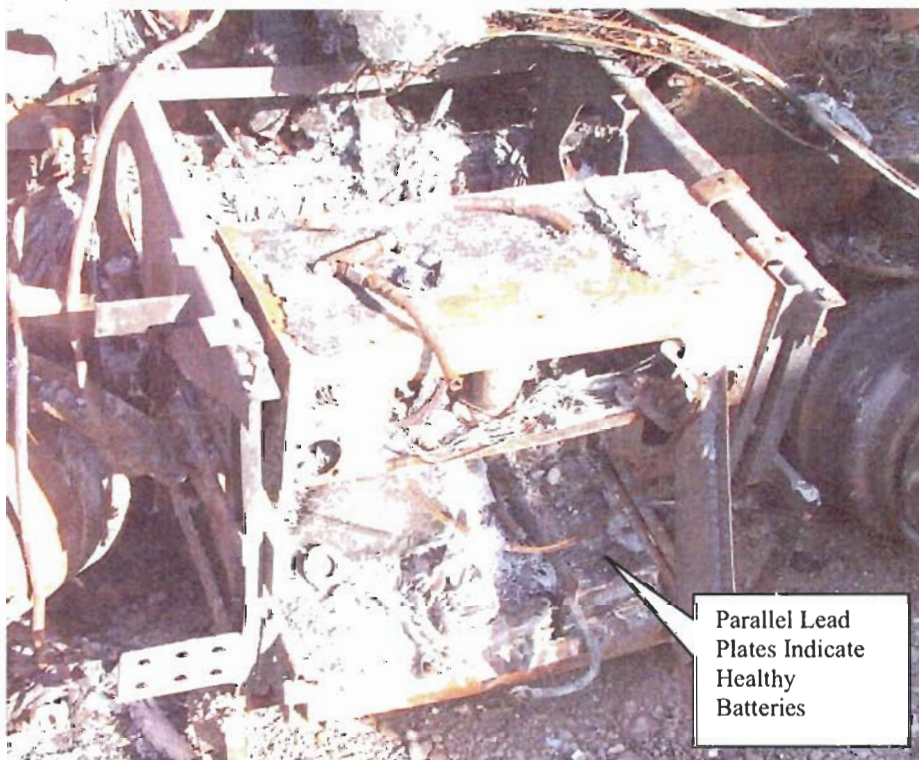
Figure 12 – The Battery Box Contains the Lead Plates from the Batteries, Which were Still Parallel and without Distortion Indicating that the Batteries Did not Explode

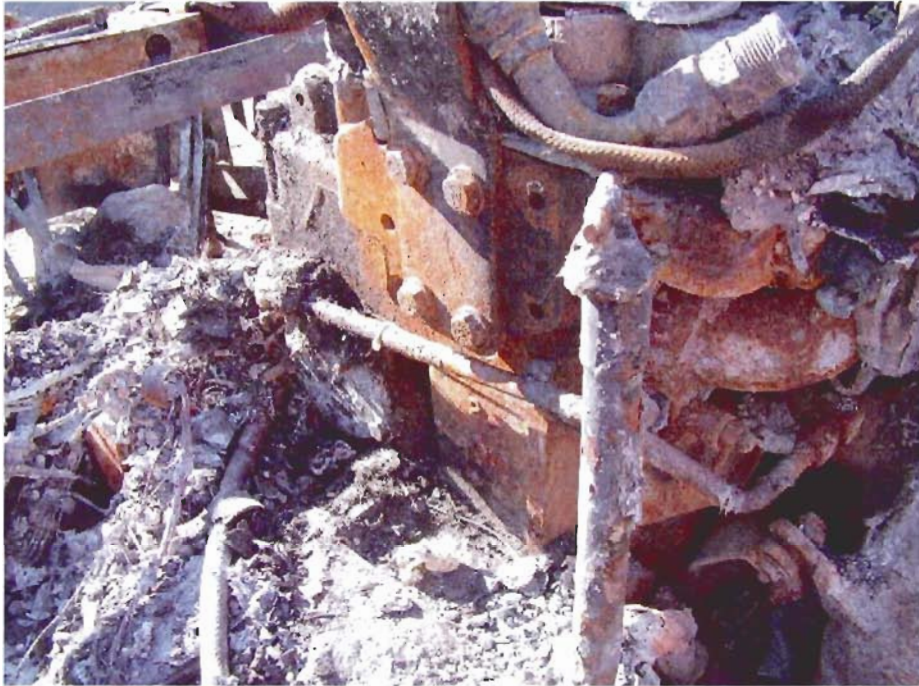
Later the General Casualty representative restated his fire origin and alternator claims, but the other two representatives thought the crosswind drove the fire to the right, that the area of origin could not be established. They also agreed that the alternator was only missing the aluminum housing and just appeared to have been in the heat of the fire. The Caterpillar representative removed the bedsprings, with the approval of the other representatives, and sifted through the debris on the forward edge of the engine block, shown after he had completed his search in Figure 13.

Figure 13 – Front of Engine After Large Debris Had Been Removed and Small Debris Sifted and Removed

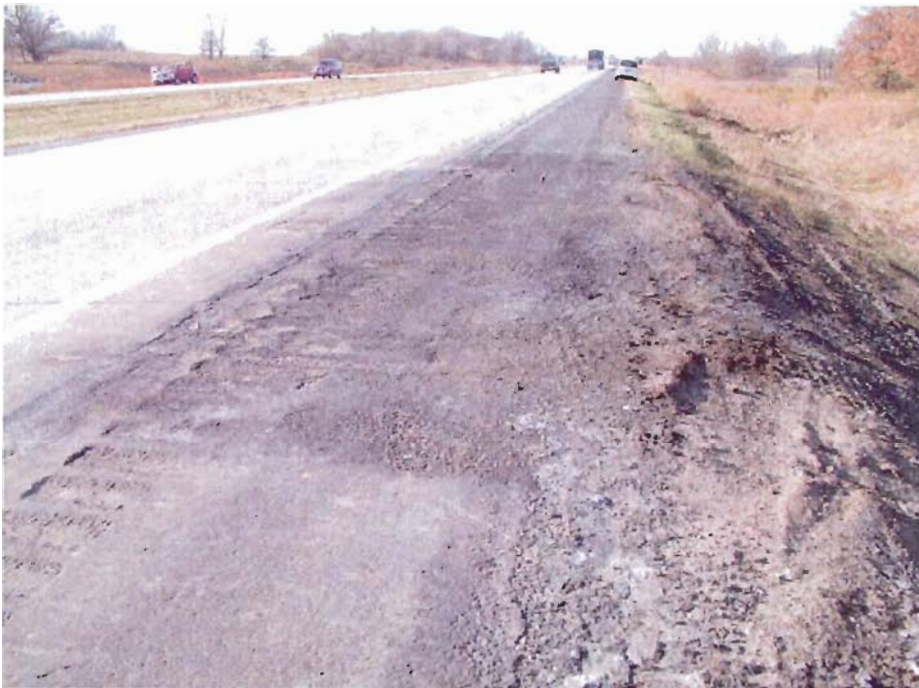
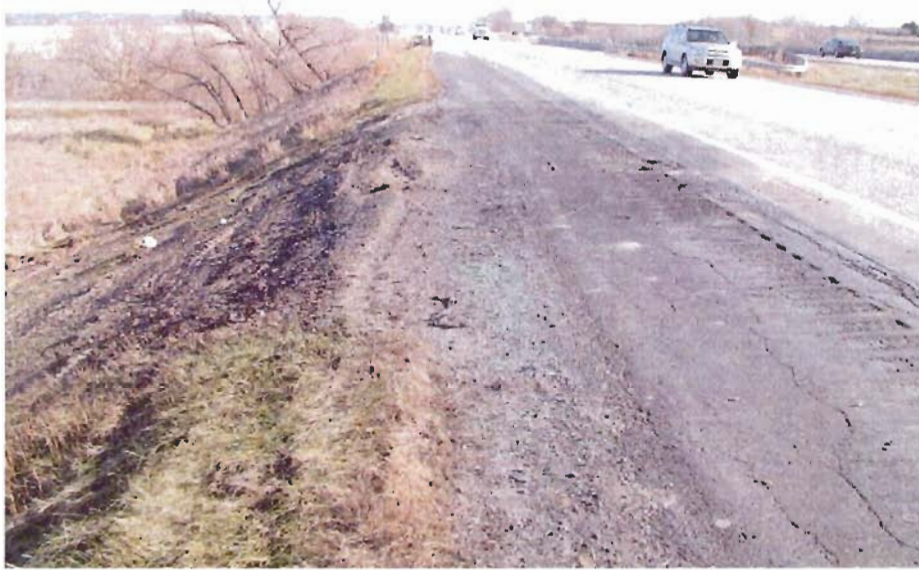
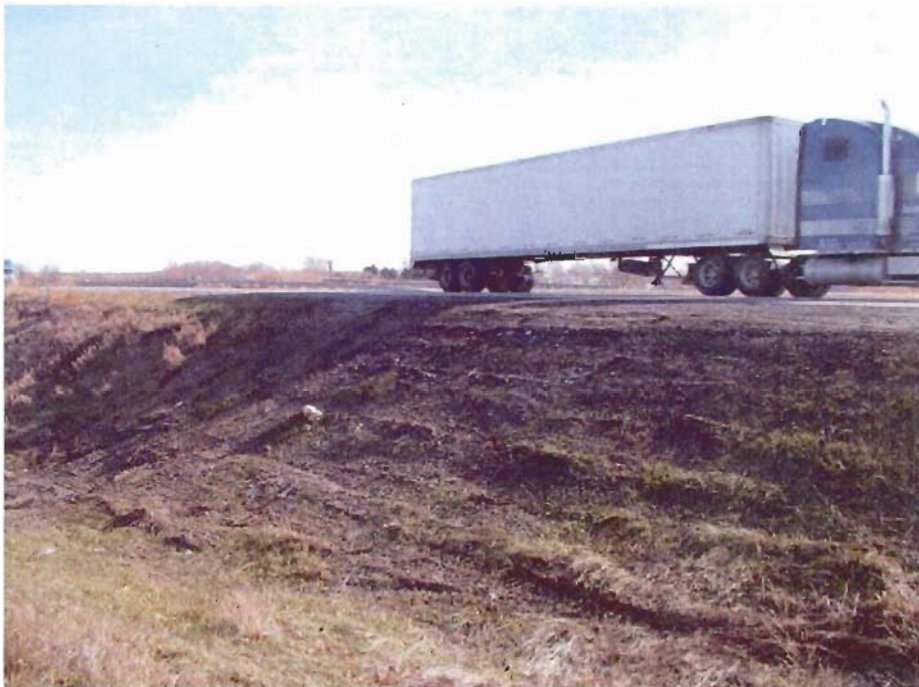
Inspection of Burn Site Results: The site of the incident was reported as I-80 westbound at the 152-mile marker. This area was examined twice before finding the burn site as 0.2 mile west of the 150-mile marker (149.8 position), just across the Polk County line. The right berm was heat damaged along a length similar to the motorhome and the berm and surrounding area was sprinkled with melted aluminum and mirrors similar to the motorhome in the salvage yard. The right-of-way beyond the berm was burnt and appeared to have been bulldozed to clear the debris or assist in arresting the fire. The scene is shown in Figures 14 to 16.

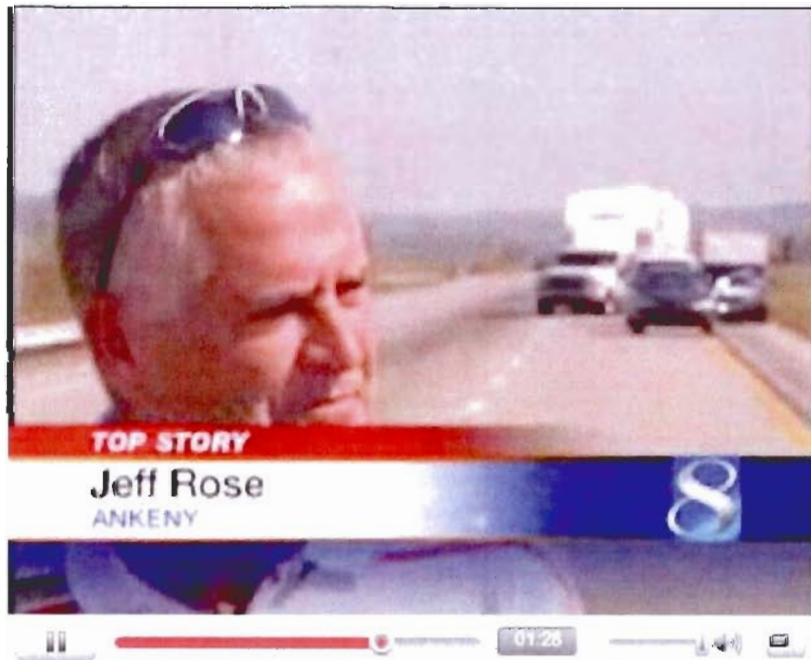
Figure 26 – The First Person Stopped Behind the Motorhome was Jeff Rose of Ankeny, IA

Note: A dark stripe is noticeable behind Mr. Rose, and more noticeable in the video clip, that appears to be the spilled fluid from the motorhome.

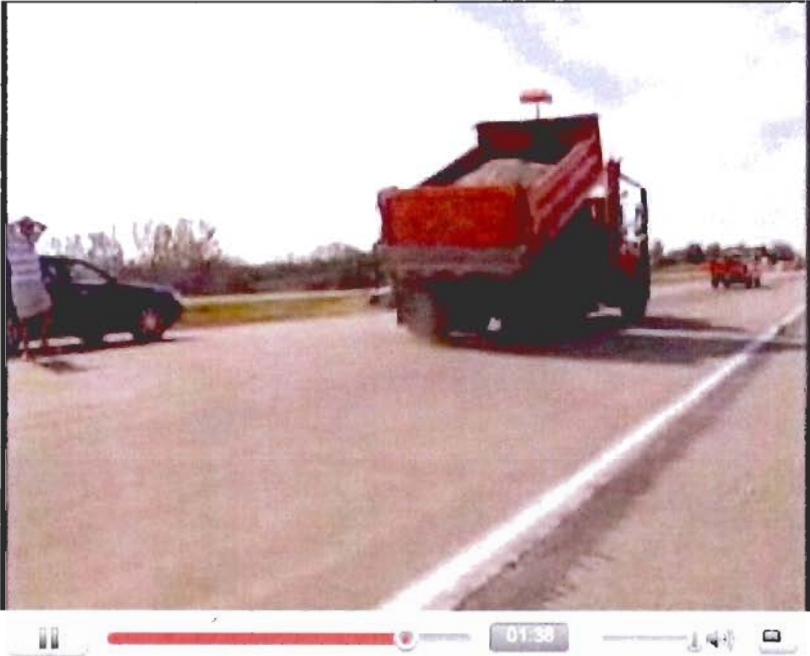
The Iowa Department of Transportation Maintenance Department in Newton, IA was called and "Rex" answered the phone. Rex said that he was present at the scene and had spread sand on the "hydraulic oil" spill. When asked if the spill could have been diesel fuel, he said he was not sure. When asked the length of the leak on the highway, he deferred all other questions to Von Richards at 515-239-1671 with Claims and Processing at the Iowa Department of Transportation. He said an investigation had been performed.

Figure 27 – The Iowa DOT Spread an Absorbent Material on the Roadway, Reportedly to Cleanup Split Diesel Fuel
