U.S. Department  
of Transportation

**National Highway  
Traffic Safety  
Administration**

Subject: Vehicle and Incident Site Inspection  
Vehicle Owner Questionnaire (VOQ) ODI 10182245

Date: 5/2/2007

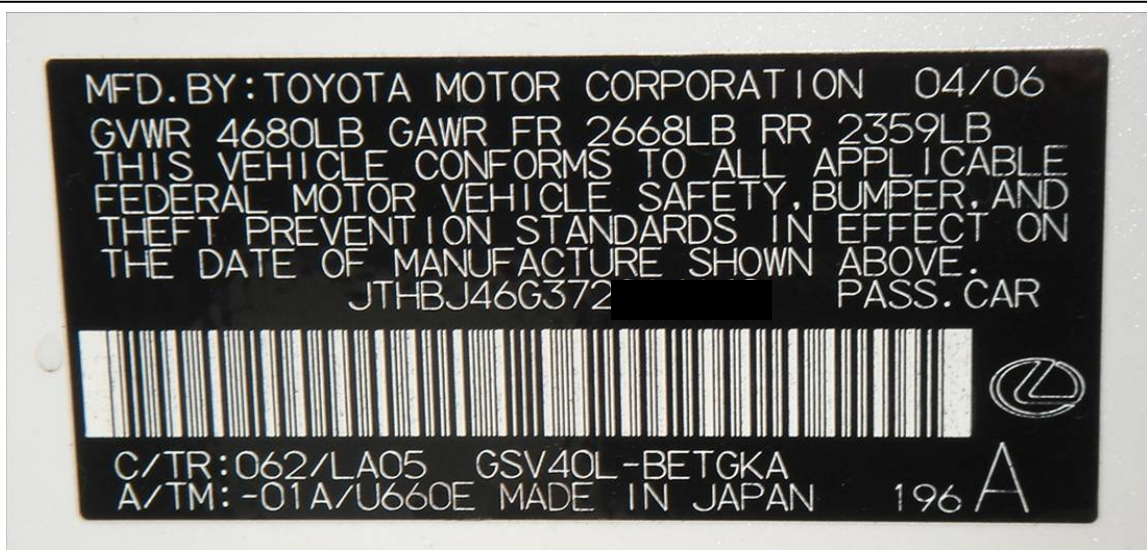
The VIN was recorded as JTHBJ46G372[REDACTED] and the initial odometer reading as 2,728 miles. The certification label indicated the date of manufacture was 04/06, and the point of manufacture as Japan (photo 1). According to the Complainant, the vehicle has been located either at a dealership in Kingsport, TN (through late January) or at the current facility since the incident occurred<sup>1</sup>. The Complainant states they have not driven the vehicle since the incident and that to the best of their knowledge the vehicle is currently in the same state as it was at the time of the incident.

Photo 1: Certification label, driver side door jam

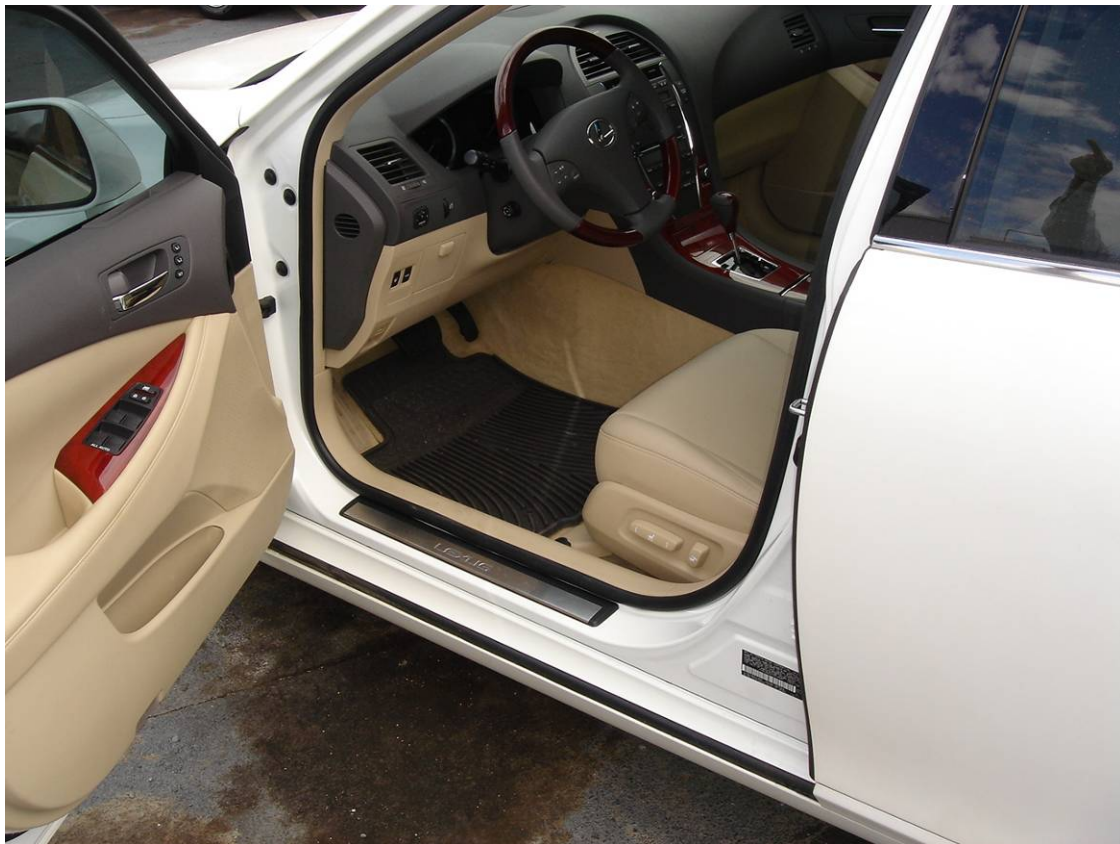
The vehicle interior is clean and its condition is consistent with the indicated vehicle mileage. Rubberized all weather mats of the type which are the subject of NHTSA Preliminary Evaluation (PE) 07-016 are installed at all four seating positions. The driver side all weather mat (see photos 2 through 5) is installed on top of the original equipment carpet mat and is unsecured by a retention device. The all weather mat was removed for inspection. A retention device is securing the carpet mat and the device is properly engaged to the fixed flooring material (carpet). The Complainant states that the vehicle was delivered (by the dealership, new) with this floor mat configuration<sup>3</sup>.

Photo 2: Driver floor mat, as found at start of inspection process

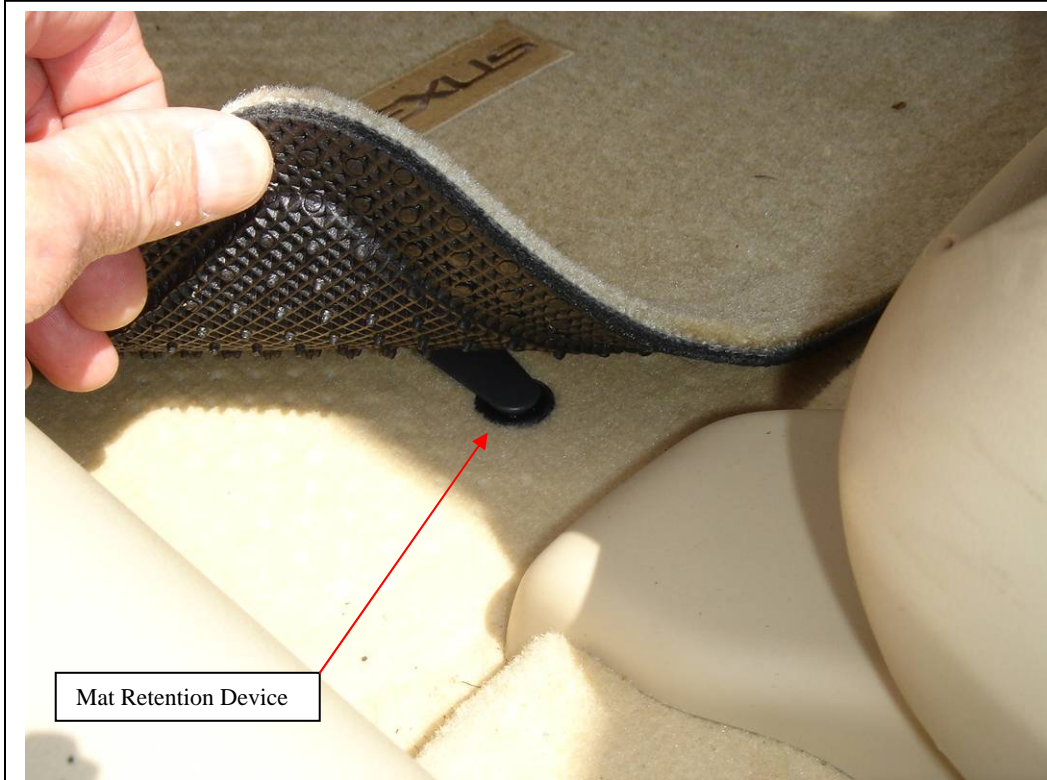
**Photo 5: Driver floor mat, as found at start of inspection process**

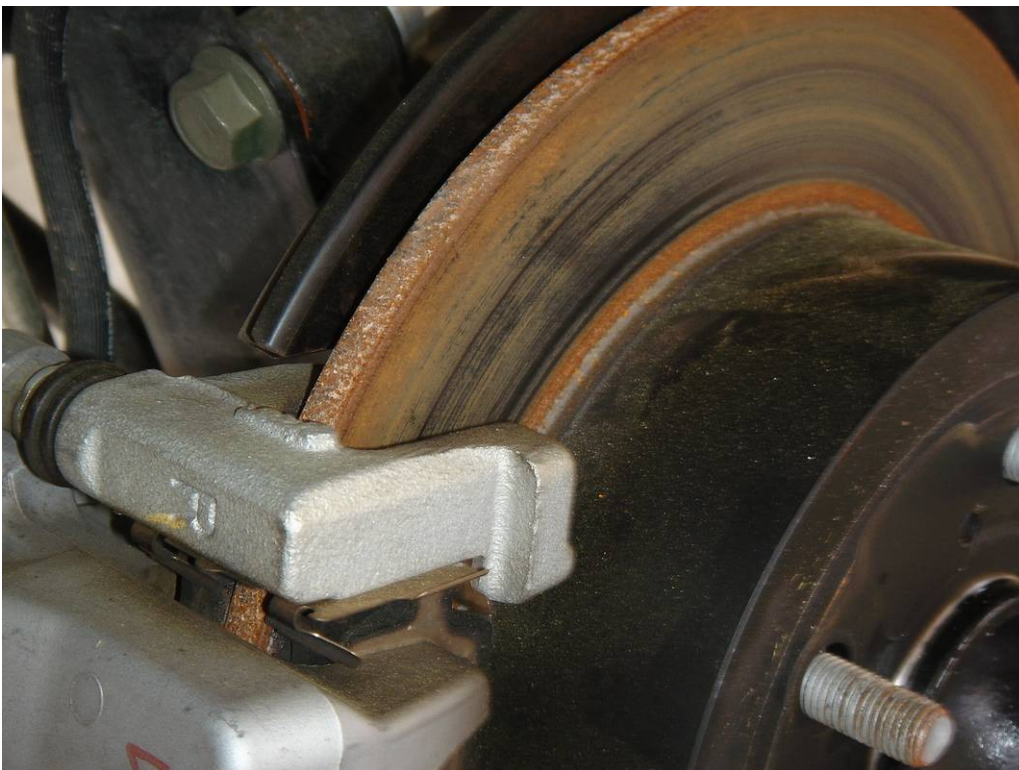
The exterior vehicle body is clean and appears to be without damage or abnormality. Tire tread depth and wear appears consistent with the indicated vehicle mileage. Discoloration, rust and surface damage to the brake rotors is visible through all four wheel apertures. The engine compartment appears normal<sup>2</sup> and consistent with indicated vehicle mileage; engine oil, coolant, power steering and brake fluid levels were within expected levels.

**Photo 6: RHR disc brake rotor, before disassembly**

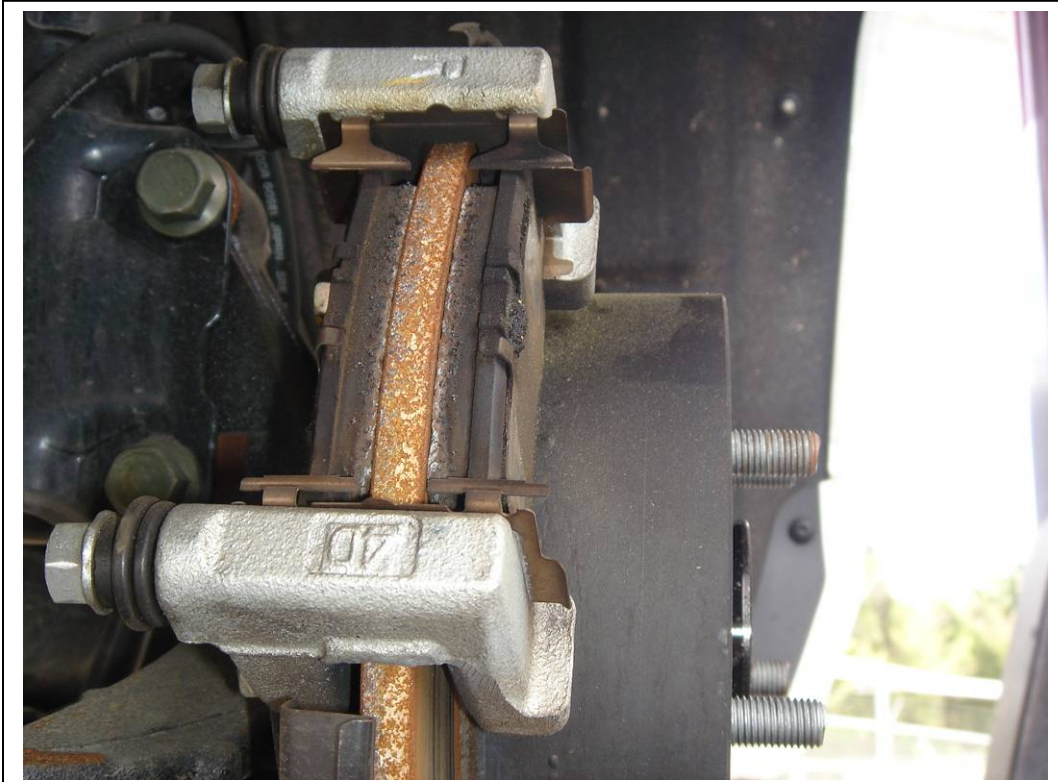
**Photo 7: RHR rotor and pads, caliper removed**

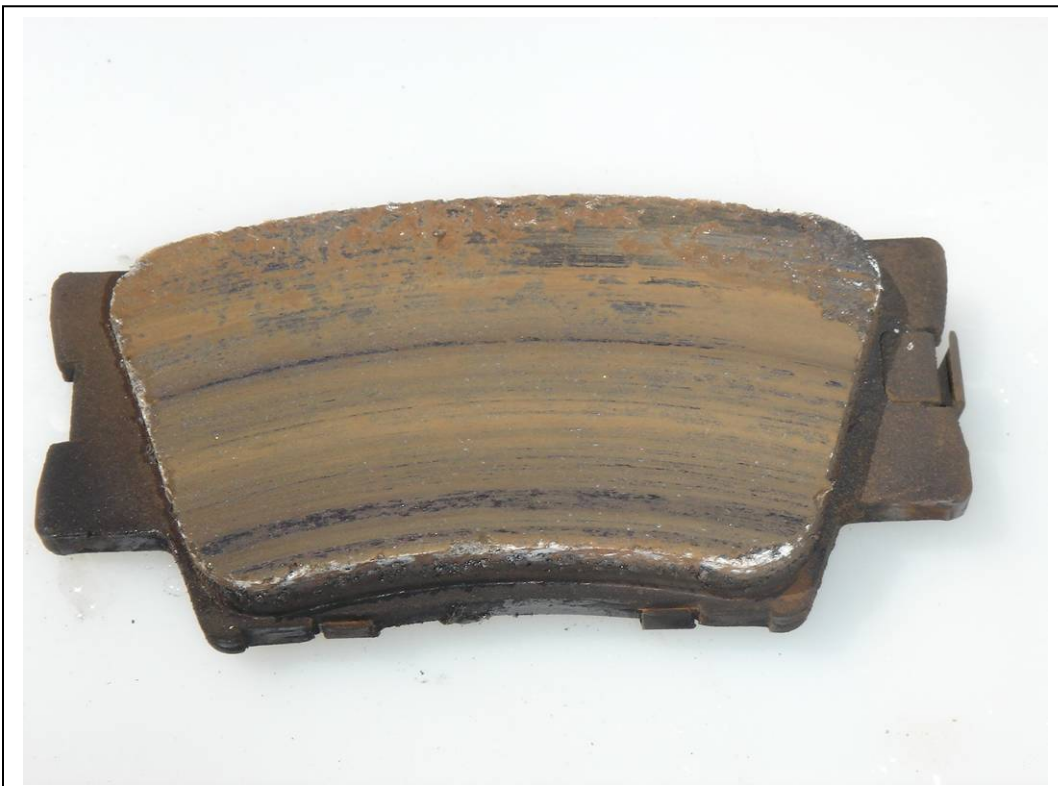
**Photo 8: RHR outboard disc brake pad, friction surface/rotor side**

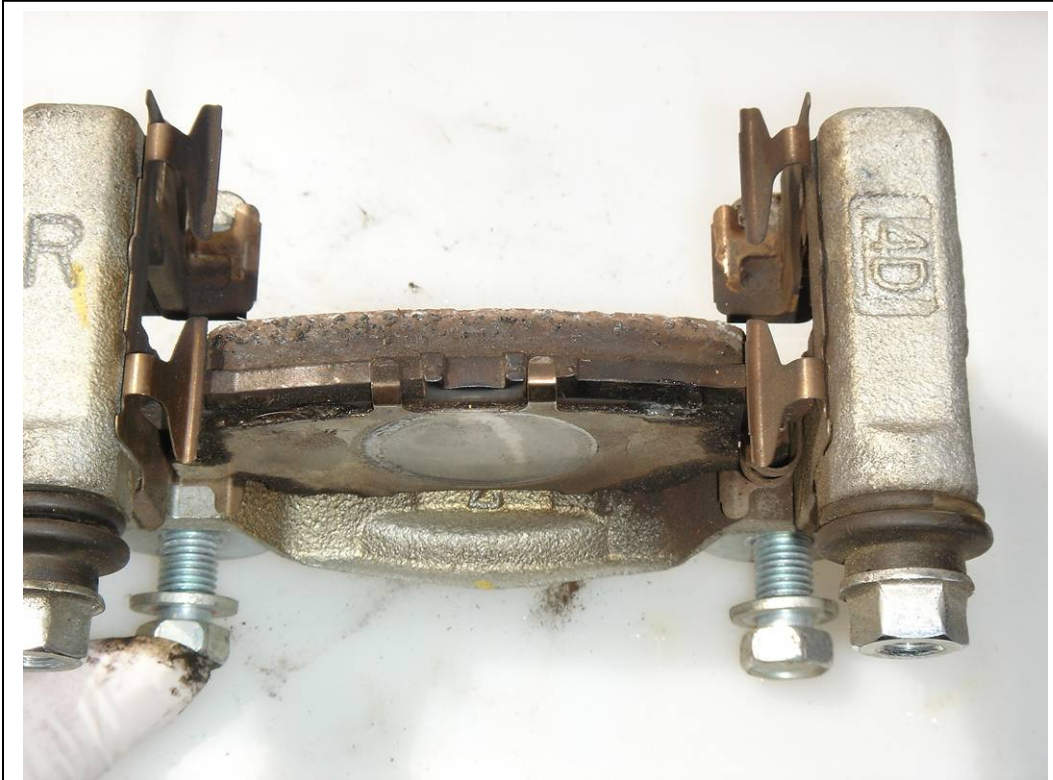
Photo 9: RHR brake caliper mount and inboard brake pad, non-rotor surface

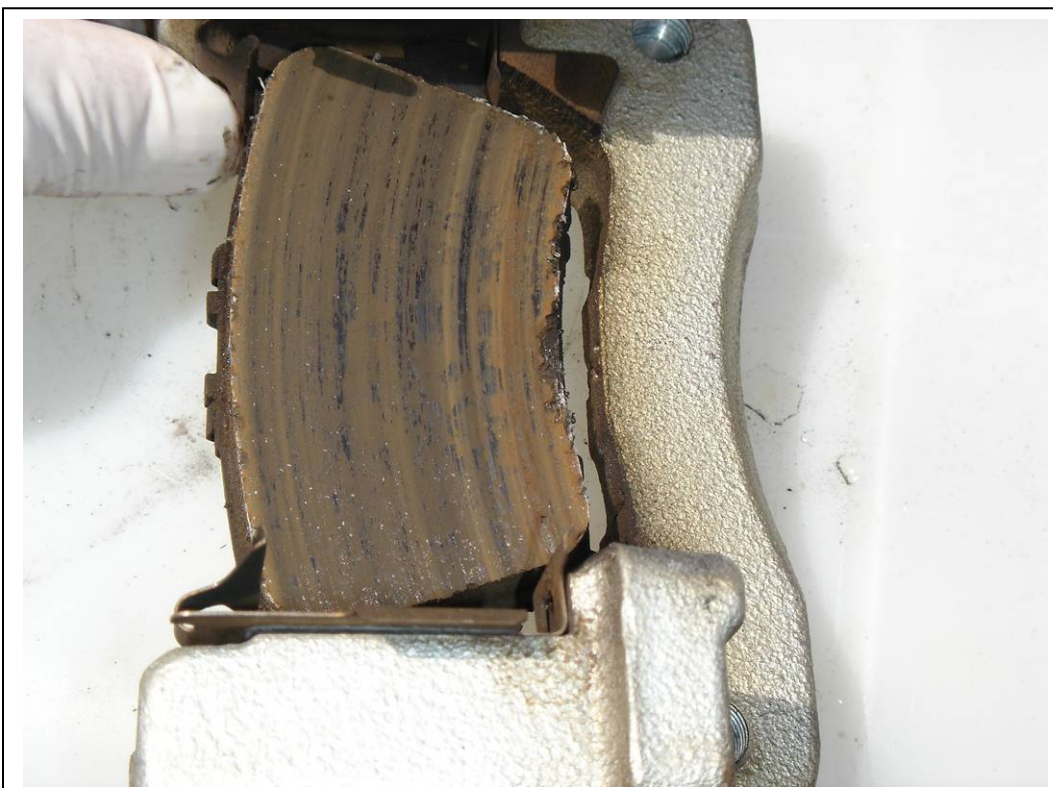
Photo 10: RHR inboard disc brake pad, friction surface

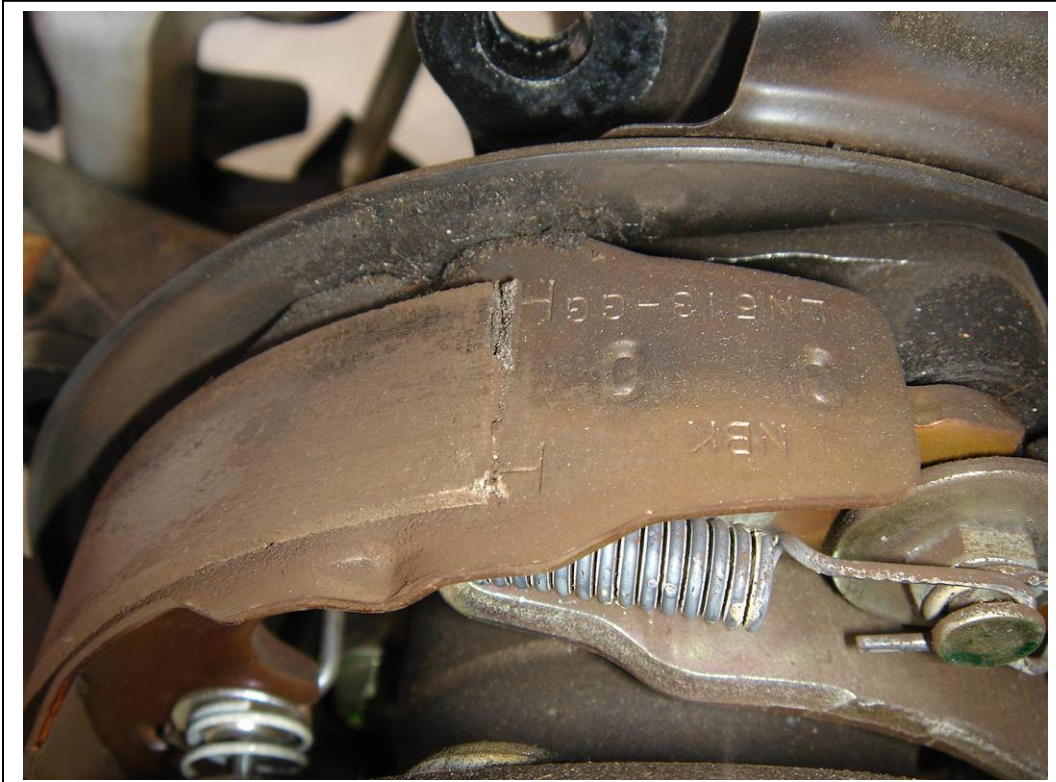
<sup>4</sup> This includes damage to the park brake components also.

Photo 11: RHR park brake (Drum-In-Hat type) rear shoe and hardware, drum removed

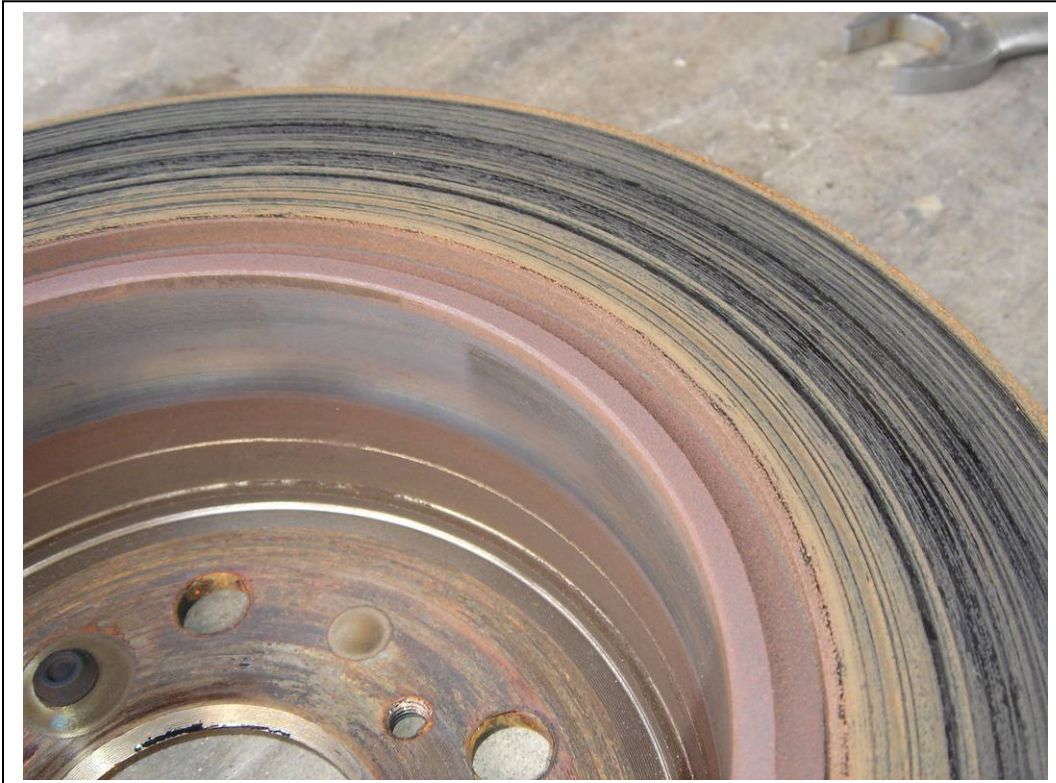
Photo 12: RHR park brake drum and inboard service brake friction surfaces

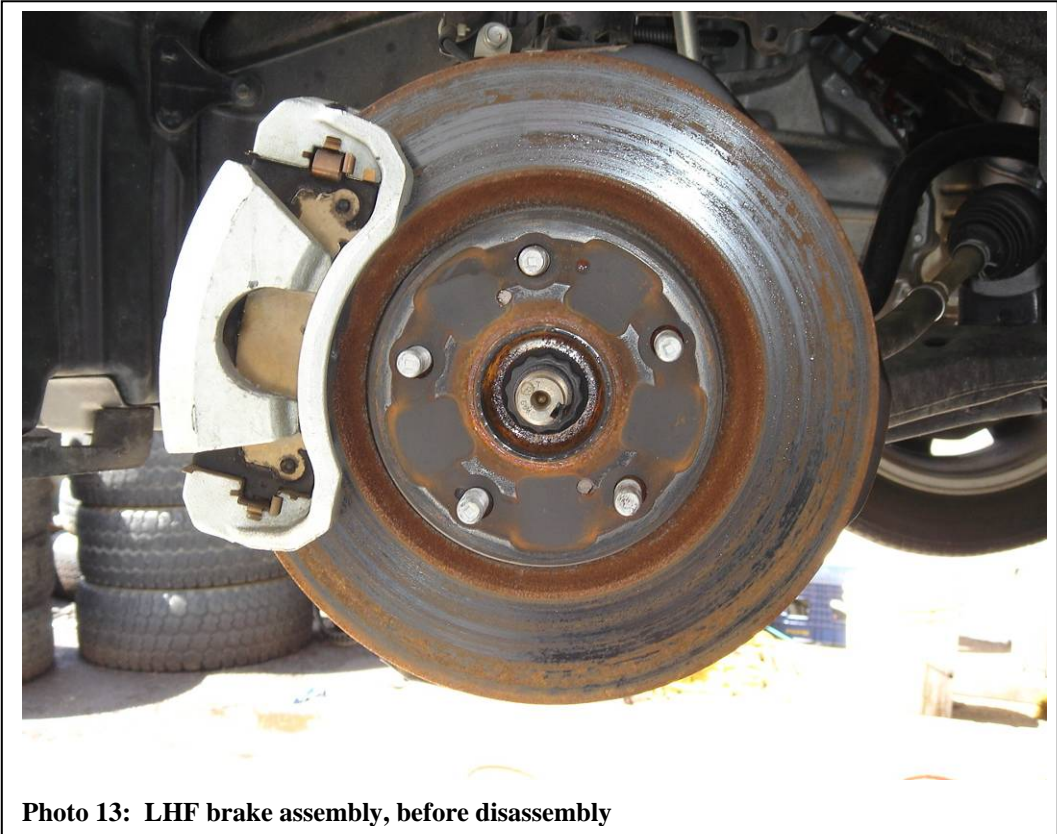
Photo 13: LHF brake assembly, before disassembly

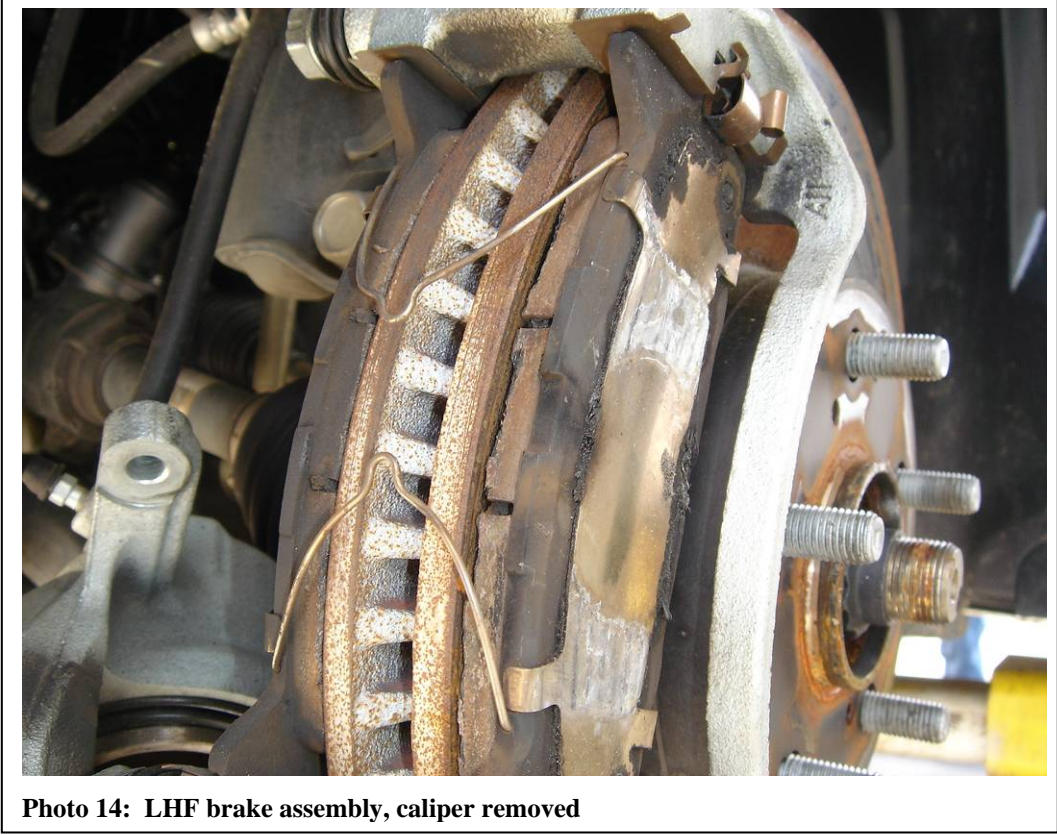
Photo 14: LHF brake assembly, caliper removed

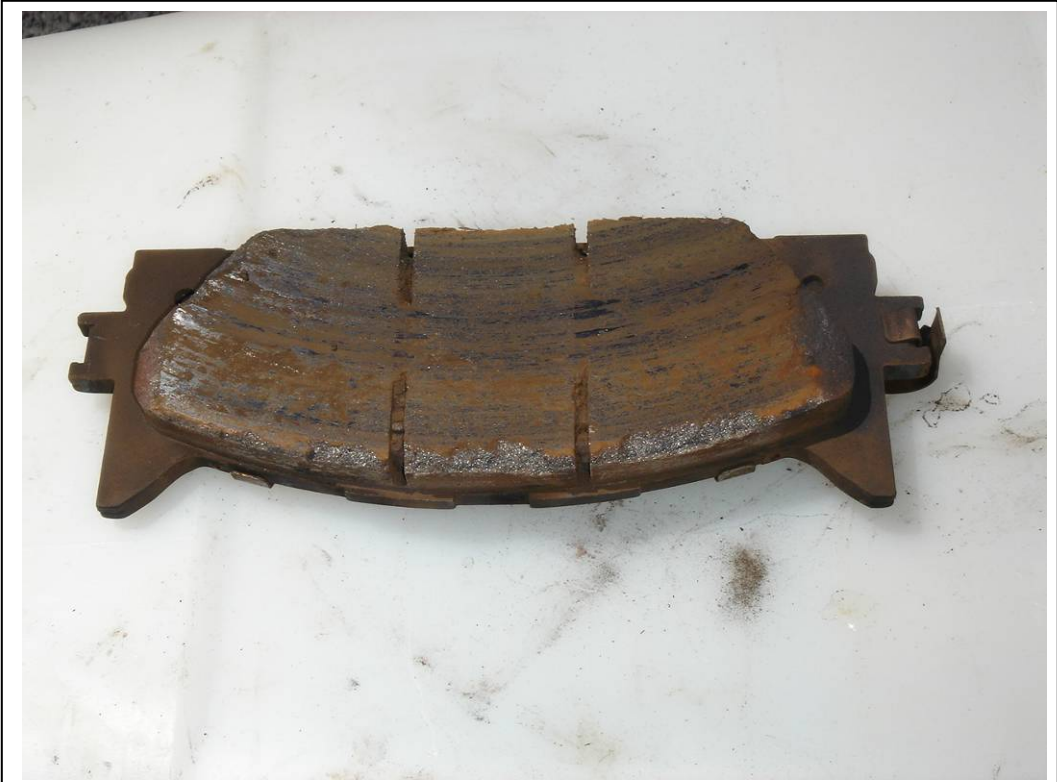
**Photo 15: LHF outboard brake pad, friction surface**

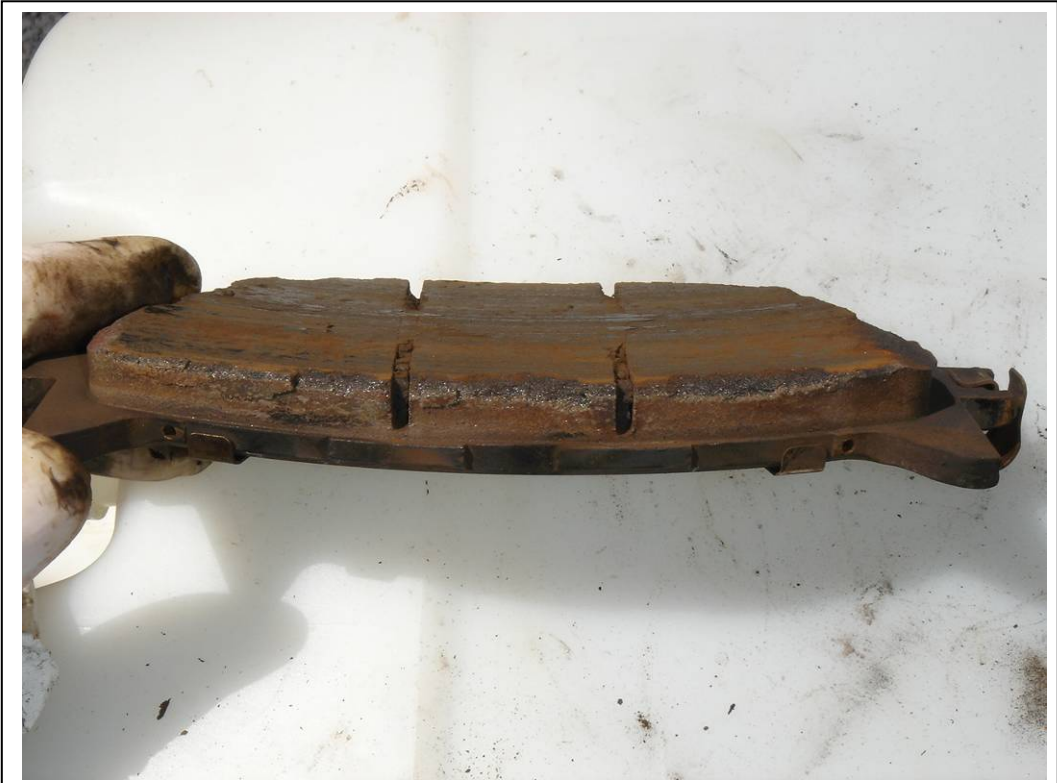
**Photo 16: LHF outboard brake pad, friction surface**

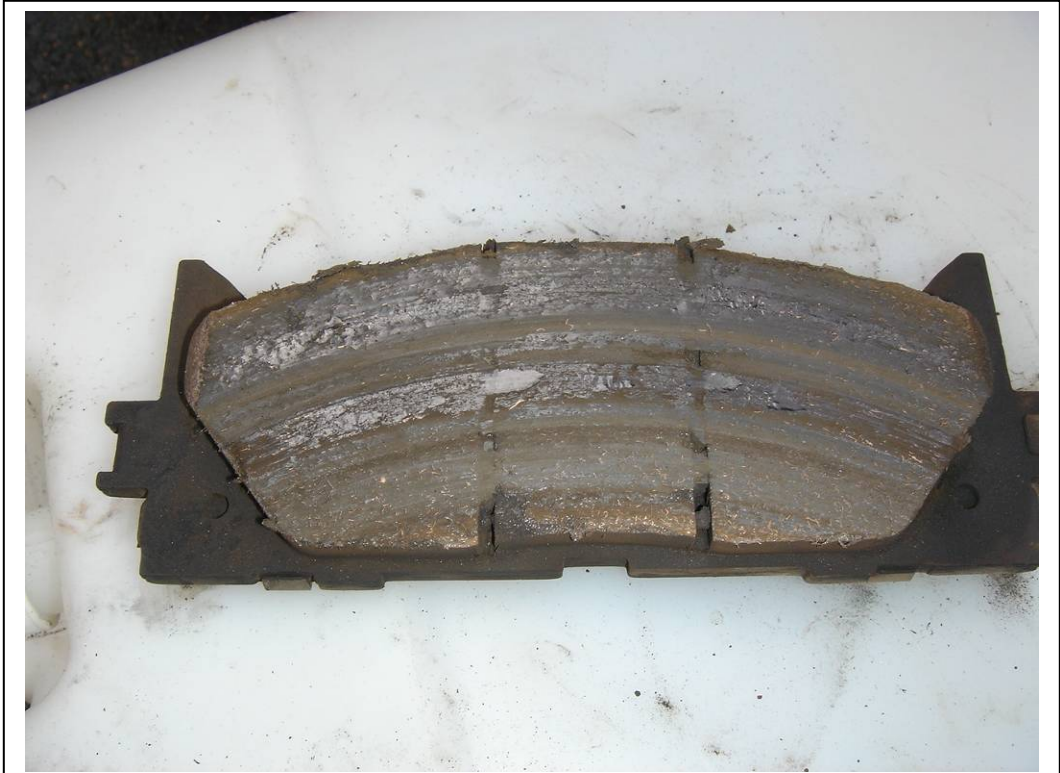
Photo 15: LHF inboard brake pad, friction surface

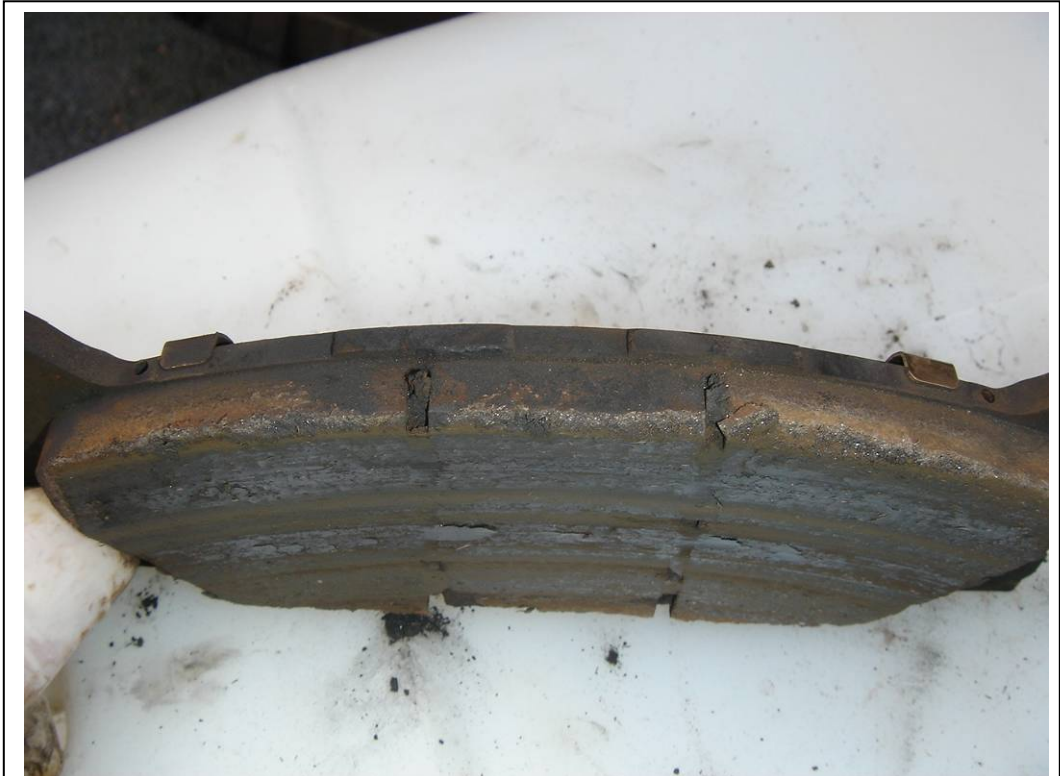
Photo 16: LHF inboard brake pad, friction surface
