#07-08-64-007D: General Power Sliding Side Door Diagnosis/Repair Procedure - (Jul 21, 2008)

Subject: General Power Sliding Side Door Diagnosis/Repair Procedures

Models: 2005-2007 Buick Terraza
2005-2009 Chevrolet Uplander (Includes Canada and Mexico)
2005-2009 Pontiac Montana SV6 (Includes Canada and Mexico)
2005-2007 Saturn Relay

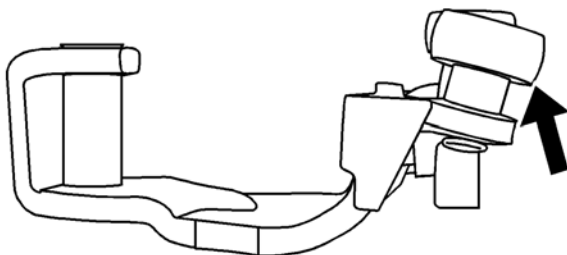
The power sliding side door motor continues to run for up to three seconds after the door has fully closed or the customer may describe this as a grinding noise (Overcinch).

1. A center roller bracket may be bent or have loose rollers. Refer to the illustration above.
2. The power sliding side door may not have the latest programming.
3. The door is closing too quickly. It needs to see two detente signals 450 milliseconds apart. The latest program calibration for the PSD, in combination with the door to body adjustment and the proper seal flange adjustment at the rear latch, slows the sliding door into the latch, allowing the system to appropriately determine the secondary and primary latch position. This minimizes overcinching.

1. Remove and inspect the center roller bracket. If the rollers are loose to the bracket or bent, replace the bracket.
2. After replacing the center roller bracket, check for a properly tensioned door. Refer to Rear Side Door Actuator Cable Tension Adjustment.
3. Upload the new programming. Latest PSD Software calibration can be found on the Service Programming System (SPS) using "TIS2WEB". Input of the VIN will find the latest software calibration program to upload to the PSDM controllers in the vehicle . If the overcinching is still present, go to step 4.

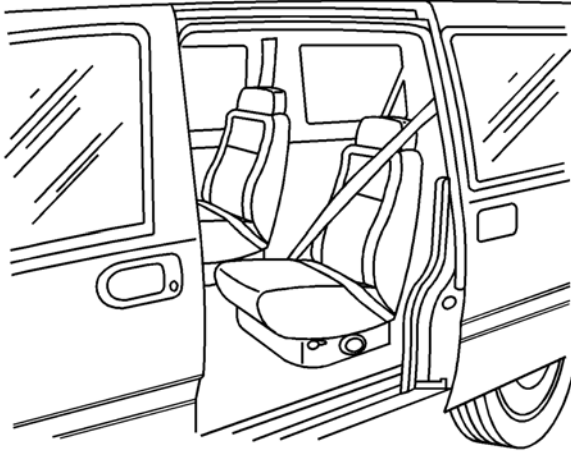
1. Inspect the door opening and tracks for obstructions. Refer to the illustration above.

1. Eliminate any obstructions in the tracks.

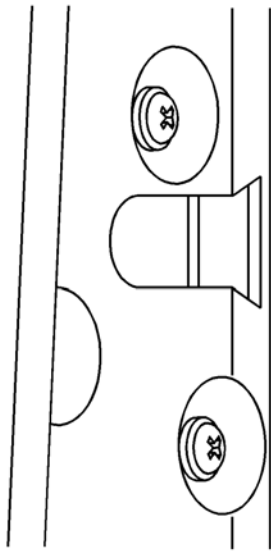
2. Inspect the C-Pillar striker alignment. Refer to the illustration above. Look for witness marks on the top and bottom of the latch. Turn the system off and close the door. Open the door slowly and look to see if the door jumps up, or falls off the striker. The striker should line up with the center of the latch. Its purpose is to hold the door shut and adjust in or out, not up and down. Up or down adjustments should be made at the center roller bracket.

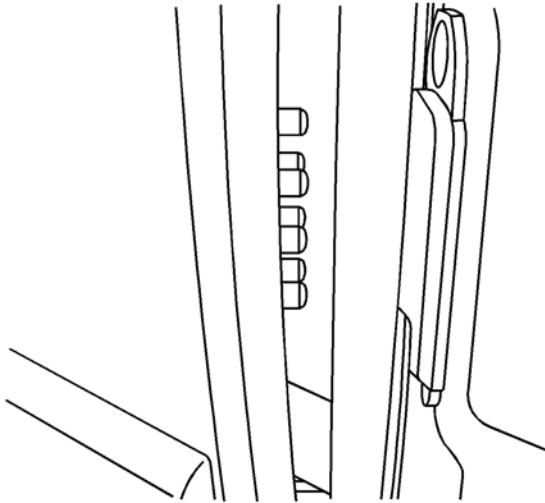
3. Inspect the pad and plunger alignment. Refer to the illustration above.

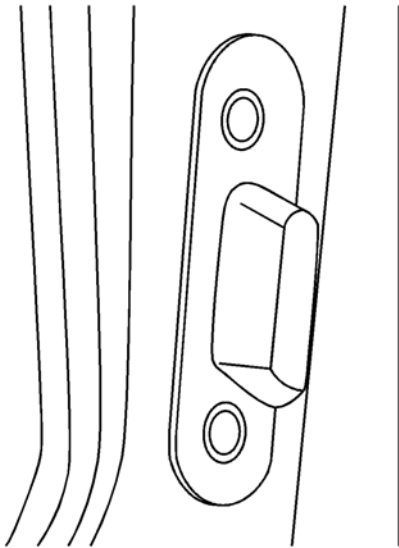
4. Inspect the pin and pocket alignment. Refer to the illustration above. Coating the pin with white lithium grease will leave visible witness marks on the pocket.

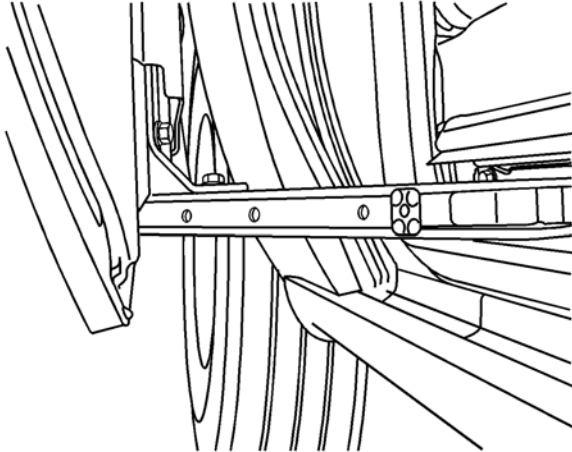
5. Inspect the lower hinge arm clearance to the primary seal. Refer to the illustration above. If there are witness marks on the lower weatherstrip towards the front, the lower roller bracket will need to be adjusted.

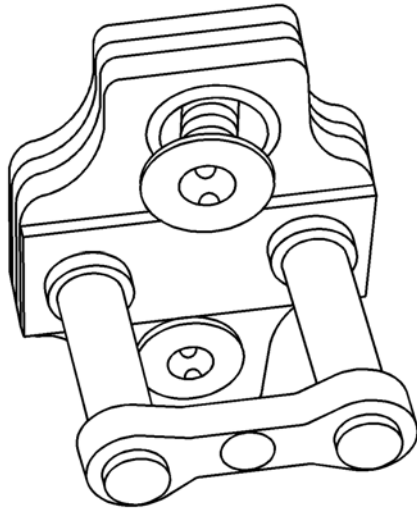
6. Inspect all door hardware for alignment and to make sure it is properly seated. Refer to the illustration above.

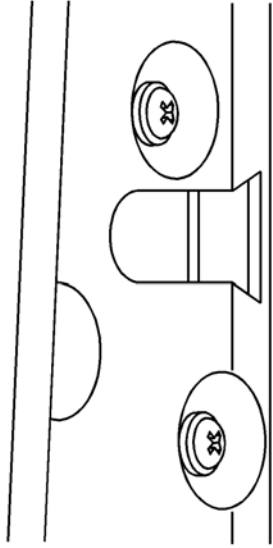
1. Inspect the "C" pillar for proper alignment. Refer to the illustration above.

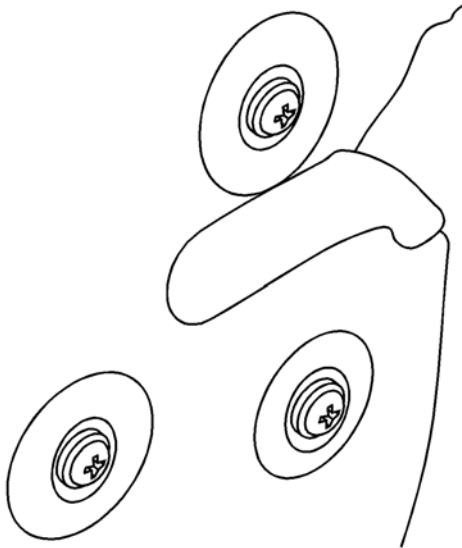
2. Inspect the "C" pillar for latch wear. Refer to the illustration above.
3. Inspect the "C" pillar for a bent striker.

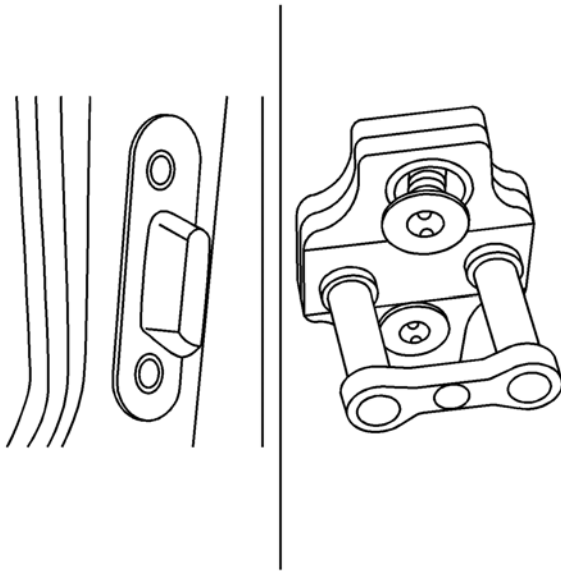
4. Inspect all door hardware for alignment and make sure it is properly seated. Refer to the illustration above.
